**Reference: Dam Break and Inundation Assessments
Equity Silver Mine, Houston, B.C.**

**DAM BREAK AND INUNDATION ASSESSMENTS
EQUITY SILVER MINE**

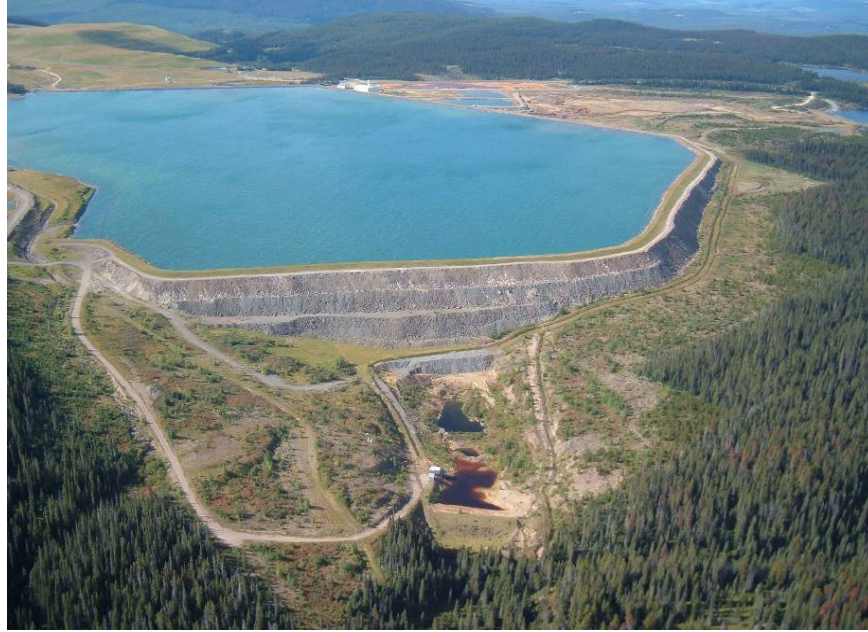
Photo 1: Aerial photograph of the Tailings Pond Dam No. 1 with Seepage Pond in foreground and treatment facilities in the background. Taken 29 August 2006.

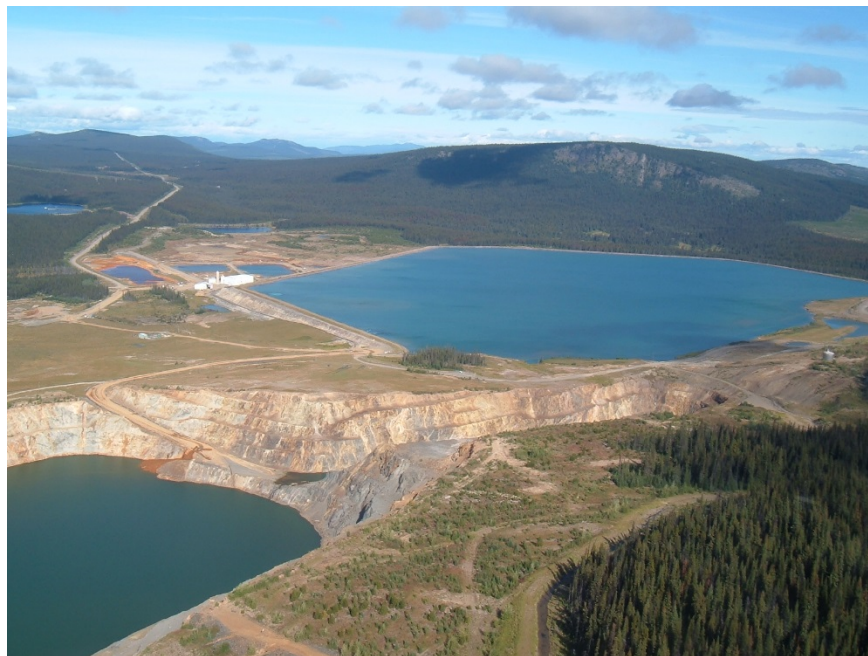
Photo 2: Aerial photograph of the Main Zone Pit and Tailings Pond Dam No. 2 with treatment facilities on the left of the photograph. Note electrical substation in open area directly downstream of Dam No. 2. Taken 29 August 2006.

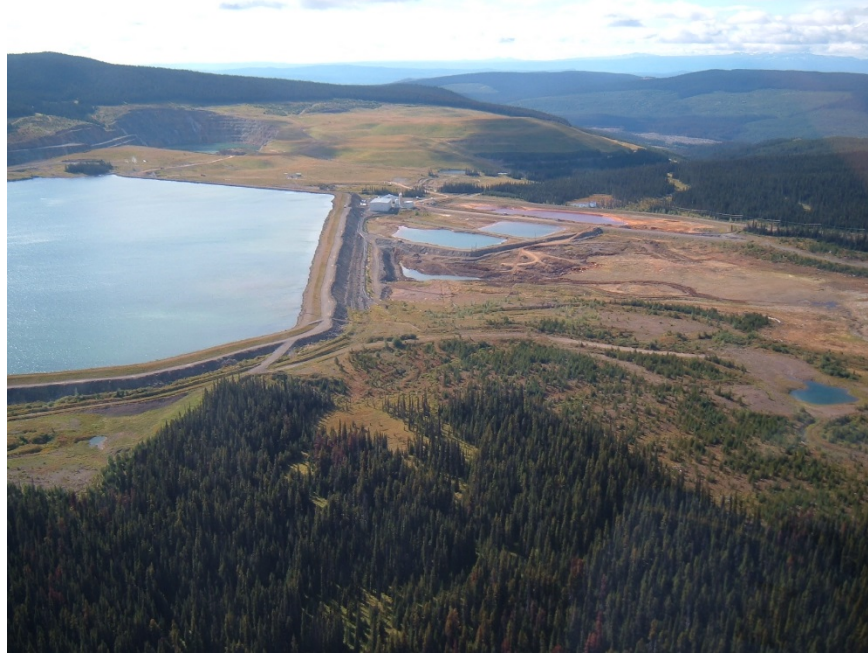
Photo 3: Aerial photograph of the Tailings Pond Diversion Dam and downstream treatment facilities.
Taken 29 August 2006.

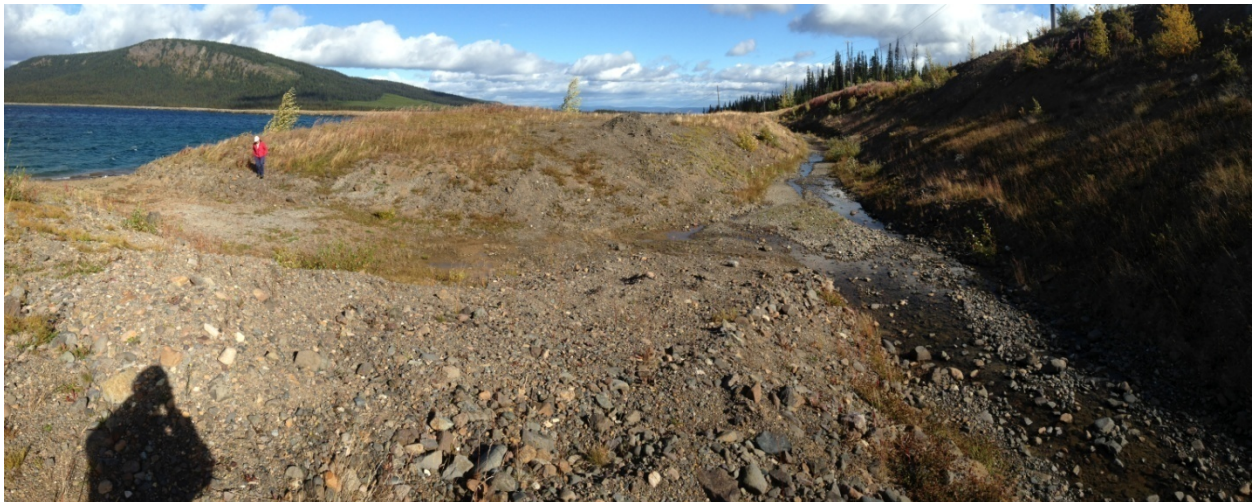
Photo 4: Tailings Impoundment spillway channel and outlet into Berzelius Diversion Channel.
Taken 18 September 2014.

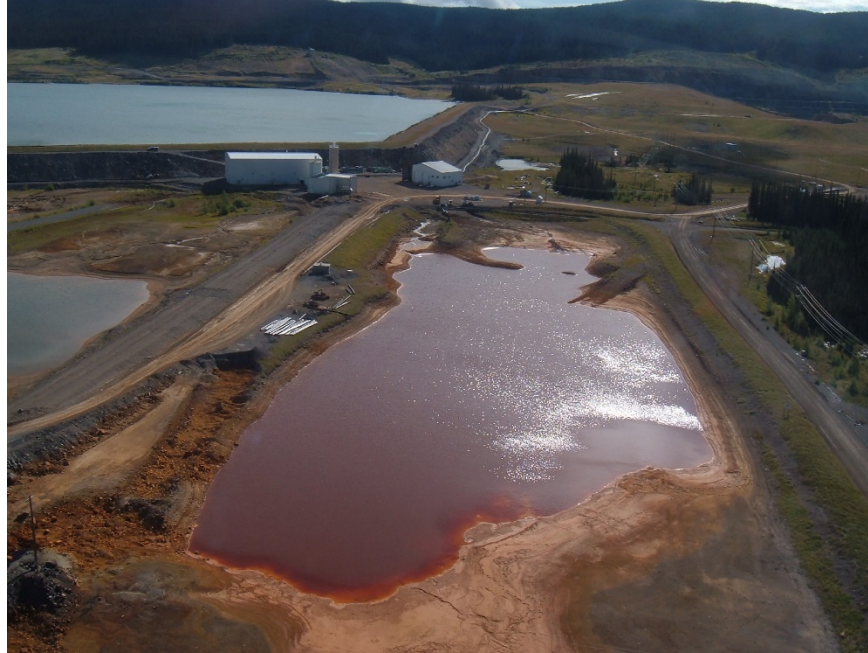
Photo 5: Aerial photograph of the ARD Storage Pond, treatment facilities and offices, and Tailings Pond with Dam No. 2 in the background. Taken 29 August 2006.

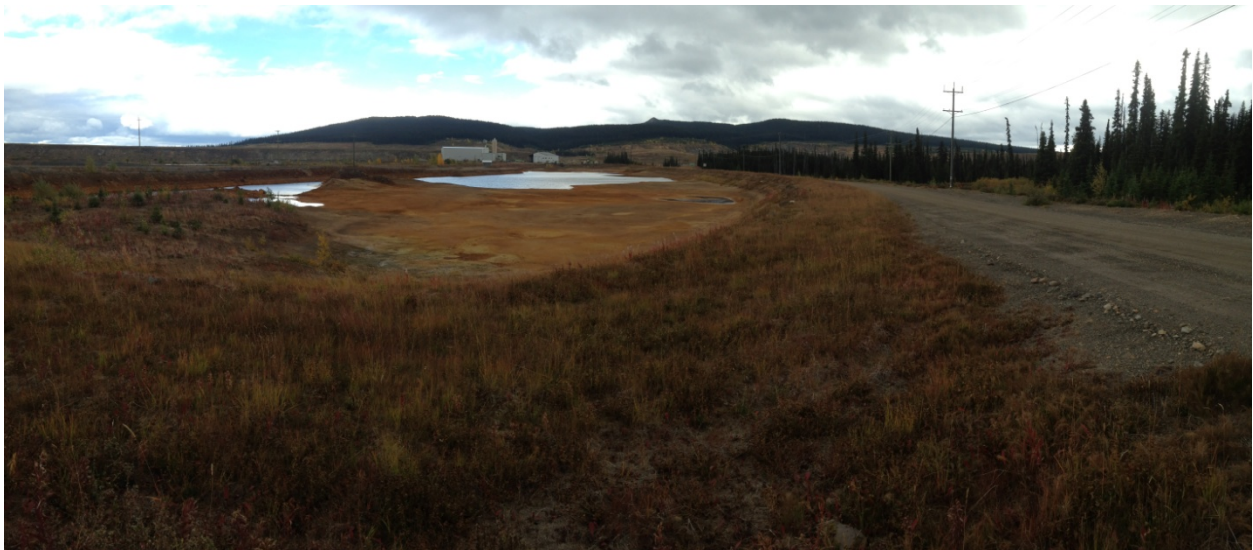
Photo 6: ARD Storage Pond, view of the pond and upstream side of the dam, and the South Dam on the left hand side of the photo. Note low water level. Taken 29 August 2006.

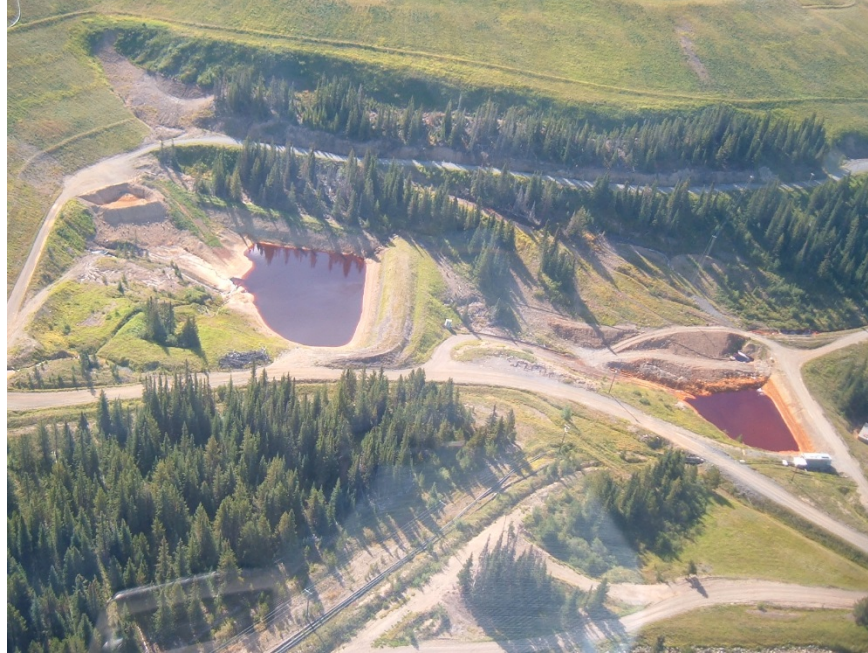
Photo 7: Aerial photograph of the ARD Surge Pond and Main ARD Pond with associated infrastructure. Taken 29 August 2006.

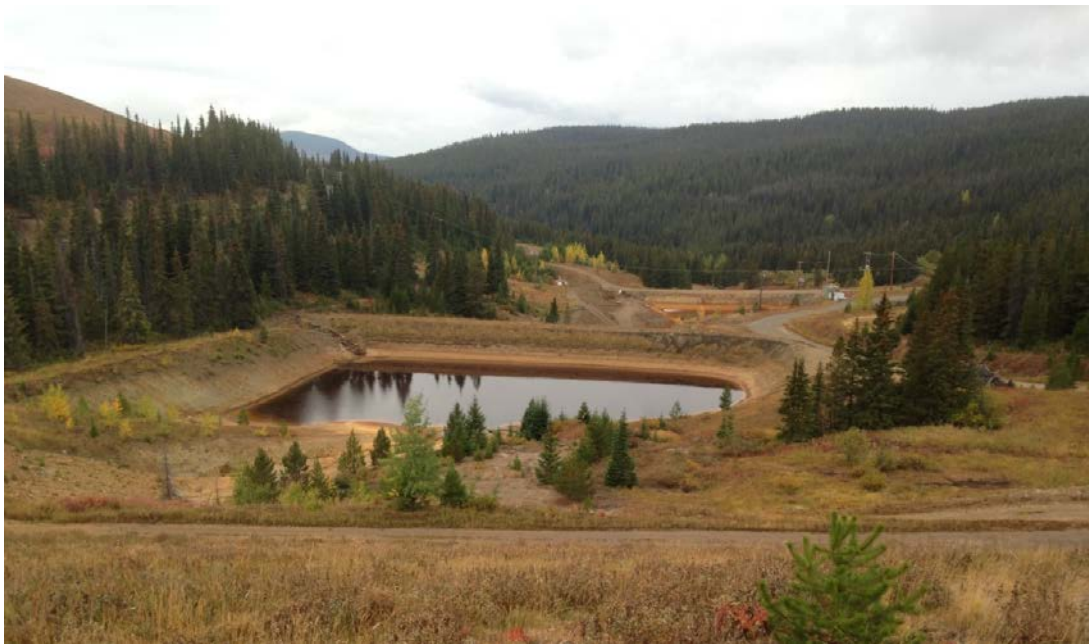
Photo 8: ARD Surge Pond and Main ARD Pond, view from the waste dump above. Taken 18 September 2014.

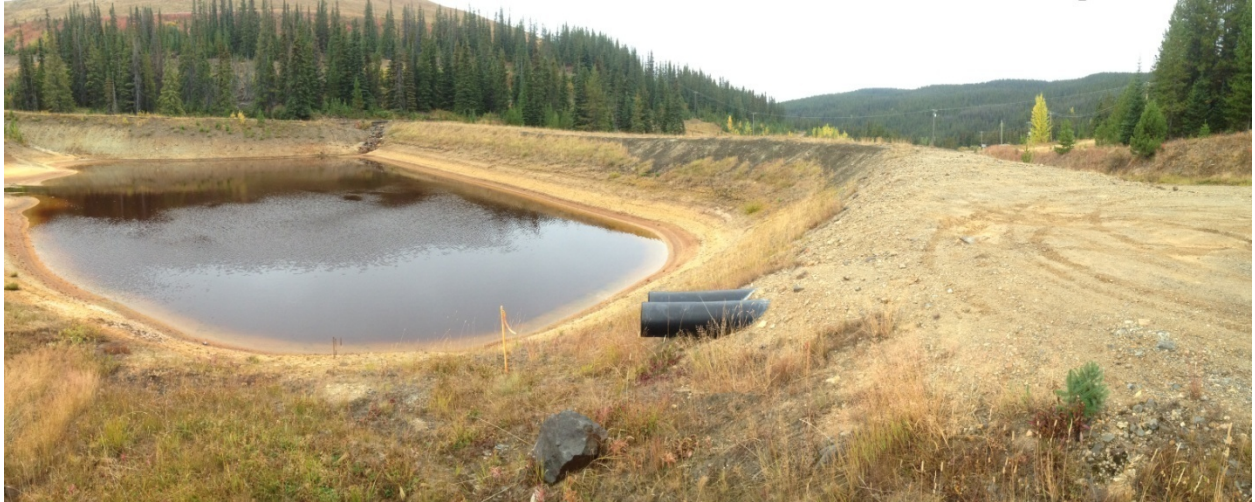
Photo 9: ARD Surge Pond, view of upstream slope and spillway inlet pipes.
Taken 18 September 2014.

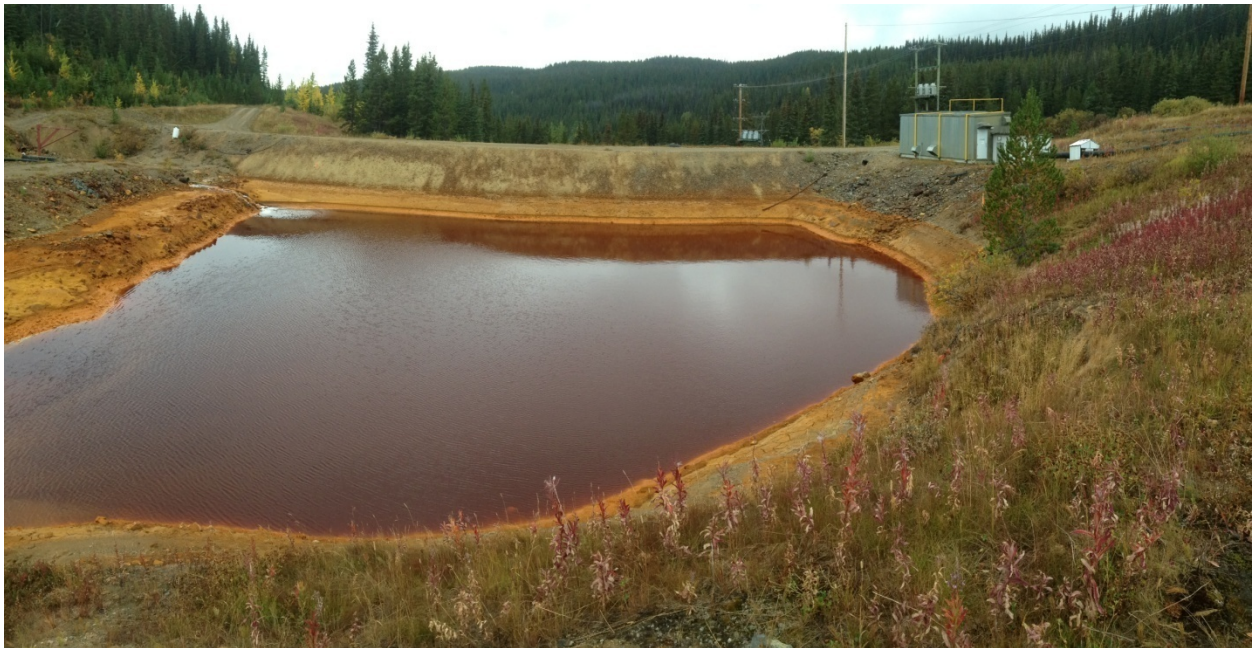
Photo 10: Main ARD Pond Dam, view of upstream side. Taken 18 September 2014.

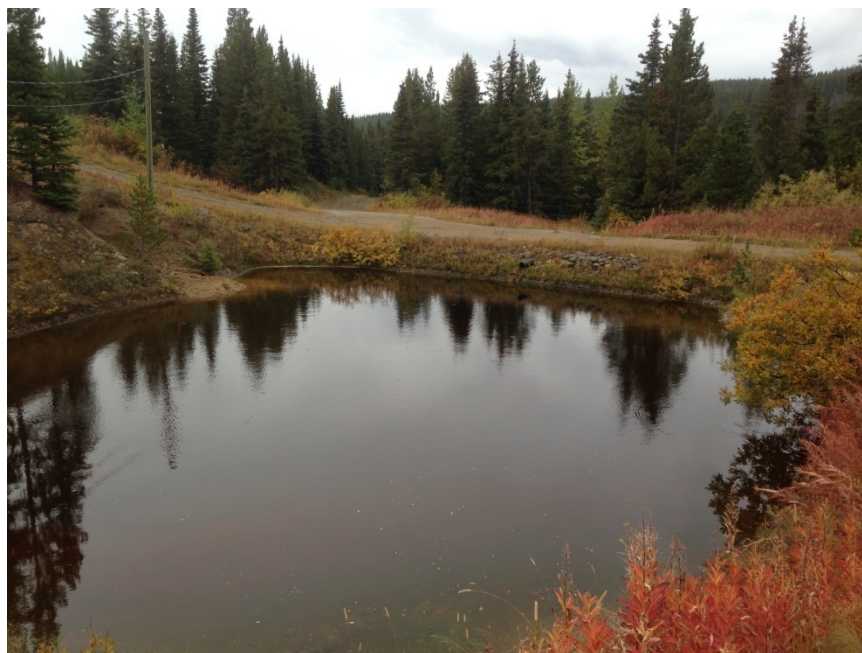
Photo 11: No. 1 Sump Dam, view of upstream crest and road. Taken 18 September 2014.

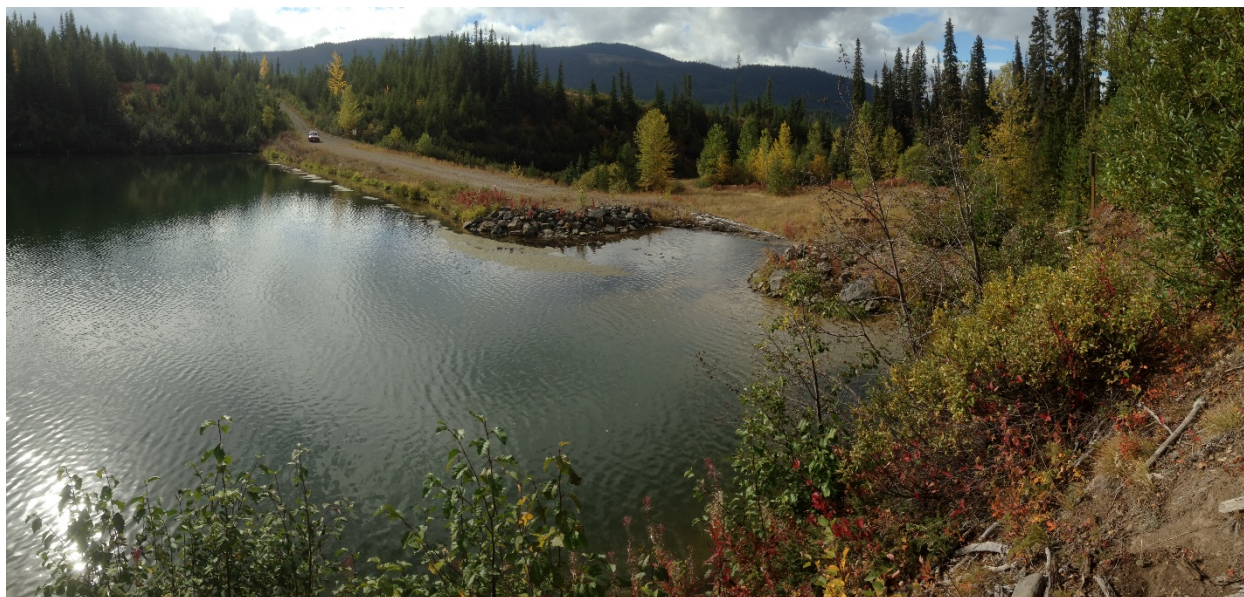
Photo 13: Bessemer Creek Silt Check Dam, view of upstream face and pond from right abutment.
Taken 18 September 2014.

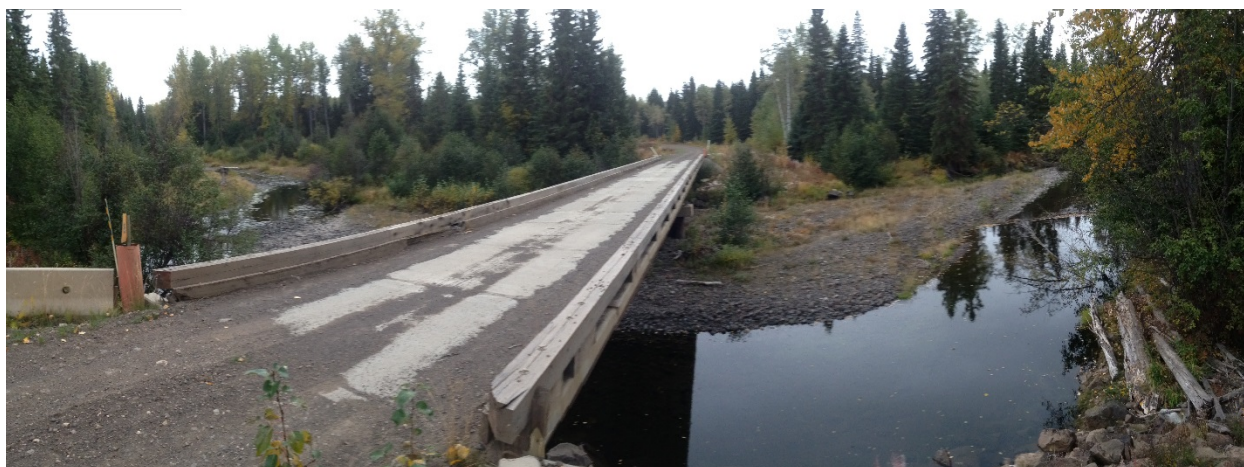
Photo 17: Bridge on Foxy Creek downstream of the confluence with Maxan Lake outlet.
Taken 18 September 2014.

Beyond, the No. 1 Seepage Pond Dam, no significant structures have been identified along Foxy Creek downstream of Dam No. 1 until the forestry bridge on Maxan Creek. At the outlet of Bulkley Lake there is a bridge crossing for CN Rail and several farms with houses and other buildings. Failure of Dam No. 1 would overwhelm and washout the No. 1 Seepage Pond Dam. **DWG02** shows that the forestry bridge on Maxan Creek may be overwhelmed and washed out by sunny-day and flood-induced failures of Dam No. 1. Despite potential attenuation in Bulkley Lake, **DWG02** shows that the bridge crossing for CN Rail downstream of the lake may be overwhelmed and washed out by sunny-day and flood-induced failures of Dam No. 1. In addition, the majority of the houses and other buildings on the farms downstream of Bulkley Lake will be within the floodplain of both the sunny-day and flood-induced failures of Dam No. 1. However, some of the flow may bypass the flat area leading to Bulkley Lake and head directly to the area downstream of the lake outlet resulting in lower flood attenuation and higher flows.

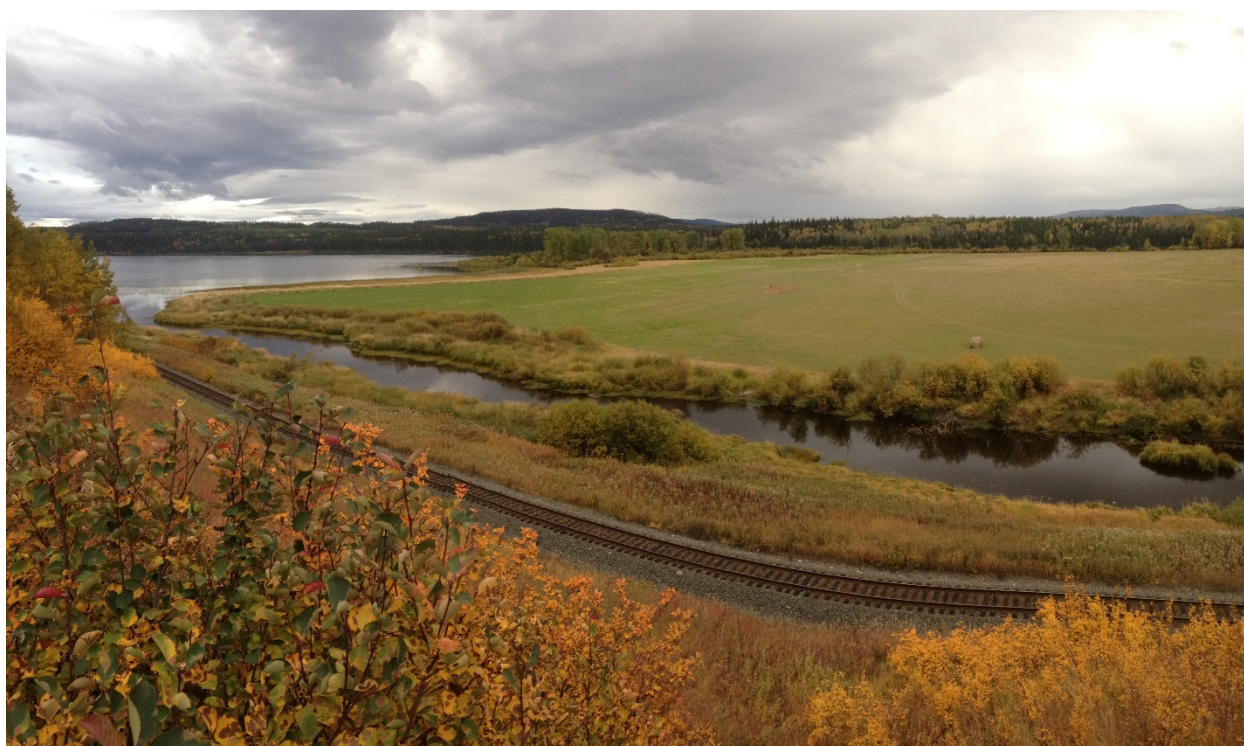
Photo 18: Outlet of Bulkley Lake. Taken 18 September 2014.

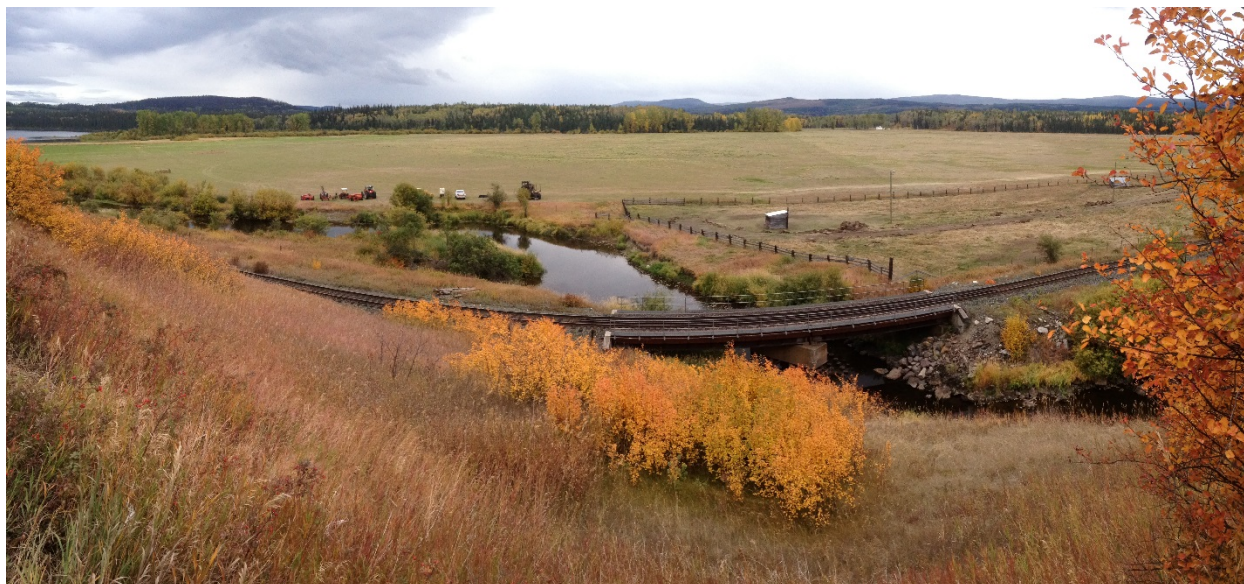
Photo 19: Railway Crossing downstream of the Bulkley Lake outlet. Taken 18 September 2014.

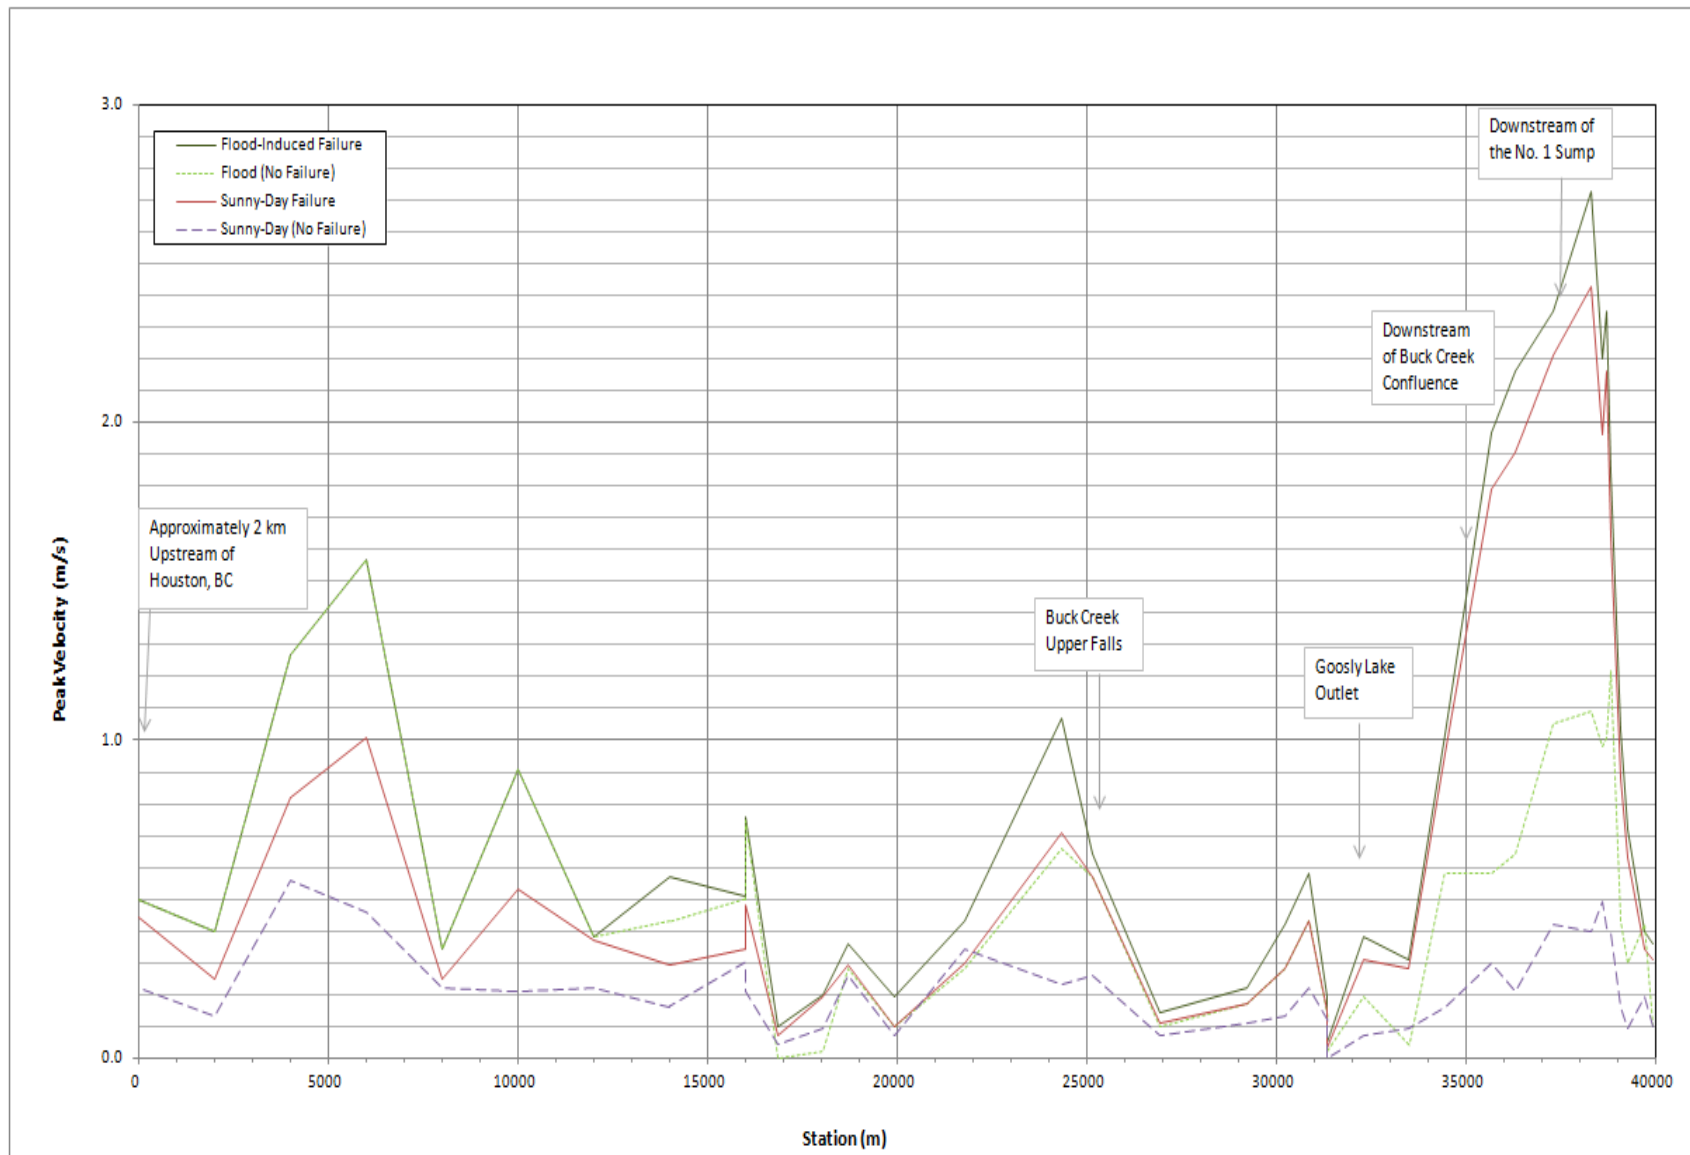
Figure C.5: Peak Velocity for Dam No. 2 (Assessment 2)
