## Tailings Storage Facility – Emergency Preparedness Plan

This document is the Emergency Preparedness Plan (EPP) for the Gibraltar Tailings Storage Facility (TSF) focusing specifically on incidents that may lead to a breach in the tailings dams, and taking into account the facility's current configuration, and its projected changes to the end of the mine's life. In August 2012, Gibraltar Mine completed a long-term deposition plan for the TSF. Cyclone sand deposition will be restarted in order to maximize the storage capacity of the existing tailings facility.

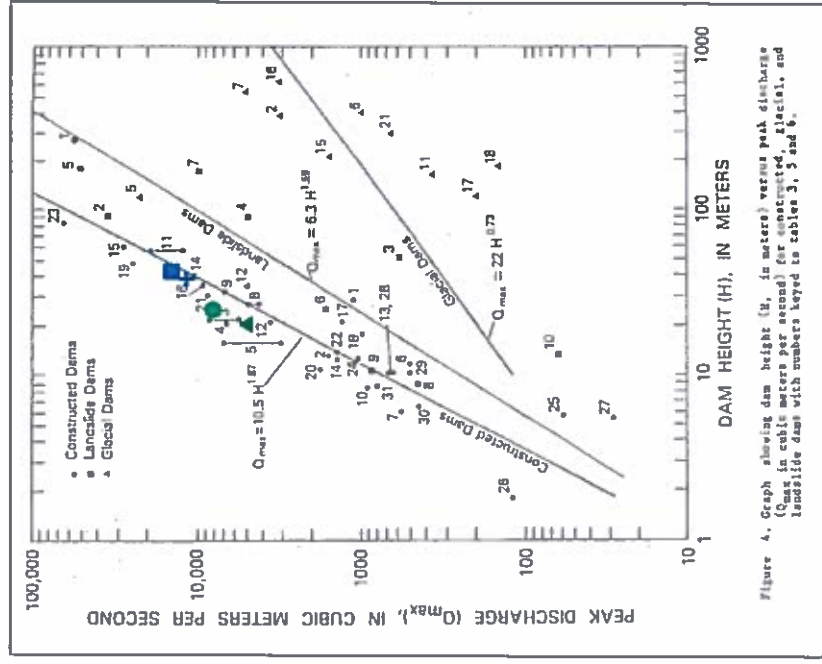
Figure 4. Graph showing dam height (H, in meters) versus peak discharge (Q<sub>max</sub> in cubic meters per second) for constructed, glacial, and landslide dams with numbers keyed to tables 3, 5 and 6.

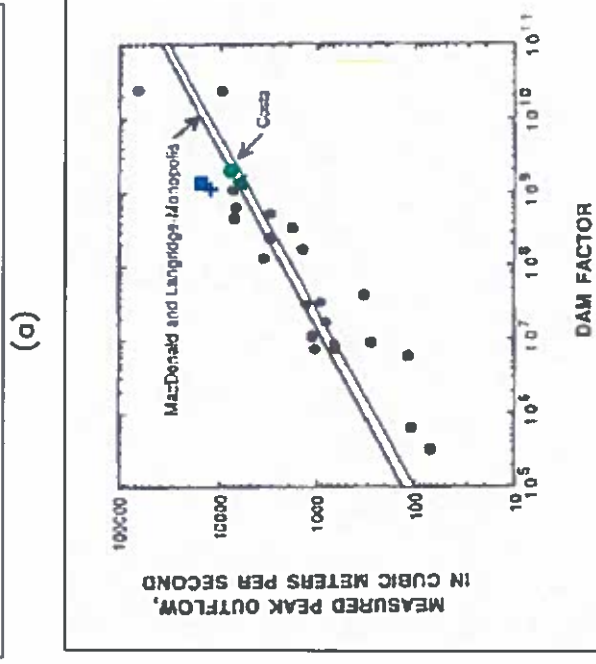
Figure 6. Graph showing measured peak outflow (in cubic meters per second) versus dam factor (H x V) for constructed, glacial, and landslide dams with numbers keyed to tables 3, 5 and 6.

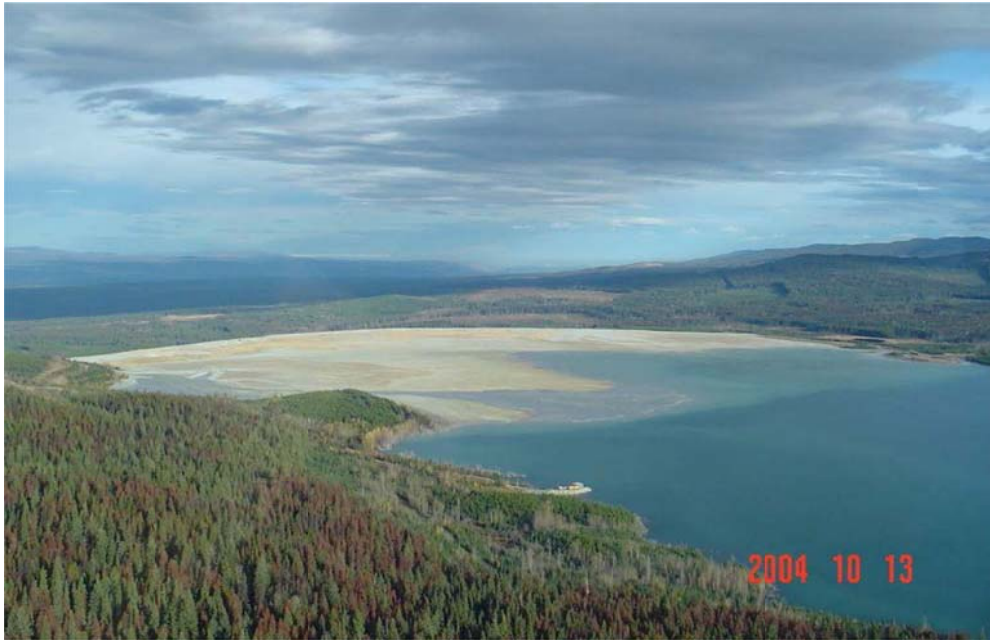
**Photo II-1 Gibraltar tailings pond, looking towards Main Tailings Dam.**

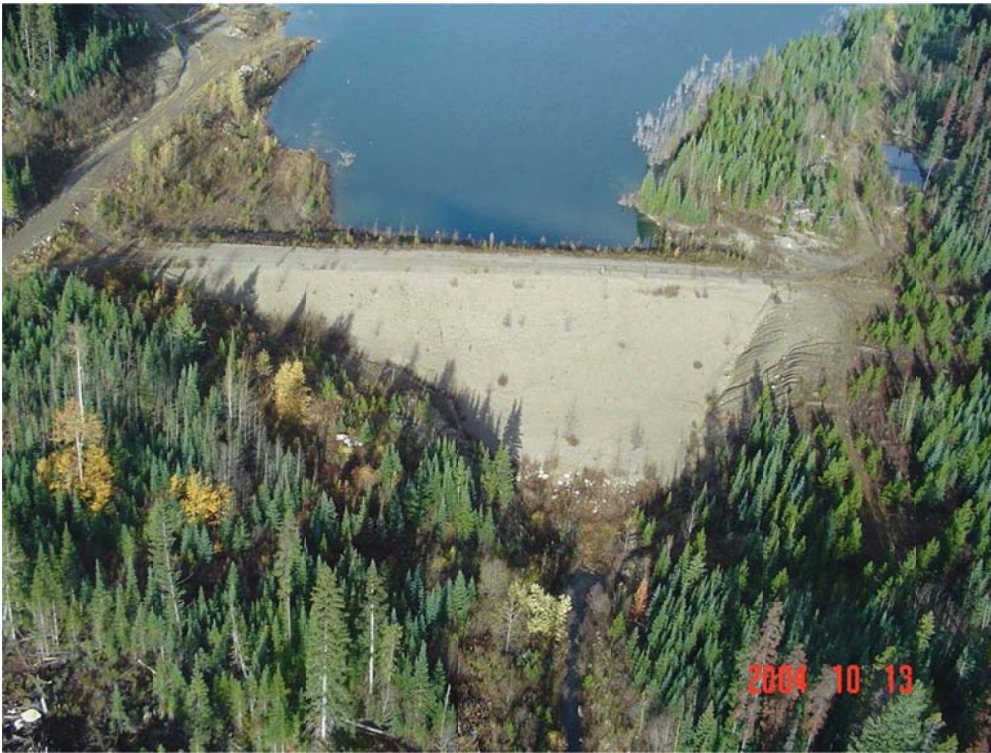
**Photo II-2 Main Tailings Dam as seen from north side of tailings pond.**

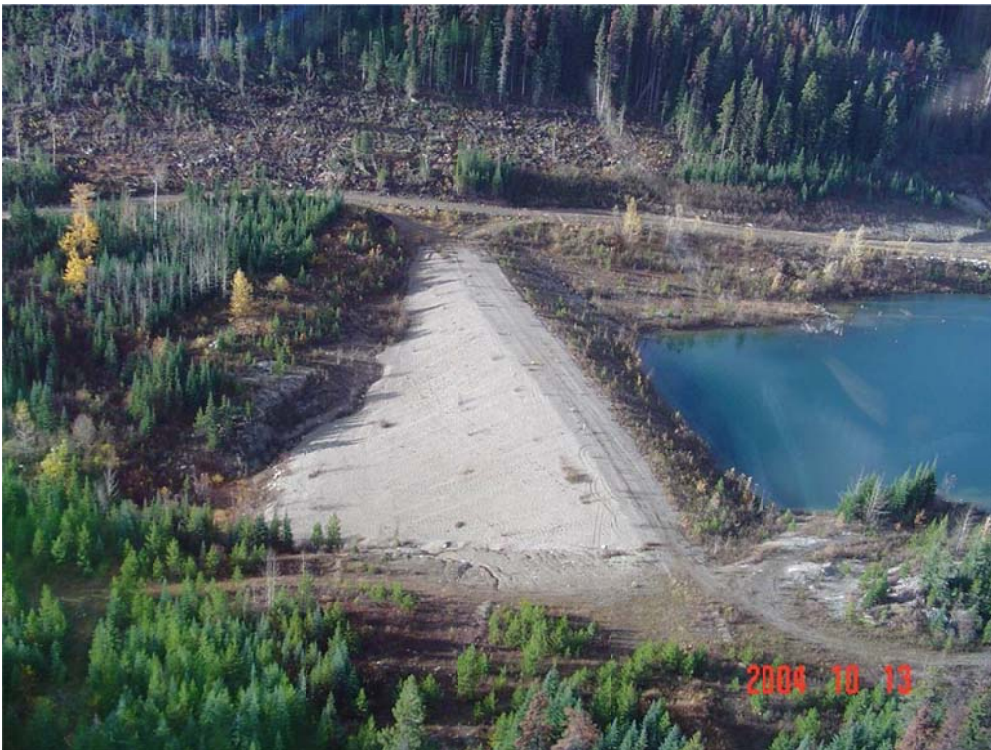
**Photo II-3 East Saddle Dam as seen from downstream.**

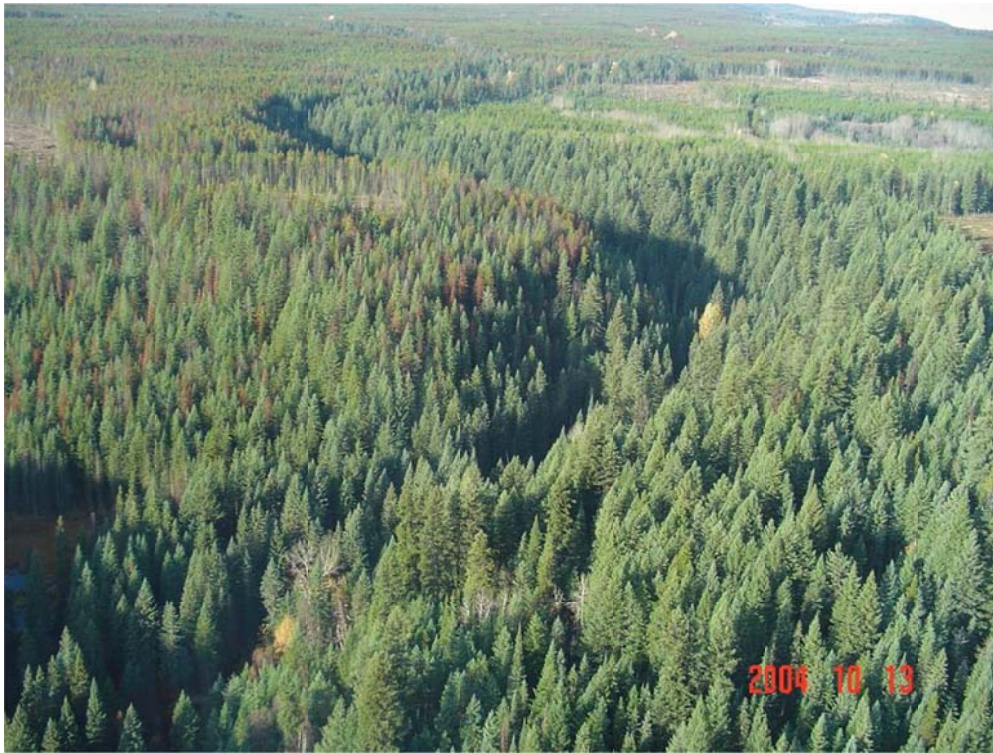
**Photo II-4 East Saddle Dam as seen from north abutment.**

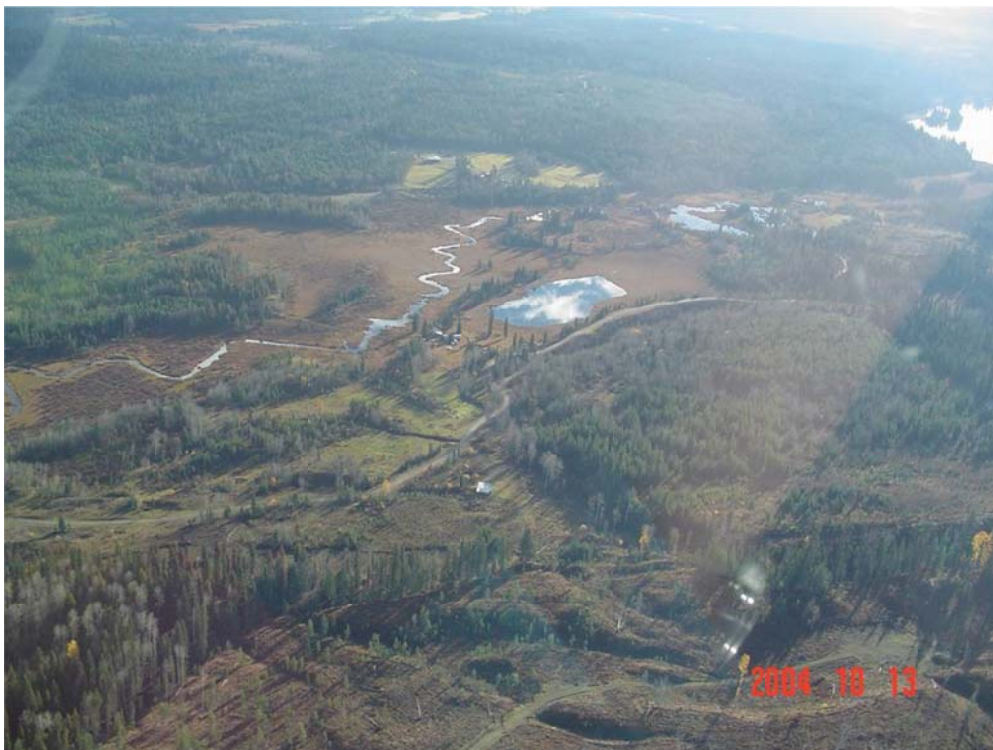
**Photo II-5** Arbutnot Creek below East Saddle Dam, looking downstream.

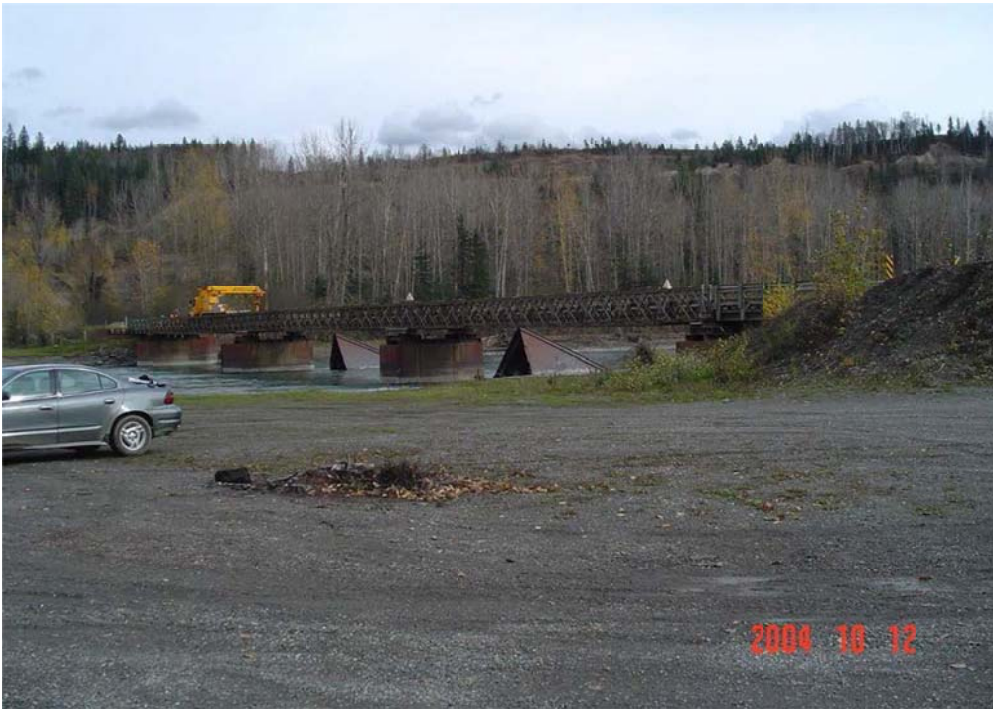
**Photo II-14** Gravelle bridge across Quesnel River, as seen from right bank.

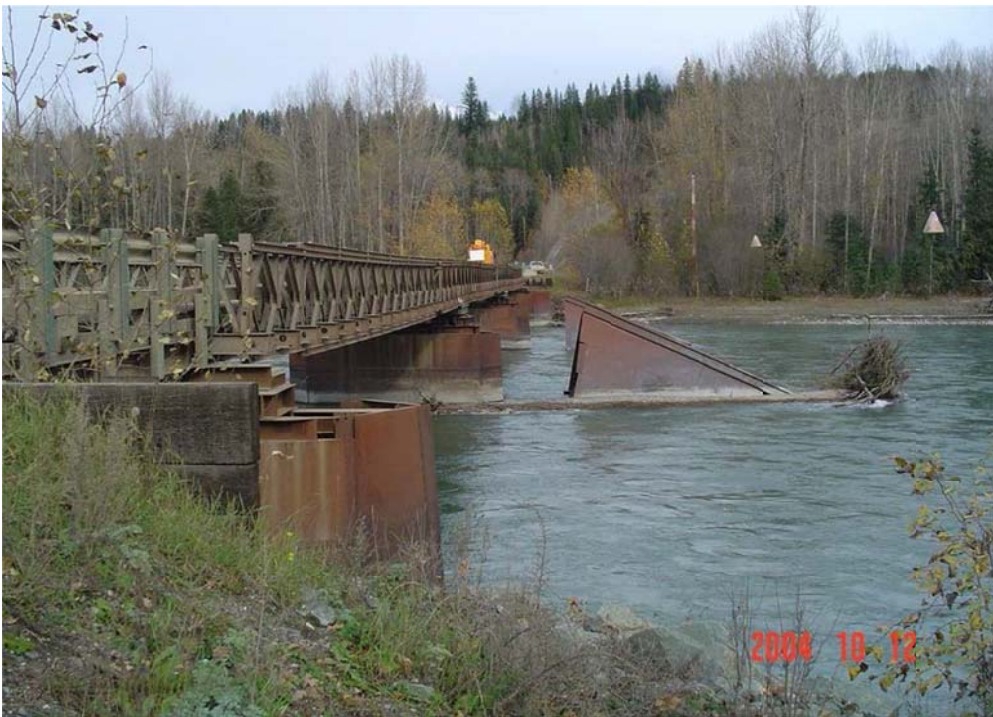
**Photo II-15 Gravelle bridge across Quesnel River as seen from left bank.**

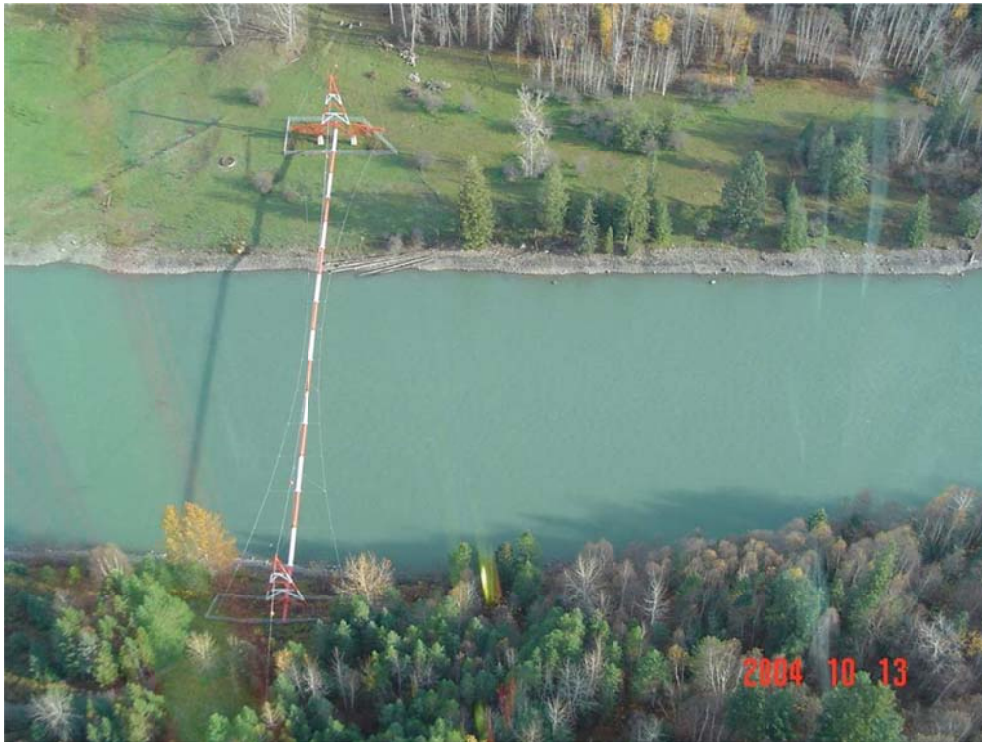
**Photo II-20** Quesnel River at power transmission line crossing.

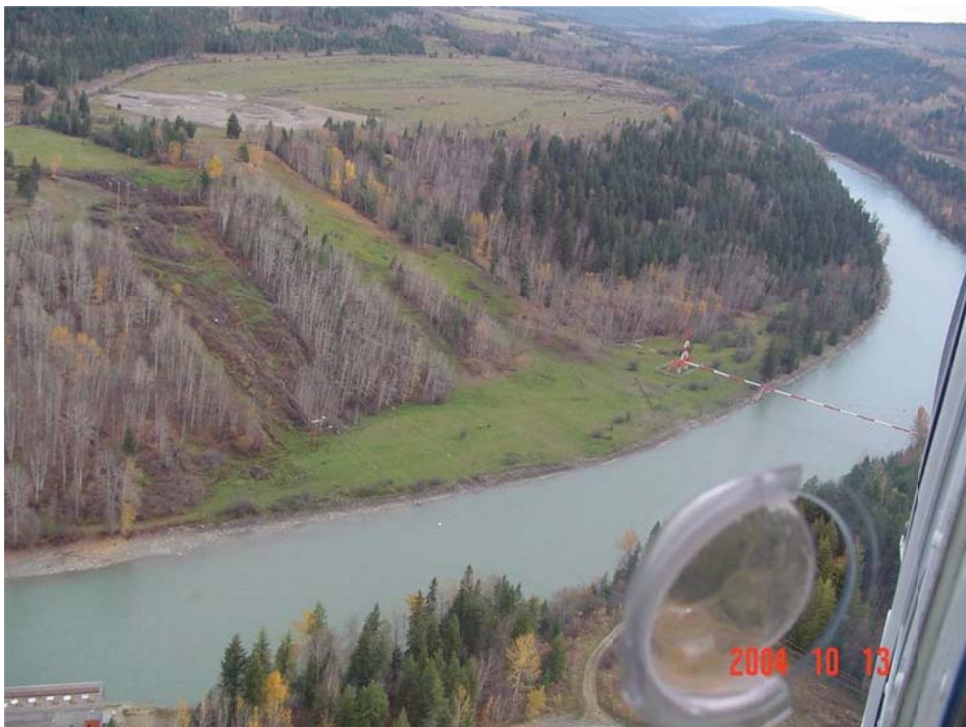
**Photo II-21 Pipeline crossing on Quesnel River at eastern municipal boundary of City of Quesnel.**

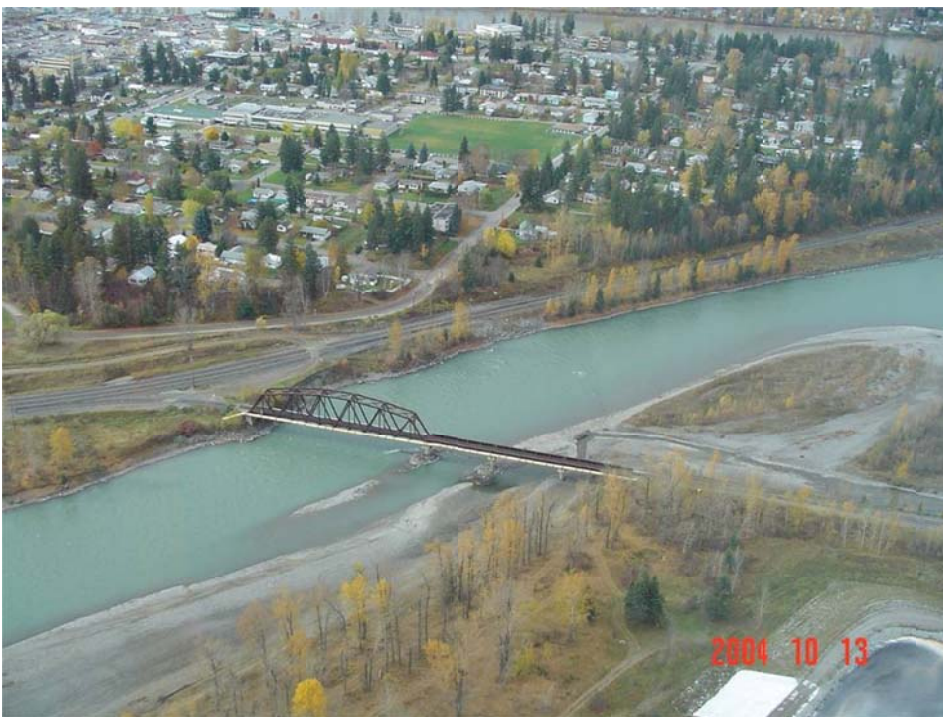
**Photo II-25** Quesnel River, looking upstream. Highway 97 bridge in foreground, railway bridge at mid-photo.

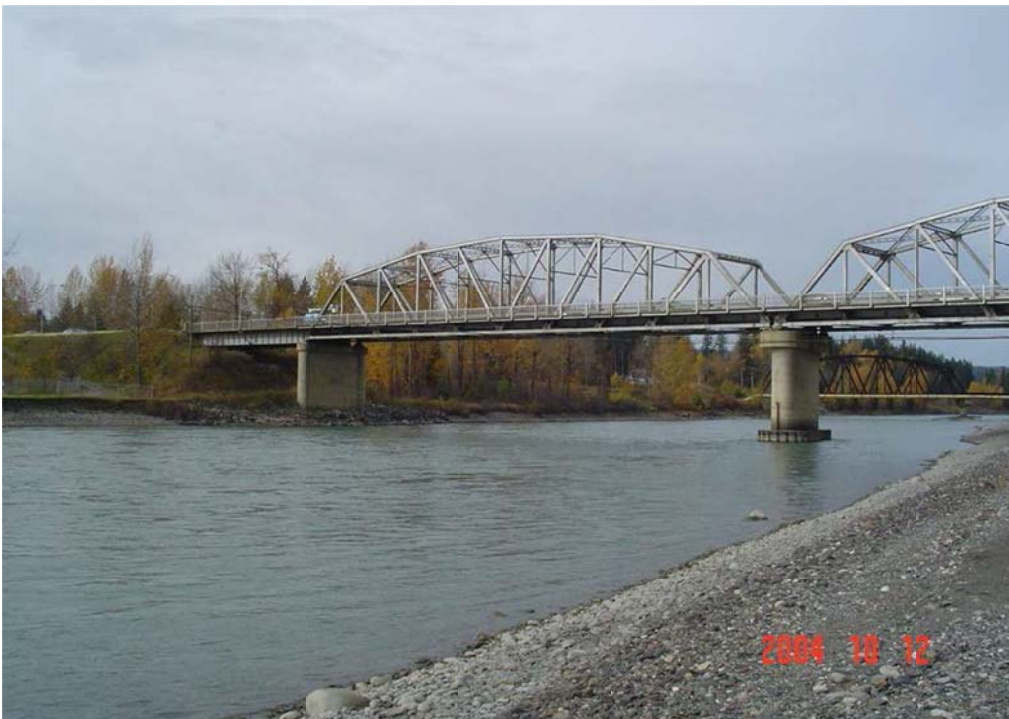
**Photo II-29** Railway bridge across Quesnel River upstream of Highway 97, looking upstream from left bank. Note pipeline strung along the side of bridge.

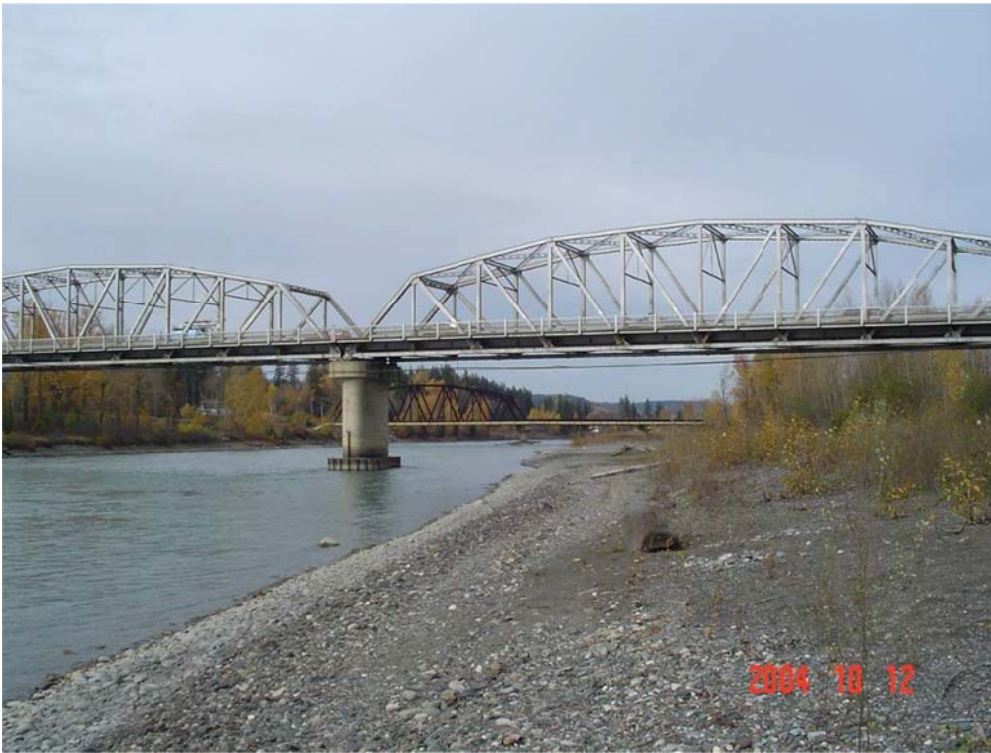
**Photo II-30** Highway 97 bridge on Quesnel River, looking upstream from left bank.

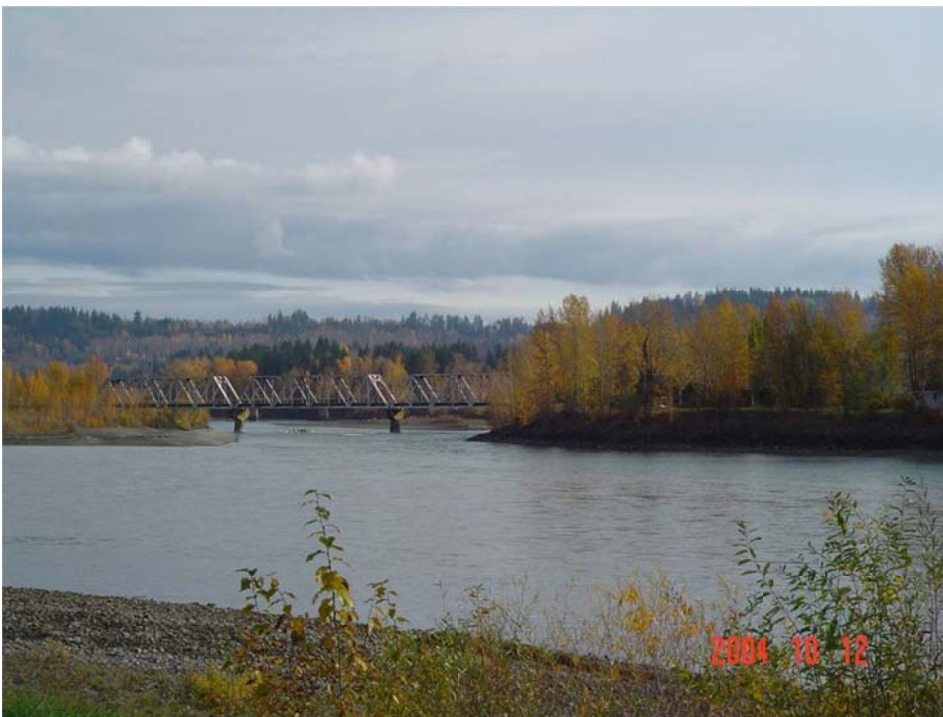
**Photo II-33** Johnston Ave. bridge across the Quesnel River, looking upstream from right bank.

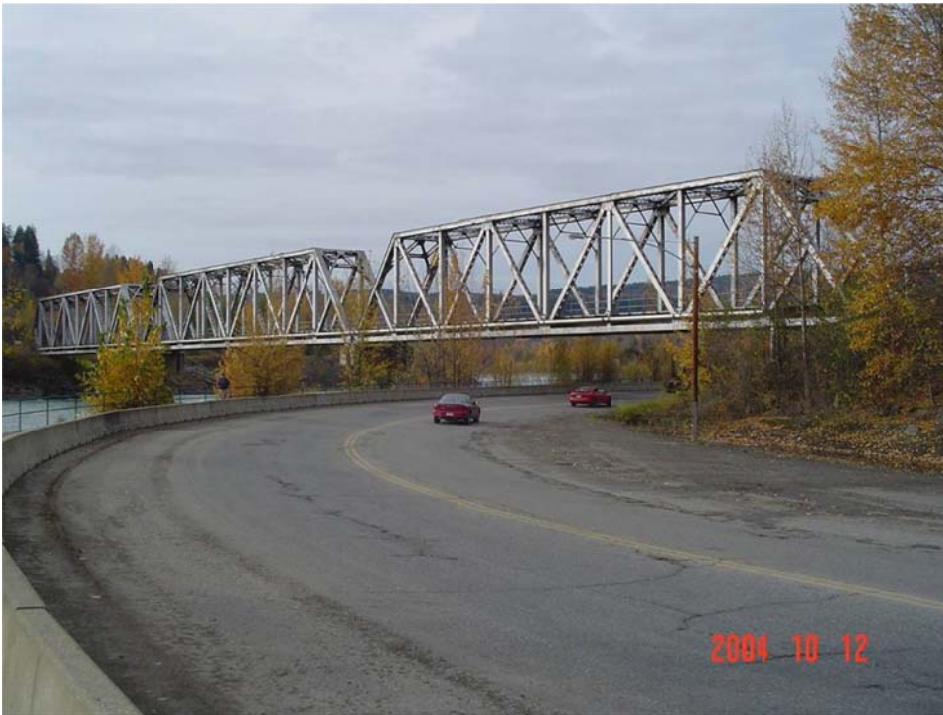
**Photo II-34** Railway bridge across the mouth of the Quesnel River, as seen from right bank of Fraser River.

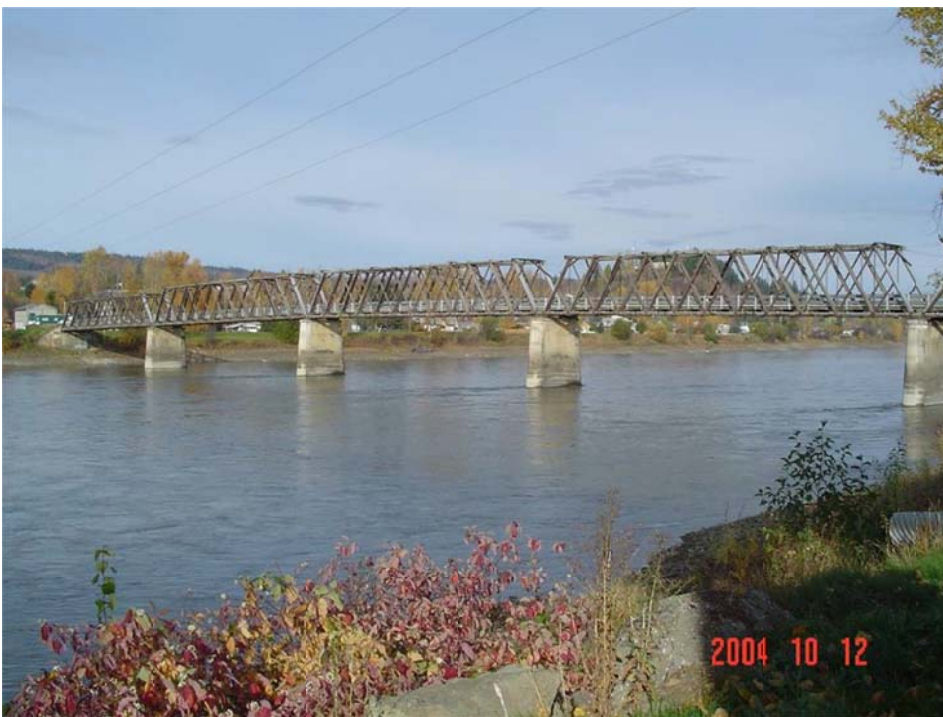
**Photo II-35** Railway bridge at the mouth of the Quesnel River, as seen from the right bank of the river. Flow is left to right.
