**HIGHLAND VALLEY COPPER  
DAM BREAK AND FLOOD INUNDATION STUDY  
BETHLEHEM TAILINGS STORAGE FACILITY POND  
NO. 2 (TROJAN)**

**FINAL REPORT**

**Re: Final Report - Trojan Dam Break and Inundation Study**

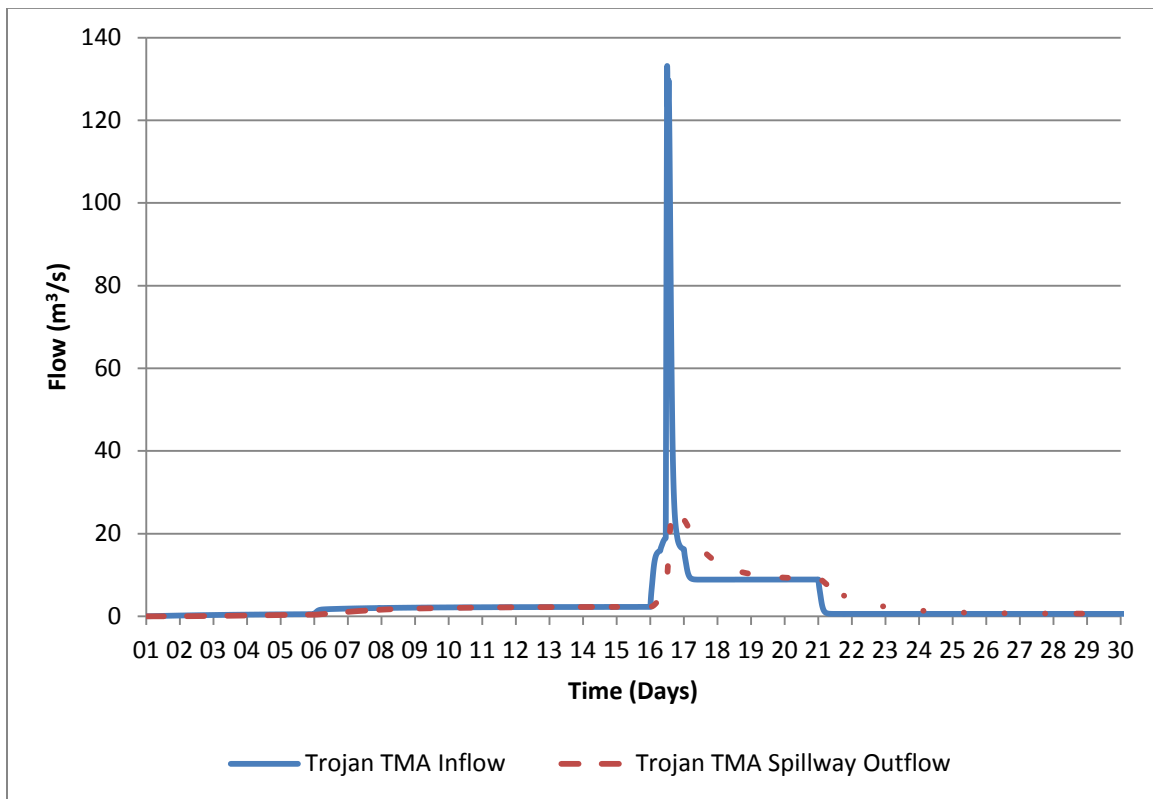
**Figure 5.5 Hydrograph of Inflow to No. 2 Pond and Outflow (Spillway Only) during 30-day PMF Rainfall Event for the Base Case**

The base case conditions were modelled for the five rainfall events outlined in Section 5.1. The resulting inflow and outflow hydrograph for the No. 2 Pond during the 30-day, PMF design storm is shown below in Figure 5.5. Figure 5.5 shows a peak inflow to the No. 2 Pond of 133.2 cubic metres per second (m<sup>3</sup>/s) for the PMF. The corresponding spillway outflow has a peak value of 26.1 m<sup>3</sup>/s. The difference between the peak inflow and outflow values is due to attenuation of inflow by the pond prior to discharging through the spillway. A summary table of the HEC-HMS results is also presented in Table 5.3.

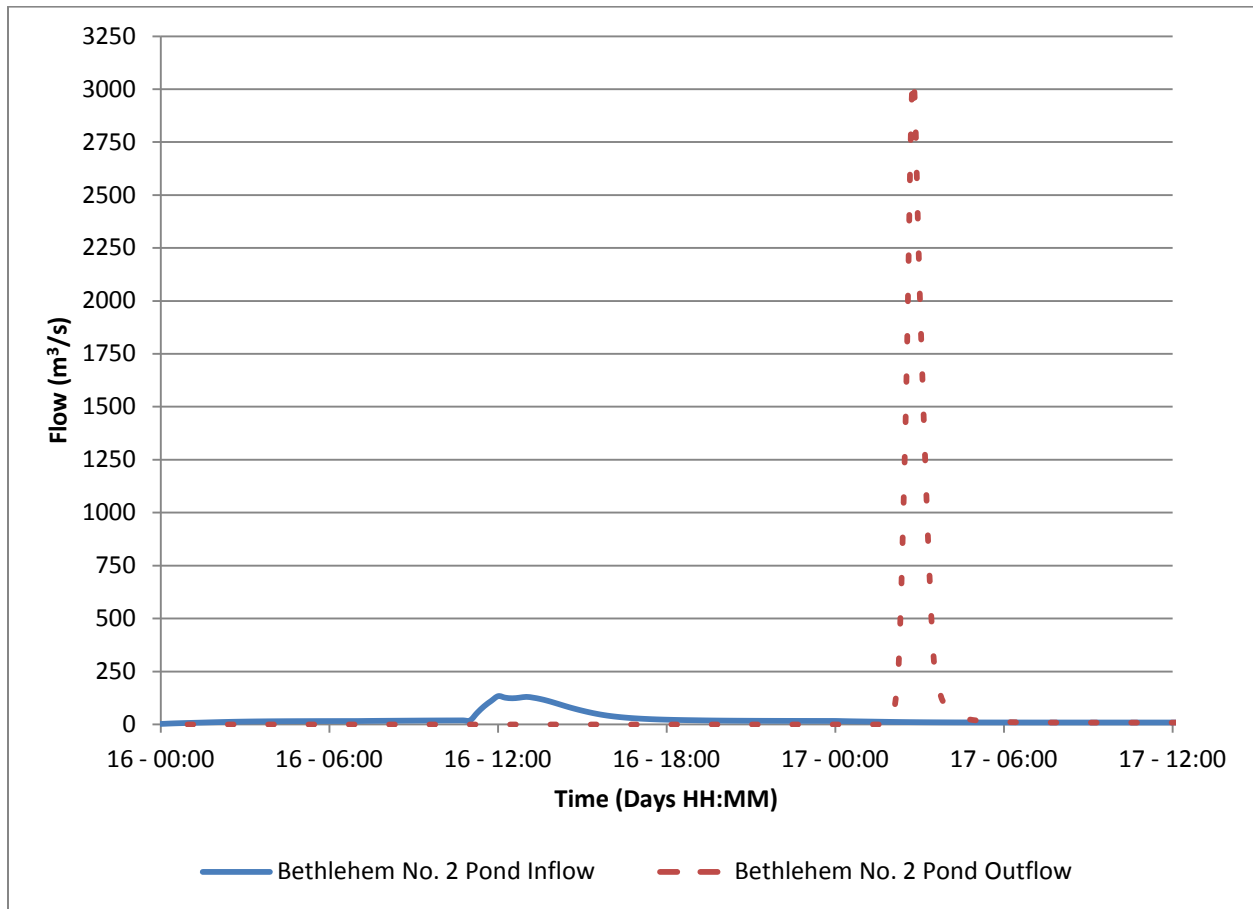
**Figure 6.1 Hydrograph of No. 2 Pond Inflow and Outflow (Spillway and Breach) during 30-day PMF Rainfall Event for Overtopping Dam Failure**

The HEC-HMS model framework used to model base case conditions (no dam failure) was modified to include both an overtopping and piping dam failure. The dam failures were set to coincide with the peak water level in the pond, which resulted in the largest flood wave downstream. Modelling results for the dam failures are presented in Tables 6.1 and 6.2 for overtopping and piping failure, respectively. The No. 2 Pond inflow and outflow hydrographs for the PMF are presented in Figure 6.1 for overtopping and in Figure 6.2 for piping failure.

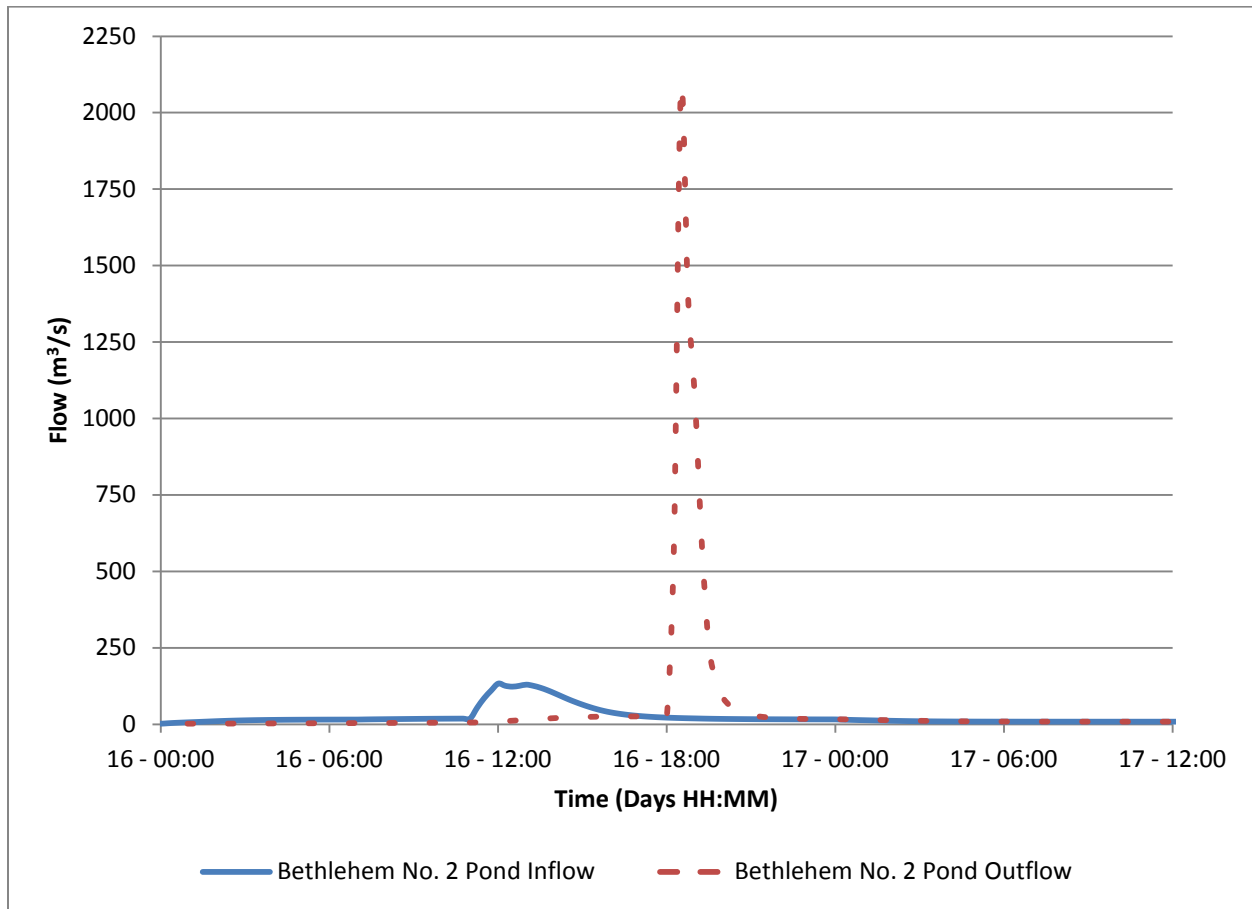
**Figure 6.2 Hydrograph of No. 2 Pond Inflow and Outflow (Spillway and Breach) during 30-day PMF Rainfall Event for Piping Dam Failure**

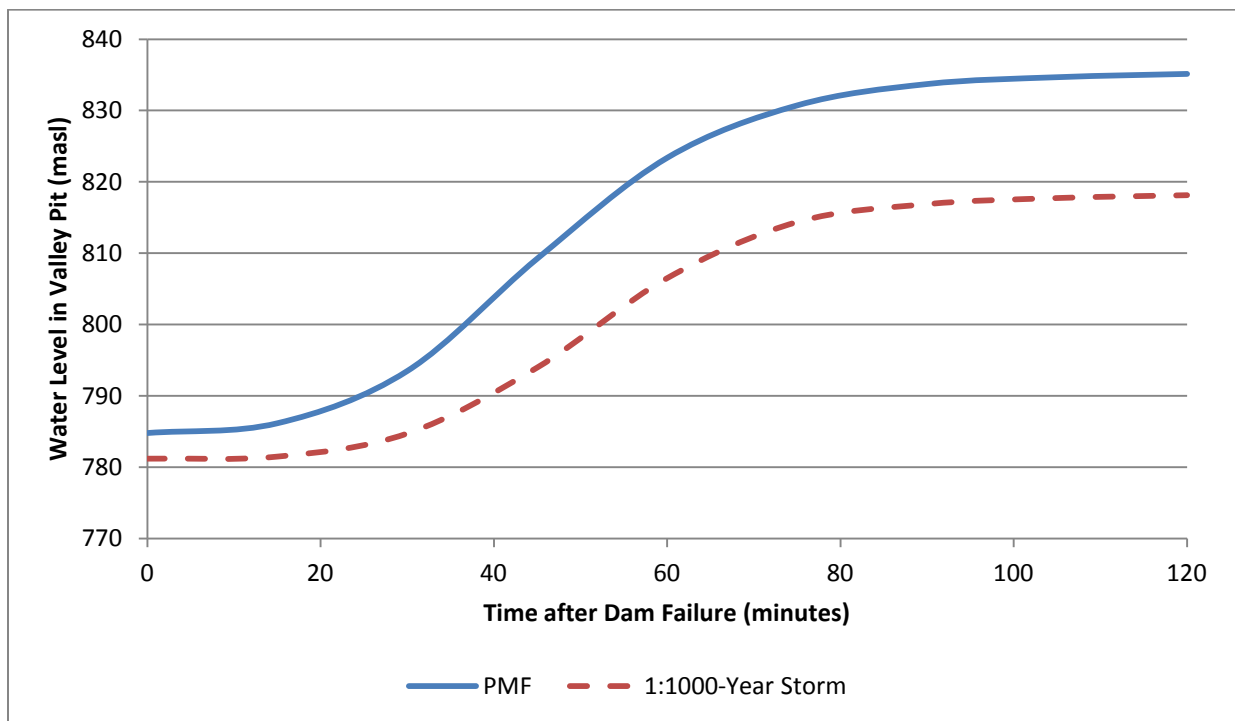
**Figure 7.1 Water Level in Valley Open Pit after 1:1000-year Storm and PMF Failure Scenarios**

Using the stage-storage data developed for Valley Open Pit, the volume of water and corresponding flood level in the pit has been modelled. Table 7.1 shows the final water surface elevation within the pit after each of the rainfall events considered for this study. This exercise was completed for both the base case and for overtopping failure. The fill rate is also presented in Figure 7.1 for both the PMF and 1:1000-year storm.

It can be seen in Figure 7.1 that the water level would raise rapidly in the pit within the first two hours after failure. It should be noted that the fill depth exceeds elevation 805 masl within the first 40-60 minutes after dam failure. The information provided in Figure 7.1 should be used in the preparation of the Emergency Preparedness Plan (EPP), as it provides information regarding an acceptable evacuation time after dam failure.

As shown in Figure 7.1, it will take approximately two hours for the flood water to fill the pit. It is assumed that only after this time that any significant amount of tailings will begin to enter the pit. Therefore, it is believed that the flood water poses the most immediate risk to workers in the pit.
