**HVC Tailings Dams - Highland Tailings Storage Facility and 24 Mile Lake  
Response to MEM Memorandum- February 3, 2015**

This report outlines KCB's assessment of conditions at the L-L Dam and H-H Dam of the Highland Tailings Storage Facility, as well as at 24 Mile Lake, relative to the specific aspects raised by the MEM memorandum, based on a review of available documents, to prepare a "summary of knowledge". This assessment has been sealed by a qualified professional engineer and complies with generally-accepted professional practice common to the local area.

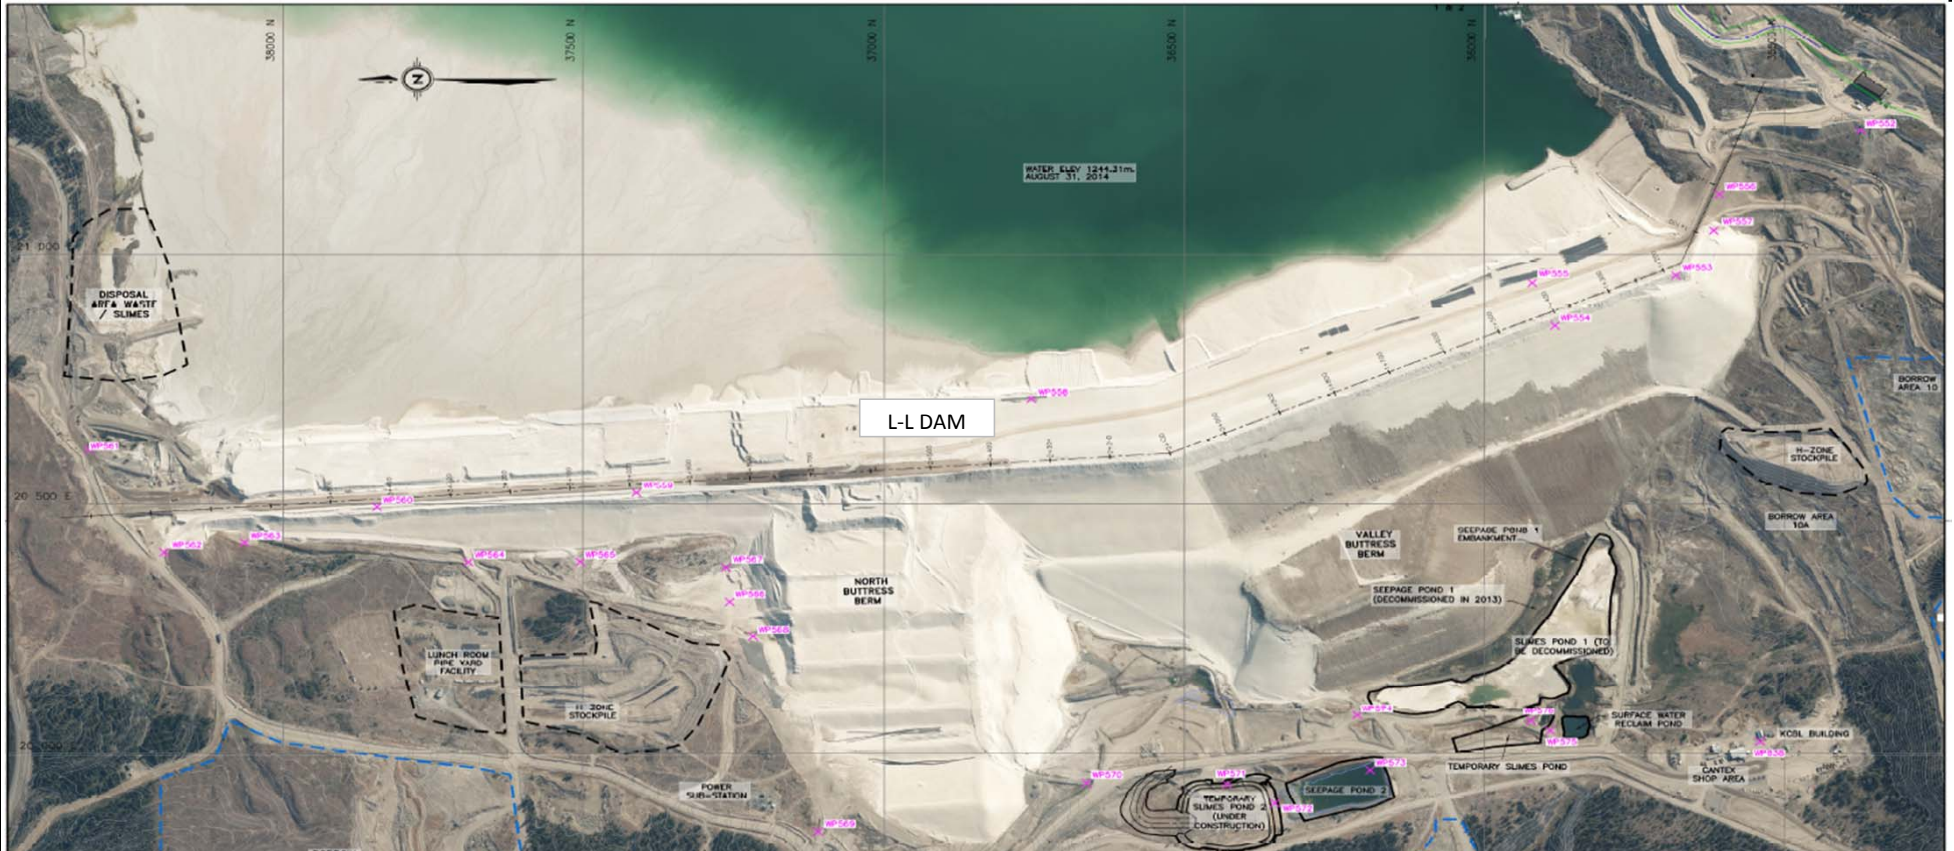
<p>AS A MUTUAL PROTECTION TO OUR CLIENT, THE PUBLIC AND OURSELVES, ALL REPORTS AND DRAWINGS ARE SUBMITTED FOR THE CONFIDENTIAL INFORMATION OF OUR CLIENT FOR A SPECIFIC PROJECT AND AUTHORIZATION FOR USE AND/OR PUBLICATION OF DATA, STATEMENTS, CONCLUSIONS OR ABSTRACTS FROM OR REGARDING OUR REPORTS AND DRAWINGS IS RESERVED PENDING OUR WRITTEN APPROVAL.</p>	<p>CLIENT</p> <p><b>TECK HIGHLAND VALLEY COPPER PARTNERSHIP</b></p>	<p>PROJECT</p> <p>HVC TAILINGS DAMS RESPONSE TO MEM MEMORANDUM</p>	
	  <p><b>Klohn Crippen Berger</b></p>	<p>TITLE</p> <p>HIGHLAND TSF L-L DAM</p>	
		<p>PROJECT No.</p> <p>M02341A87</p>	<p>No.</p> <p>2</p>
