Third Party Review of Dam Safety Inspection Report MAX Molybdenum Mine

SRK Consulting (Canada) Inc.
1CF011.000
December 2014

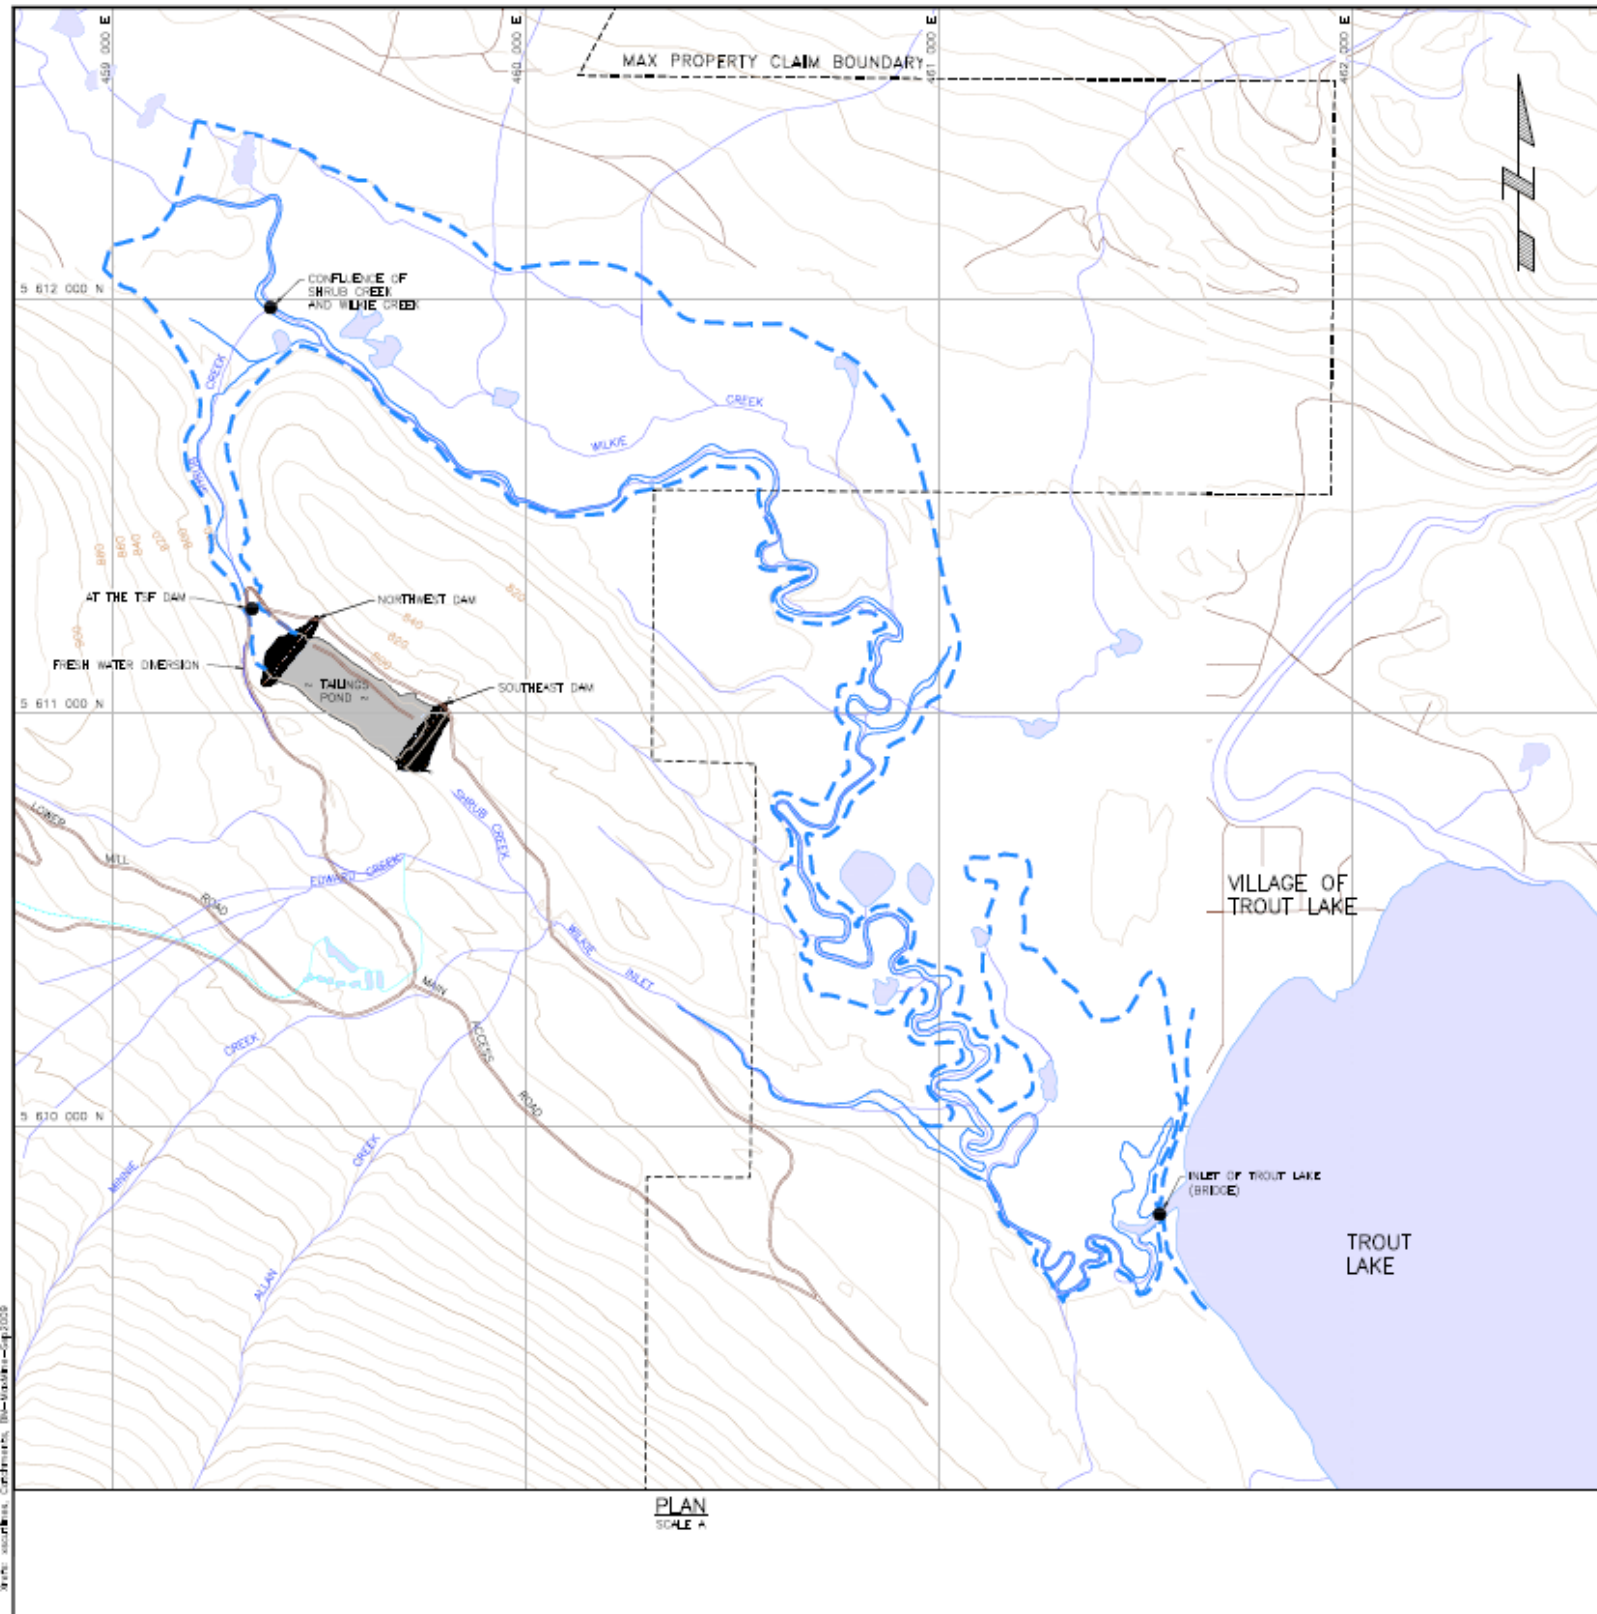
Figure 1 – Northwest Dam Inundation Map

Date: 14/10/14
 Date: 17/11/2014
 Drawn by: J. Crippen
 Checked by: J. Crippen
 Title: Northwest Dam Flood Inundation Mapping
 Project: M09508A07

LOCATION AND CATCHMENT PLAN
SCALE B

PROJECT MAX MOLYBDENUM MINE TAILINGS STORAGE FACILITY DAM BREACH AND INUNDATION STUDY
	TITLE NORTHWEST DAM FLOOD INUNDATION MAPPING
SCALE AS SHOWN	PROJECT No. M09508A07
	FIG. No. 1

Klohn Crippen Berger Ltd. 2014b. Tailings Storage Facility Dam Breach and Inundation Study letter prepared for Forty Two Metals Inc. November 28, 2014.
