NEW GOLD INC.

NEW AFTON DAM BREAK

INUNDATION ASSESSMENT

Re: New Afton Dam Break Inundation Assessment – Final Report

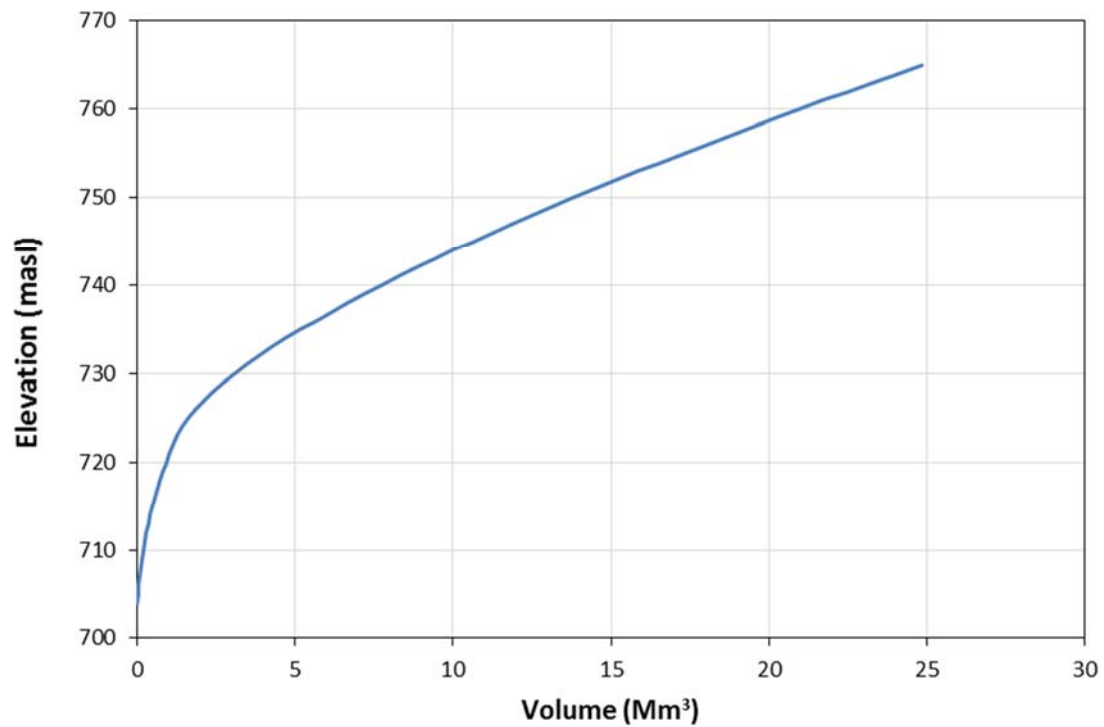
Figure A.1-1. Volume-elevation curve of the New Afton tailings storage facility.

Input parameters to BREACH include the dam and impoundment geometry as well as dam structure and dam material characteristics. Dam geometry and structure parameters were derived from information contained within the New Afton 2014 Dam Raise, Design Report (BGC, 2014). The volume-elevation curve of the impoundment to its permitted crest elevation is illustrated in Figure A.1-1 and input parameters to the BREACH program are summarized in Table A.1-1 below.

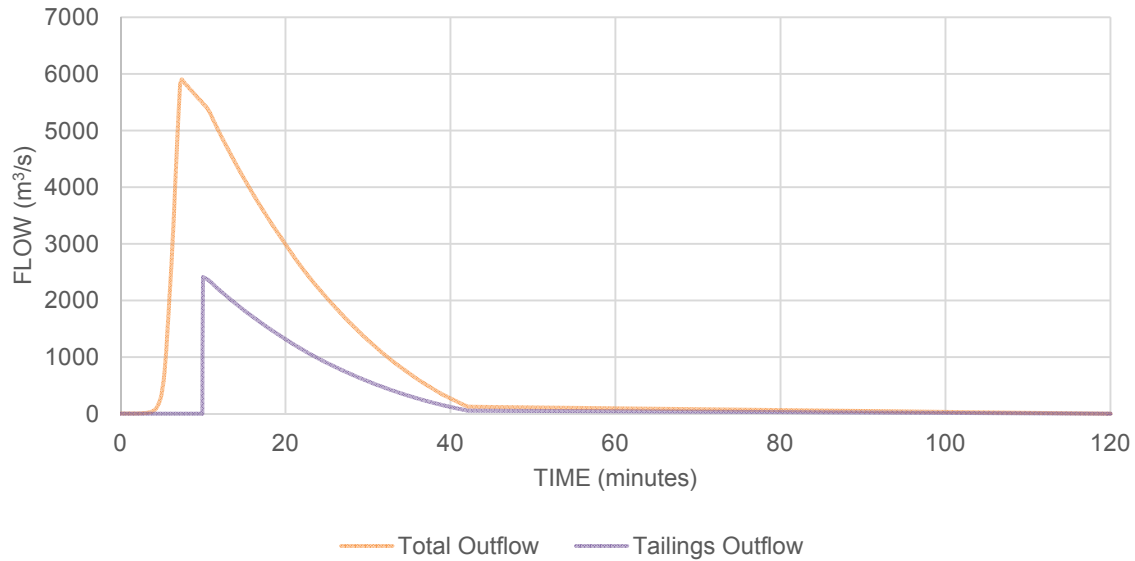
Figure A.1-2. Dam A overtopping breach hydrograph.

The overtopping breach hydrograph for Dam A is provided in Figure A.1-2. In this hypothetical overtopping scenario, the breach initiates with a nominal flow of water over the dam crest. This flow initiates erosion of a narrow channel on the downstream dam face. The channel down-cuts parallel with the dam face and expands laterally through a combination of continuous erosion and episodic bank failure and at about 6 minutes the eroded channel intersects the upstream dam face. The channel then begins to down-cut vertically and continues to expand laterally with a significant increase in the simulated outflow discharge peaking at 8 minutes. The free water pond, draining from the entire area of the impoundment, continues to drain rapidly until 10 minutes. At 10 minutes the free water pond has been completely released and the tailings and entrapped porewater begin to discharge through the breach. The volume of material available to discharge decreases rapidly with time, as the post-failure tailings surface profile of 3° develops. At 42 minutes into the simulation, the breach is complete and limited material is discharged through the breach beyond that time.

A typical discussion of a piping and overtopping breach hydrographs is provided for Figure A.1-2 and Figure A.1-3 below.

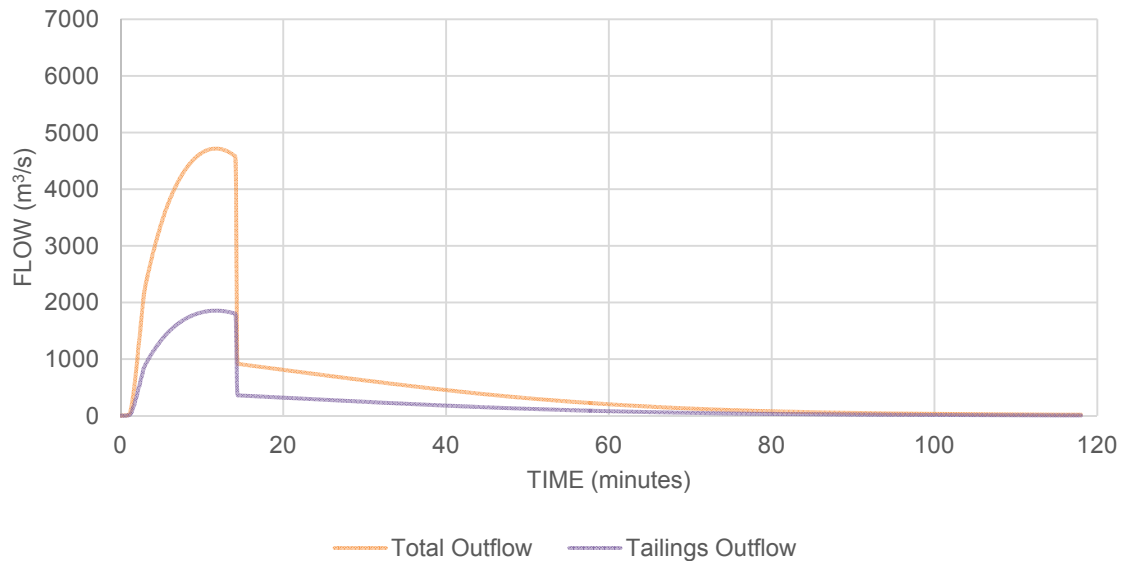
Figure A.1-3. Dam A piping breach hydrograph.

The piping breach hydrograph for Dam A is provided in Figure A.1-3. In this hypothetical failure, the breach initiates at the downstream face. The erosion progresses upstream through the dam eventually extending to the top of the tailings. The breach progressively increases in size with a corresponding increase in discharge of mixed tailings and water peaking at 13 minutes. At 15 minutes into the failure, the pipe collapses, as represented by the rapid drop in the discharge rate shown in Figure A.1-3. Immediately after the collapse, the elevation of the bottom of the breach is increased by the amount of collapsed material. After the collapse, the material acts as a weir with the remaining tailings flowing, at a reduced rate relative to the peak flow in the hydrograph, over the newly formed breach bottom where it continues to erode the breach bottom and sides, eventually releasing tailings until the assumed post-failure surface profile of 3° is achieved.

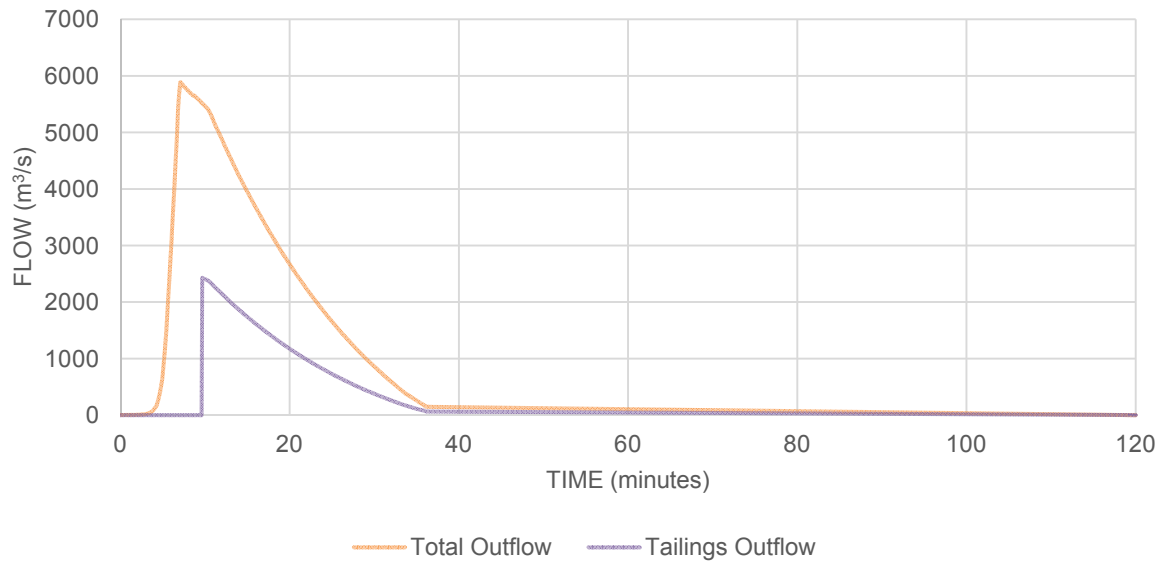
Figure A.2-2. Dam B overtopping breach hydrograph.

The progression and process described in the piping and overtopping examples above are consistent for the remaining breach hydrographs. Breach hydrographs for overtopping and piping failures for Dam B, C, South and West are included below.

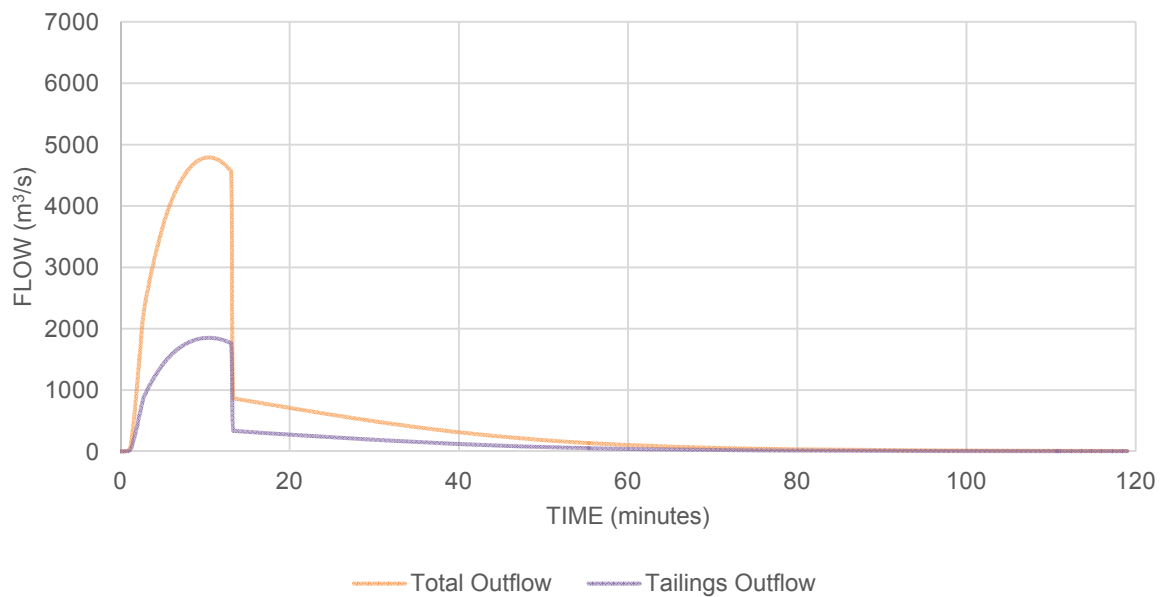
Figure A.2-3. Dam B piping breach hydrograph.

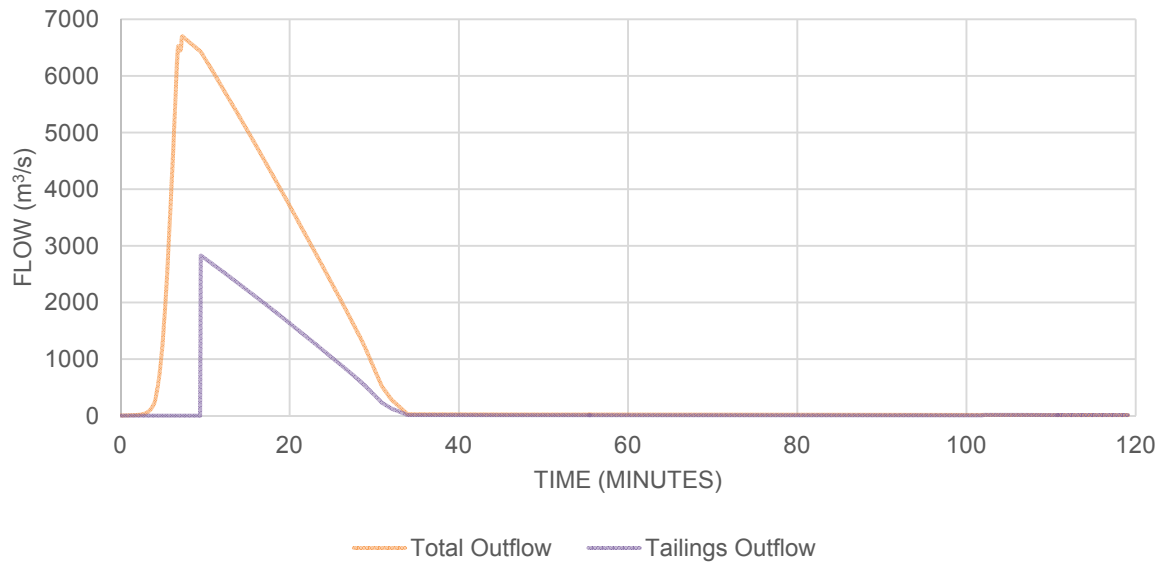
Figure A.2-4. Dam C overtopping breach hydrograph.

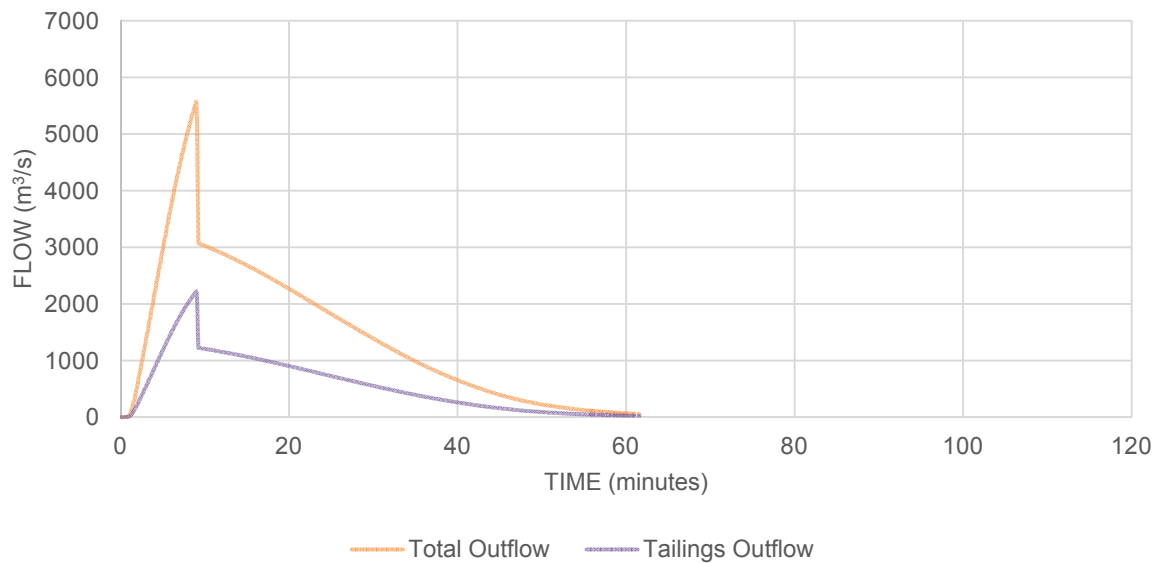
Figure A.2-5. Dam C piping breach hydrograph.

In the hypothetical piping breach of Dam C shown in Figure A.2-5 above the piping breach progresses as described above except that at 9 minutes into the failure where the pipe collapses before the tailings have dropped below the top of the piping orifice.

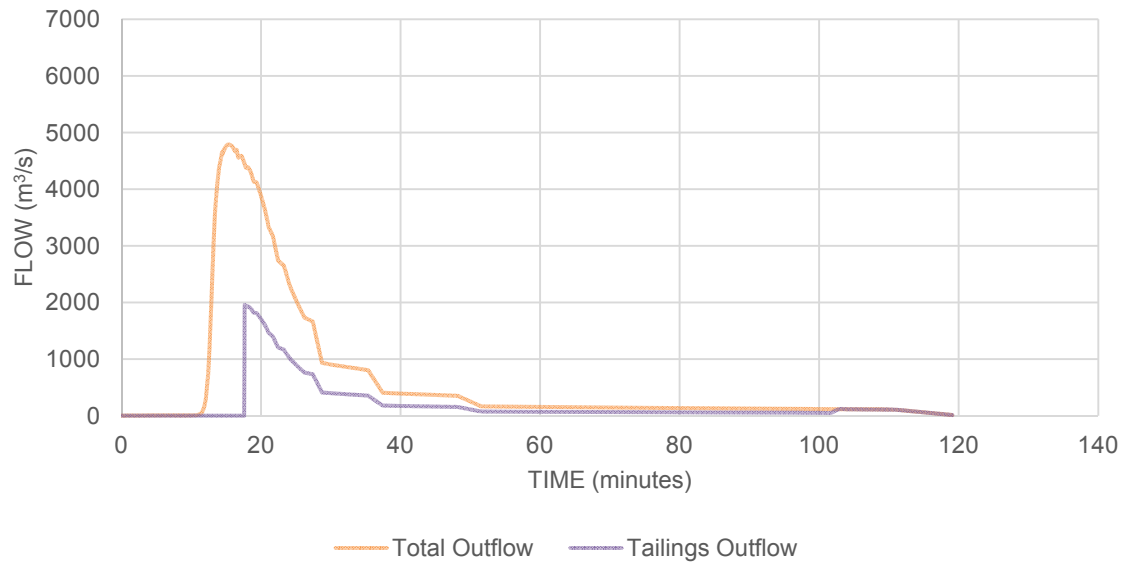
Figure A.2-6. South Dam overtopping breach hydrograph.

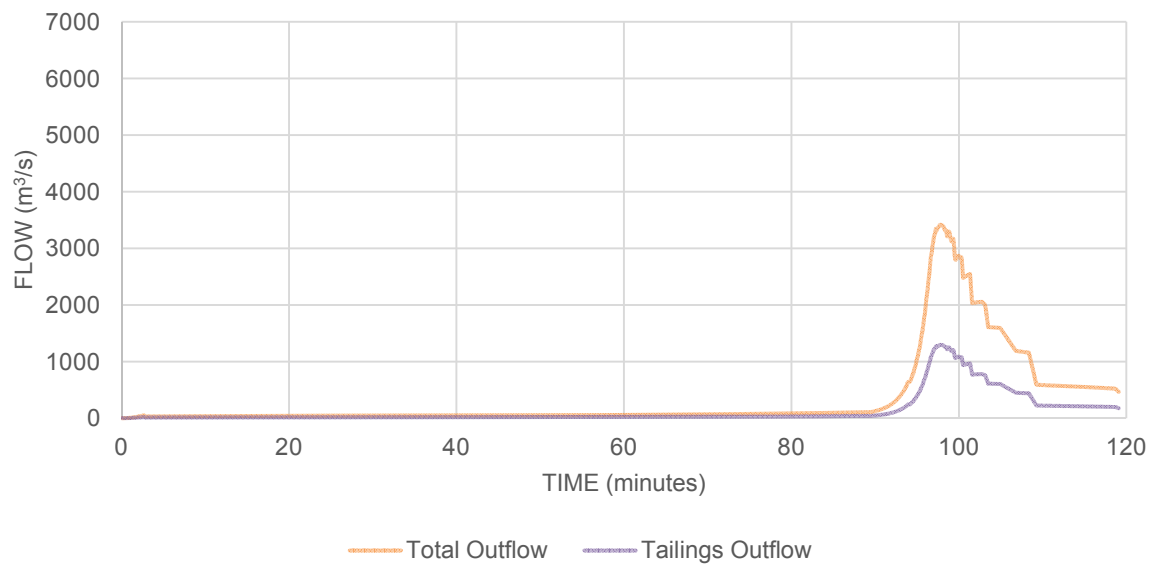
Figure A.2-7. South Dam piping breach hydrograph.

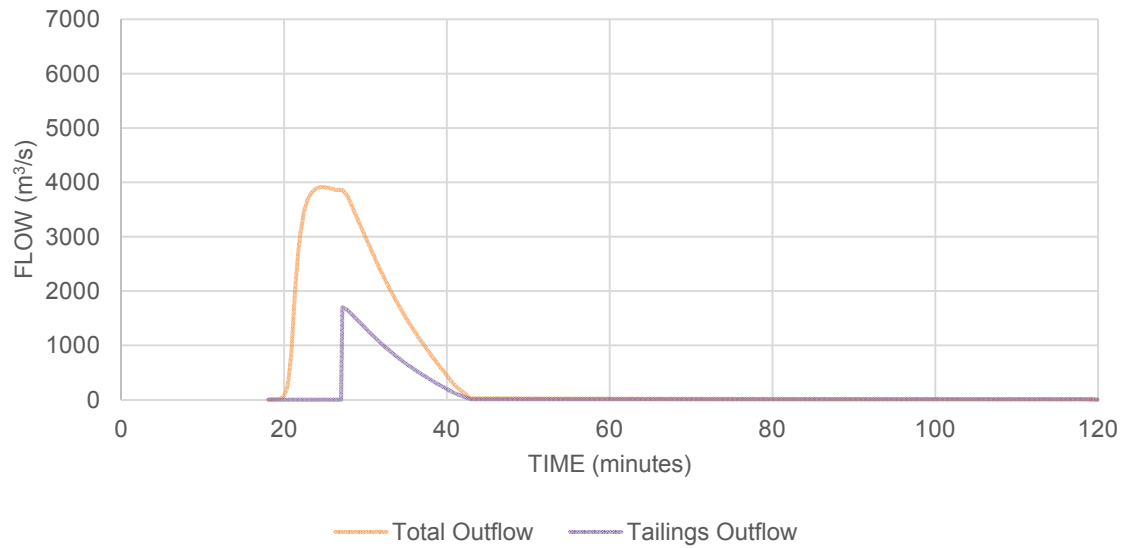
Figure A.2-8. West Dam overtopping breach hydrograph.

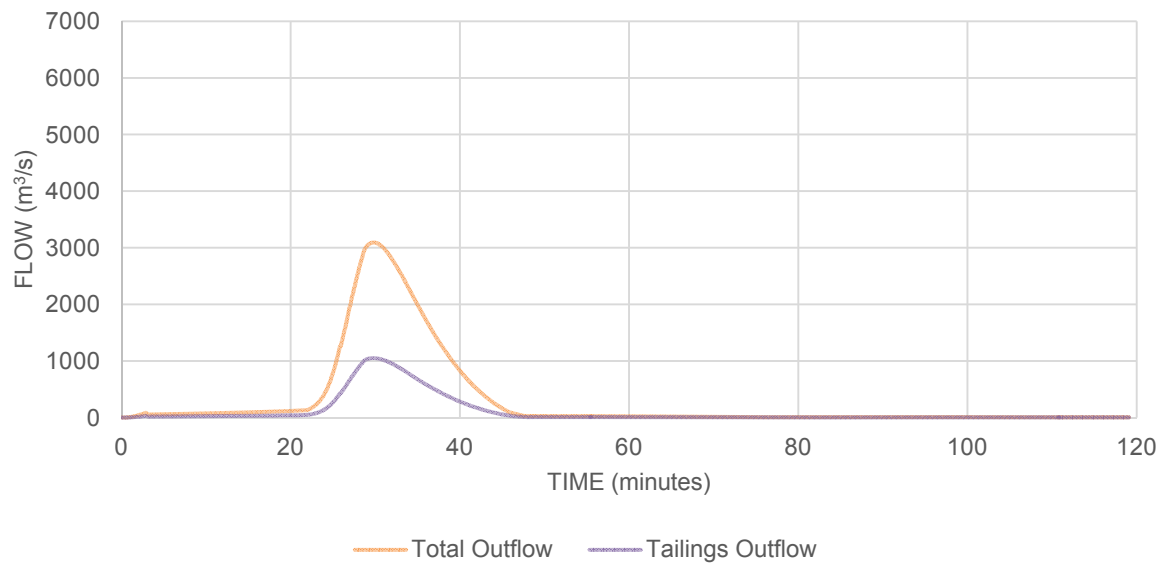
Figure A.2-9. West Dam piping breach hydrograph.
