RED CHRIS DEVELOPMENT COMPANY LTD.

RED CHRIS MINE

Emergency Preparedness and Response Plan (EPRP)

A definitive Plan to establish a clear emergency response structure specific to the Red Chris Mine TIA. This Plan is a standalone document as Emergency Preparedness and Response Plan (EPRP) but also is included as Section 9 of the Operations, Maintenance and Surveillance Manual (OMS).

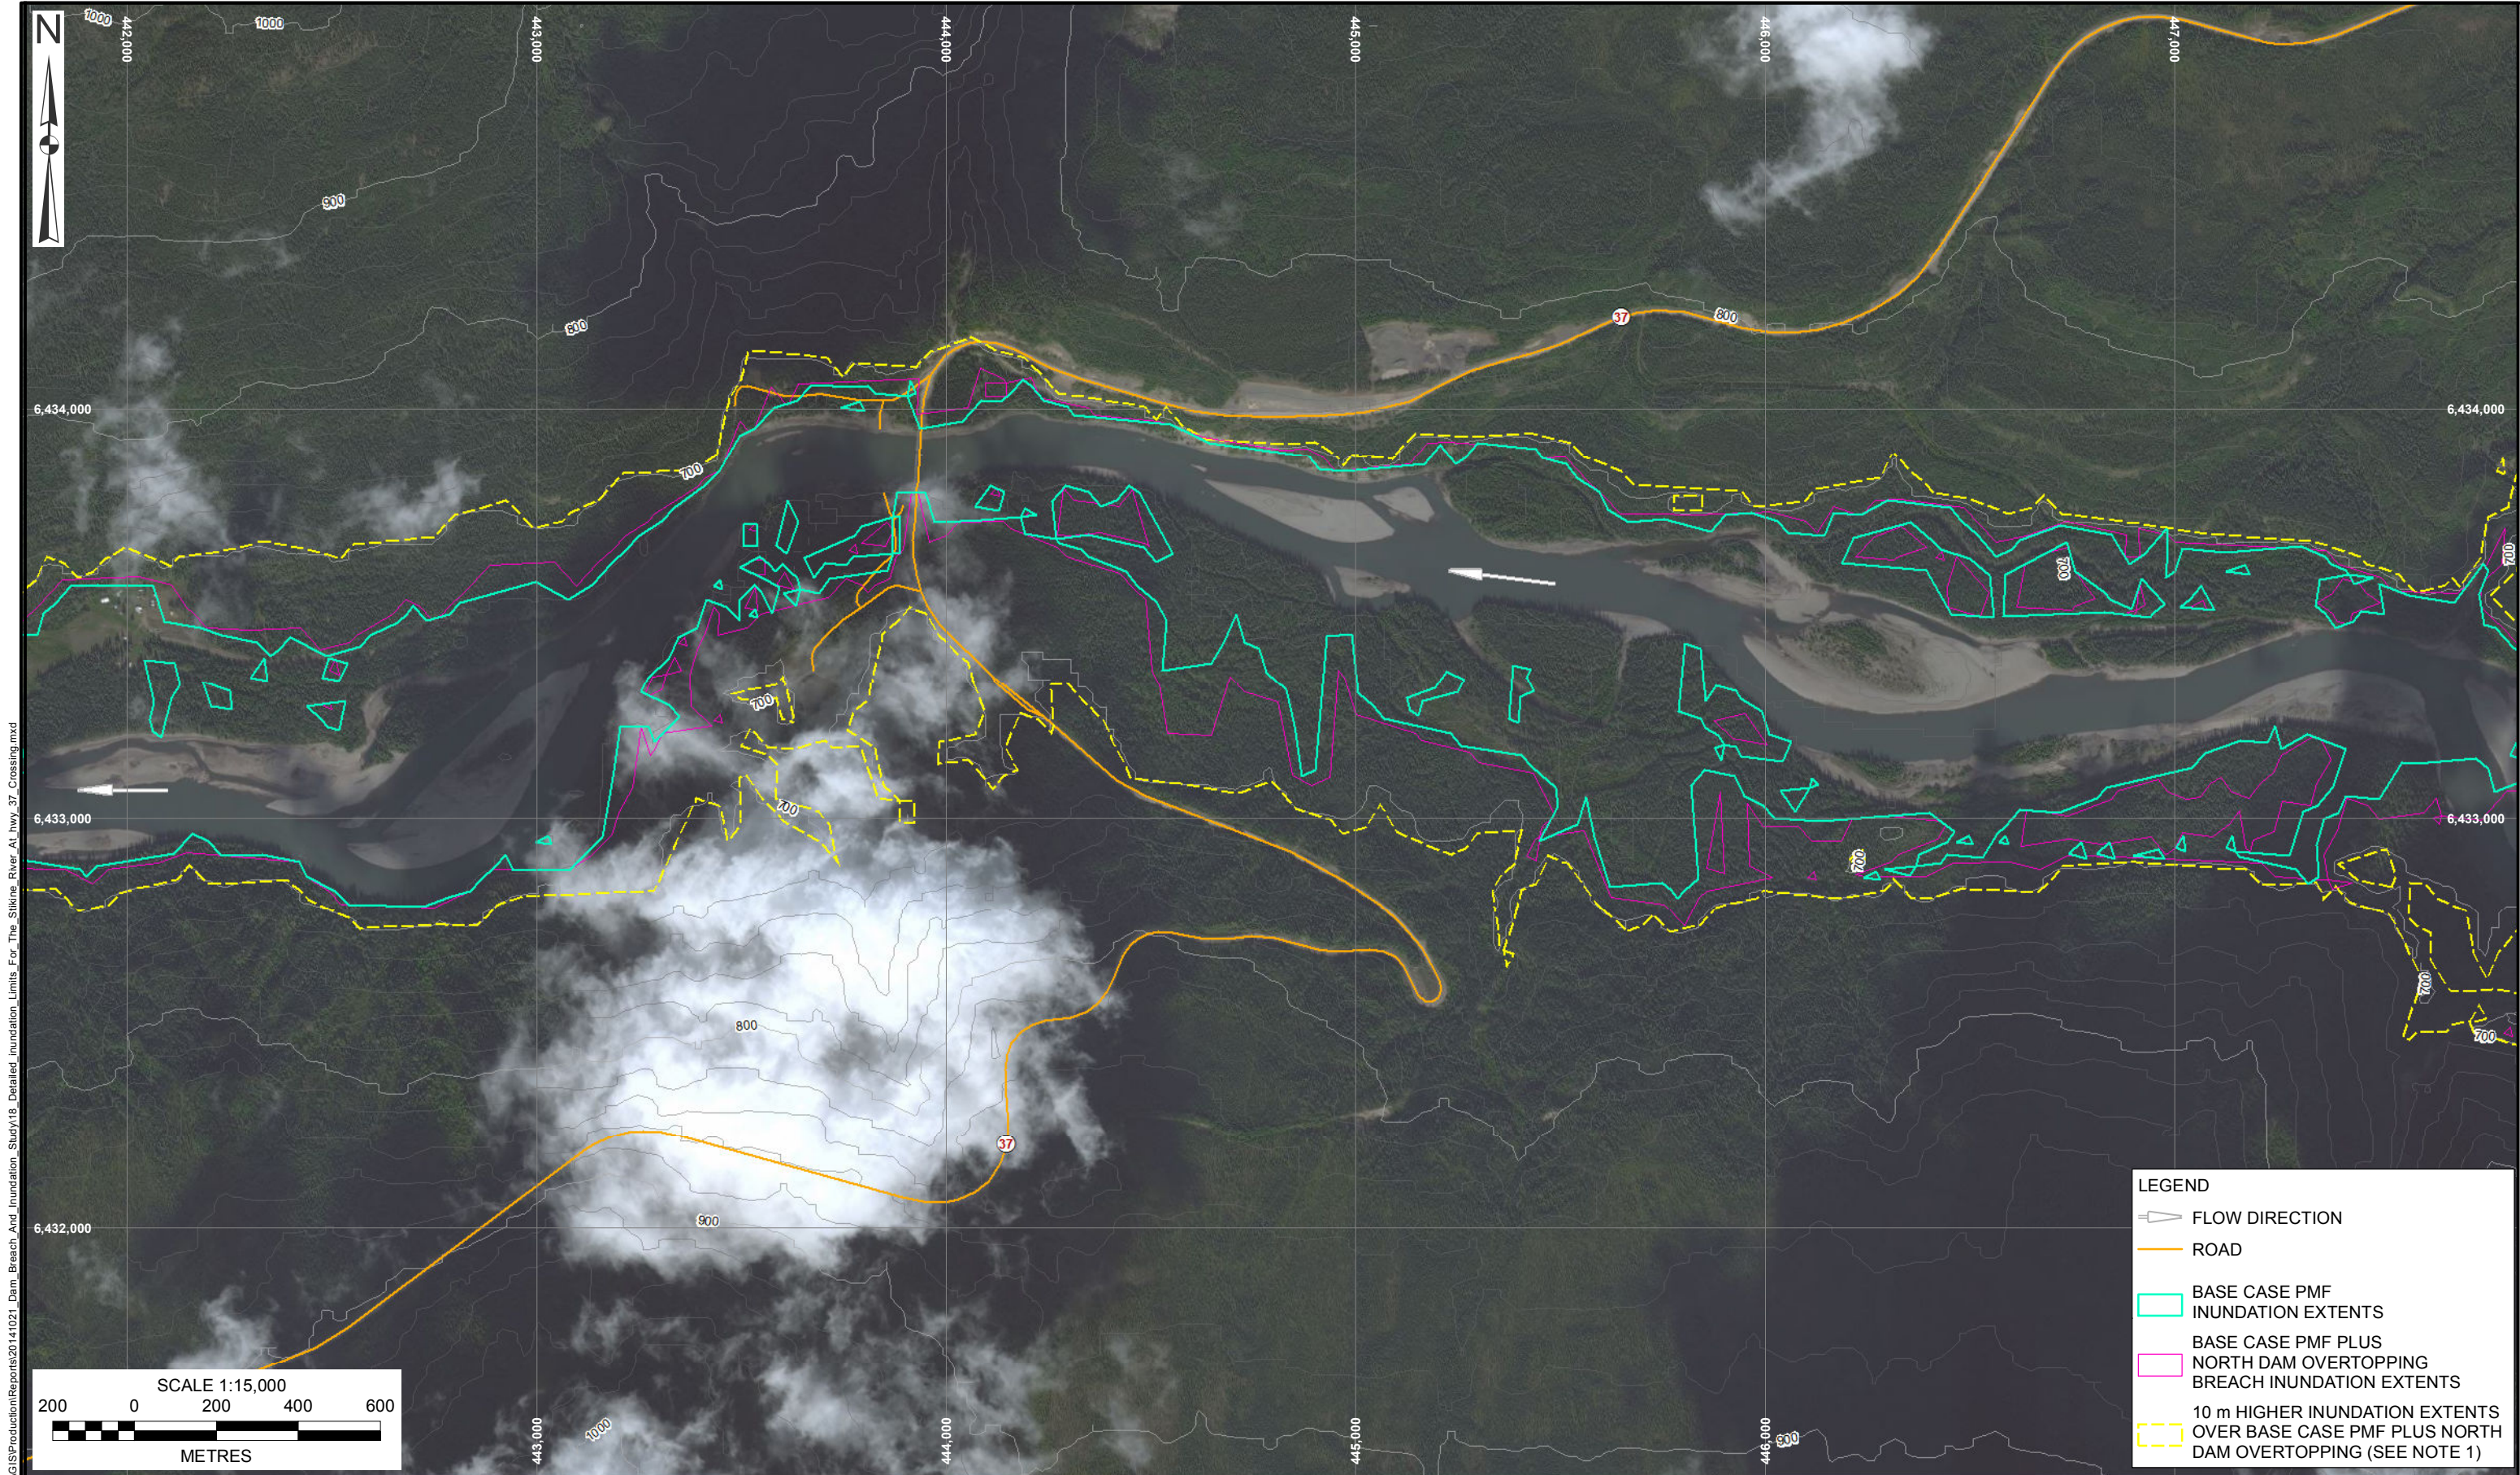
PROJECT: DAM BREACH AND INUNDATION STUDY	
TITLE: DETAILED INUNDATION LIMITS FOR THE STIKINE RIVER AT HIGHWAY 37 CROSSING	
PROJECT No.: 0866-001-15	DWG No.: 18

- NOTES:
1. THE 10 m HIGHER INUNDATION EXTENTS WERE DERIVED USING THE COASTAL PMF RELATIONSHIP, WHICH IS JUDGED TO REPRESENT NON-PLAUSIBLE INUNDATION EXTENTS.
