Re: Mine Inspection February 3, 2005
Property: Mount Polley Mine

Report of Inspector of Mines

Geotechnical

Name of Property: Mount Polley Mine **Permit No.:** M-200
Location: Likely
Owner, Manager: Howard Bradley
Company: Imperial Metals Corporation
Address: Vancouver BC V6C 3B6
Persons Contacted: Ron Martel
Type of Mining: METAL MINE - SURFACE
Date of Inspection: February 3, 2005
Copies To: John Errington, Bob Lane, Diane Howe

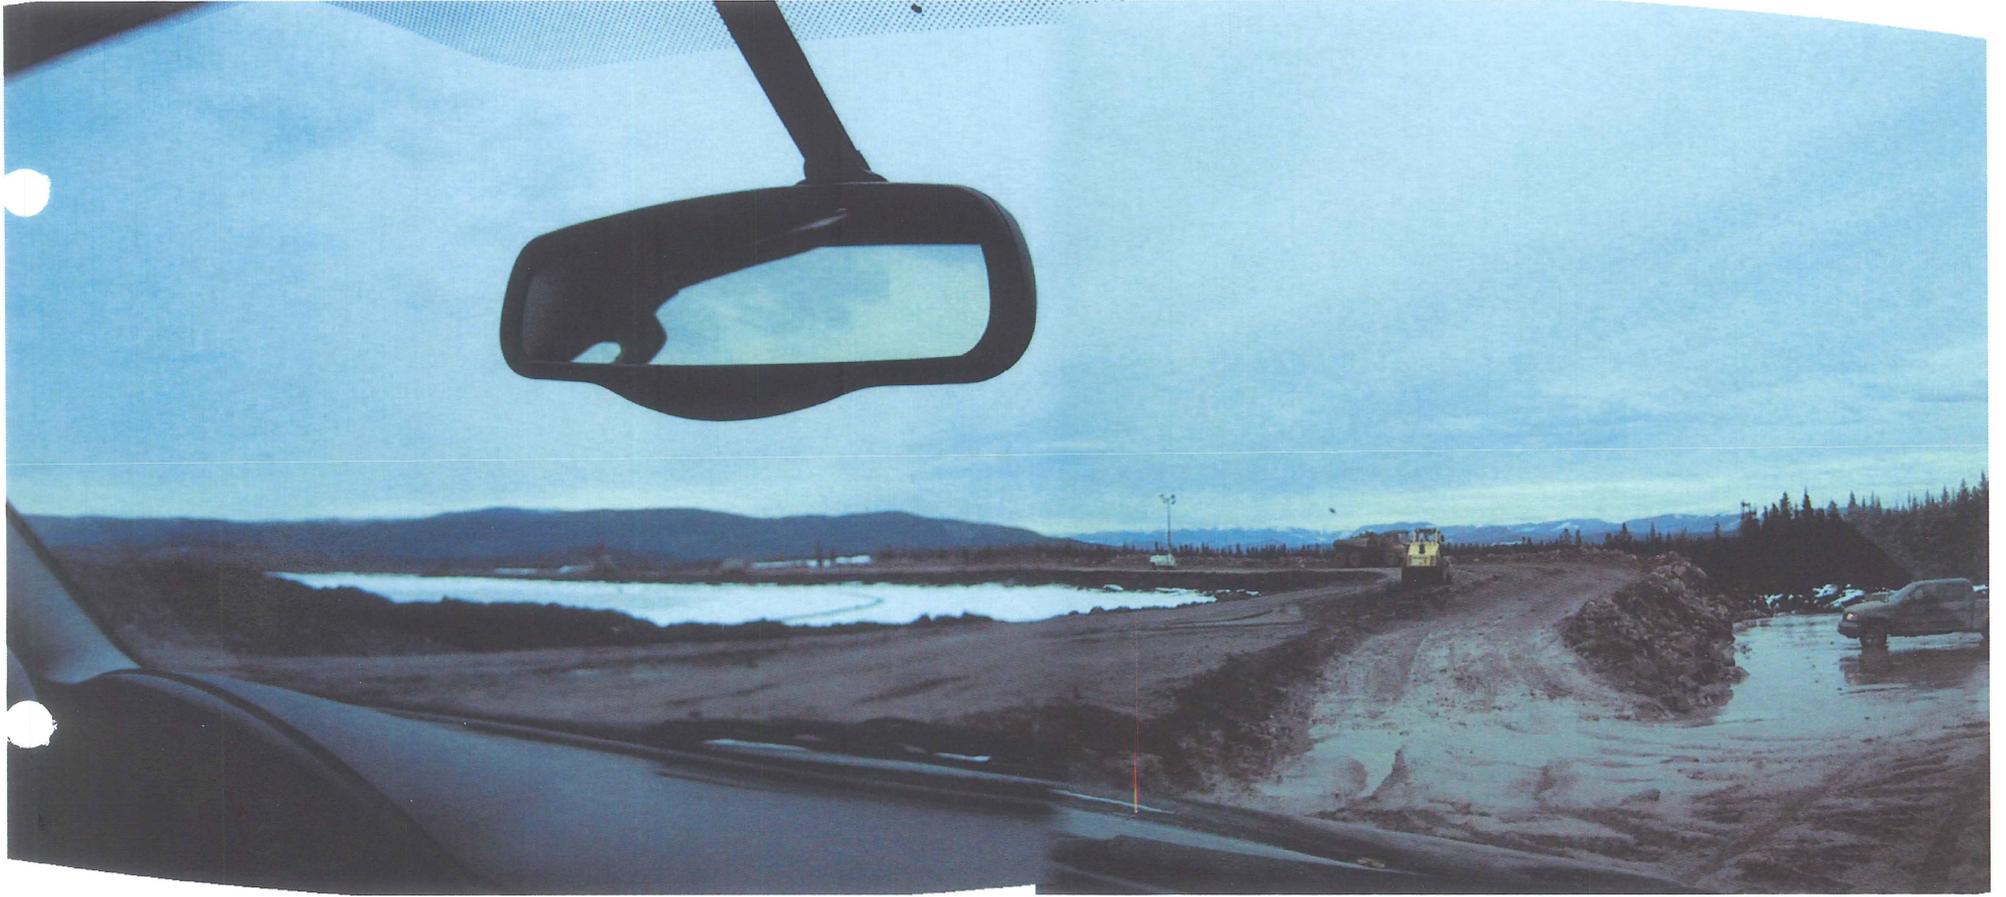
Mt. Polley - TSF
Dam raise in progress

Construction of the permitted dam raise to elevation 945 m (Stage 3c) was in progress at the time of the inspection. The next dam raise to elevation 948 m is scheduled to start May 1, 2005 following submission of the design and permit approval. The tailings facility embankment dams are planned to be constructed to a final crest elevation of 965 m by the year 2012.

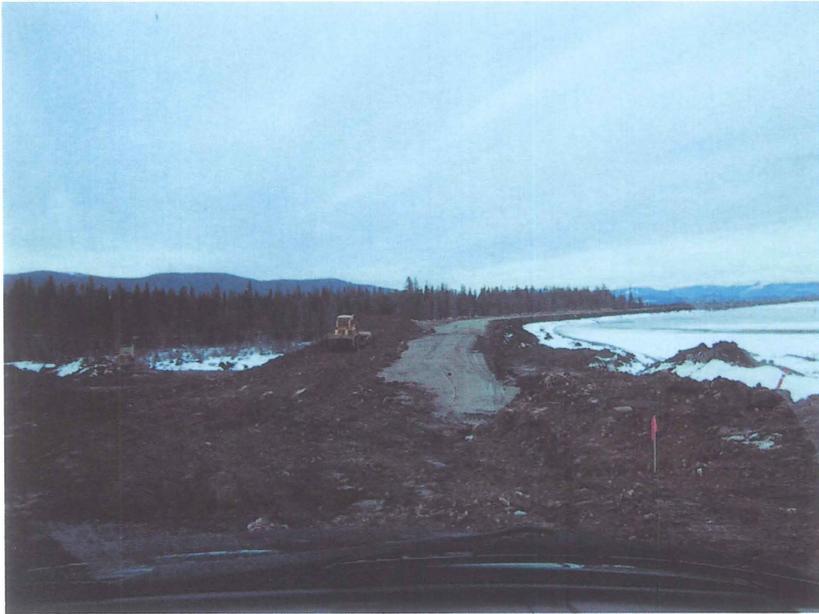
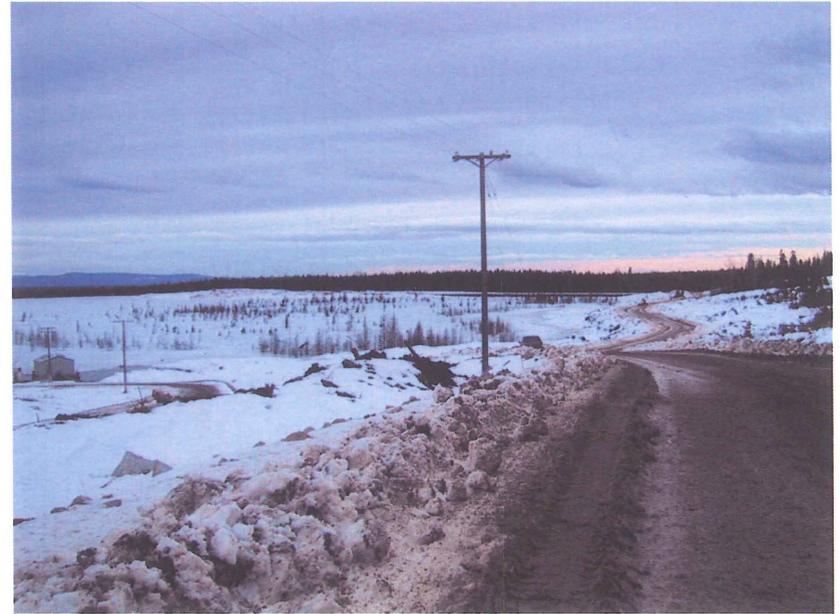
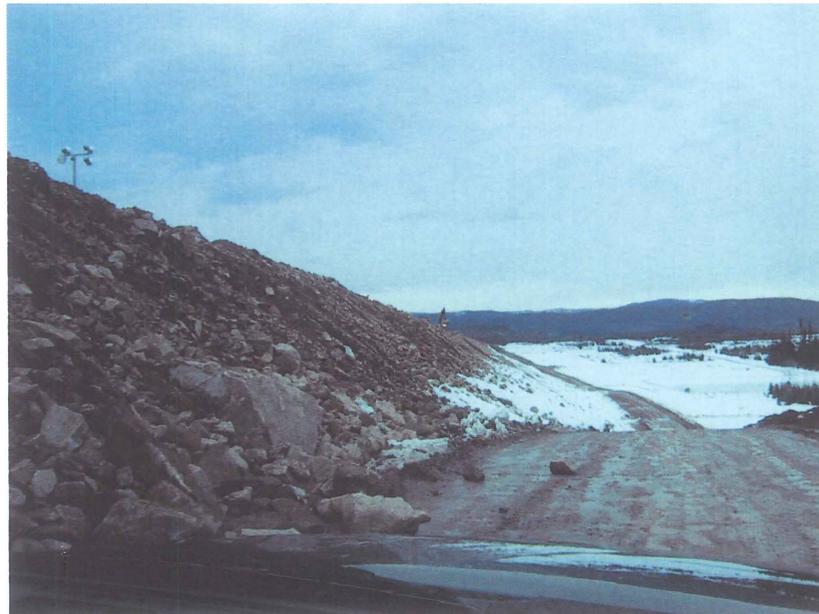
At the time of the inspection Zone C shell material was being placed. Due to the method of construction, segregation of the rock fill was noted with many large boulders rolling to the base of the slope. Better control is required to ensure the placement of a homogeneous well-graded dam shell that comprises material within the gradation specified. It is understood that construction of the downstream shell of the tailings dam with waste rock from Wight Pit is being considered. Details shall be submitted to the Ministry for review and permitting.

Construction of
d/s shell.

Reclamation of the final downstream dam slope with a soil cover is required. Rather than spreading the cover after completion of the dam embankment to final height it has been suggested that it may be more efficient to place and spread the soil as each lift of the downstream shell is placed, which would allow for progressive reclamation.

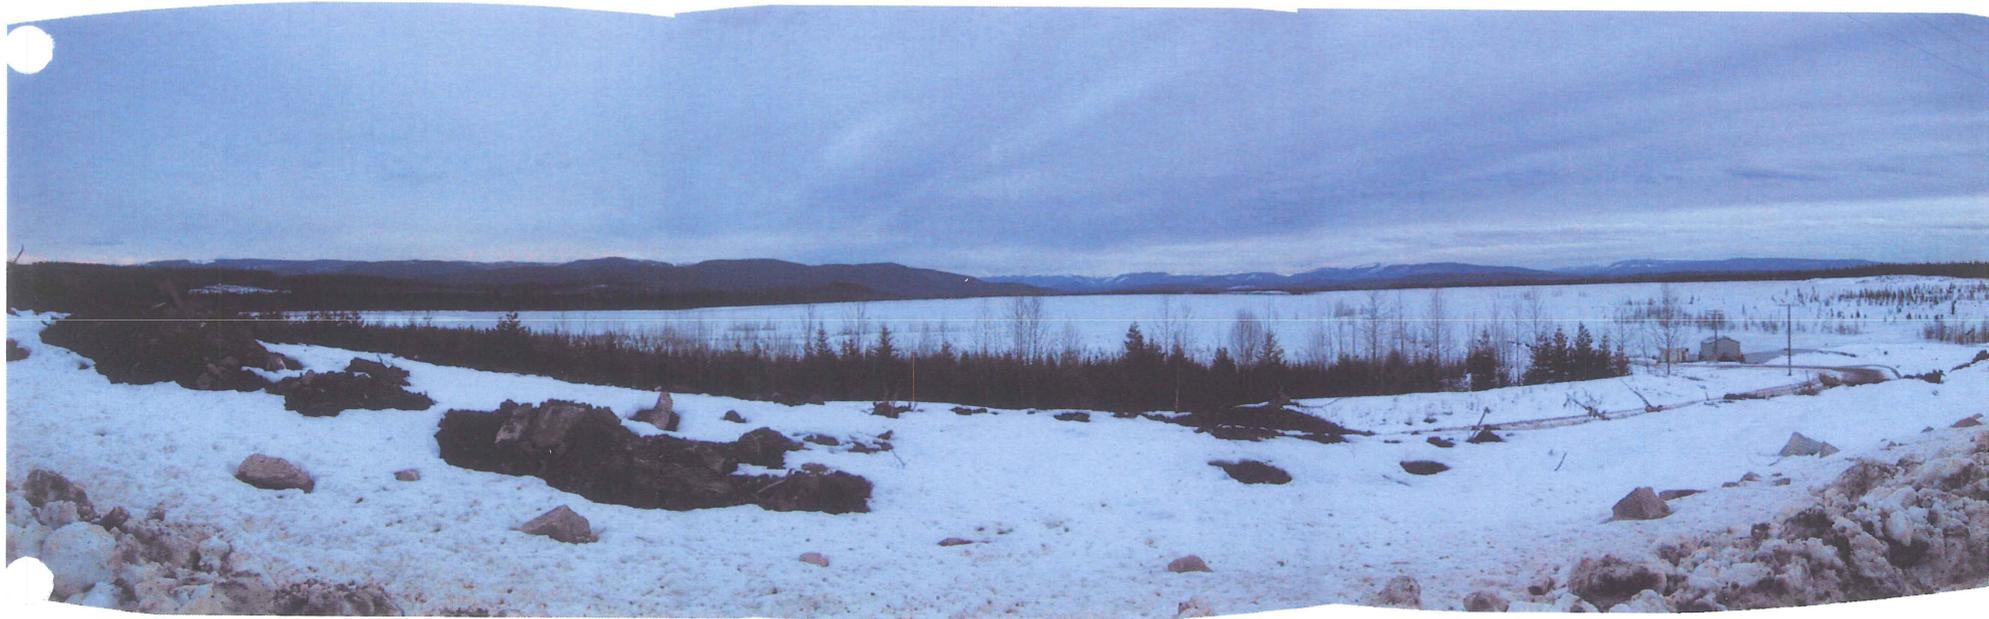
General view of TSE
- reclaim barge to right of photo

There is currently no discharge to the environment from the tailings impoundment. Projected water balance indicates there will be a surplus water volume and a discharge permit will be required from the Ministry of Water, Land and Air Protection. Plans for discharge from the TSF shall be submitted to MEM for review.
