**MOUNT POLLEY MINING CORPORATION
MOUNT POLLEY MINE**

**TAILINGS STORAGE FACILITY
REPORT ON 2010 ANNUAL INSPECTION**

**TAILINGS STORAGE FACILITY
REPORT ON 2010 ANNUAL INSPECTION
(REF. NO. VA101-1/29-2)**

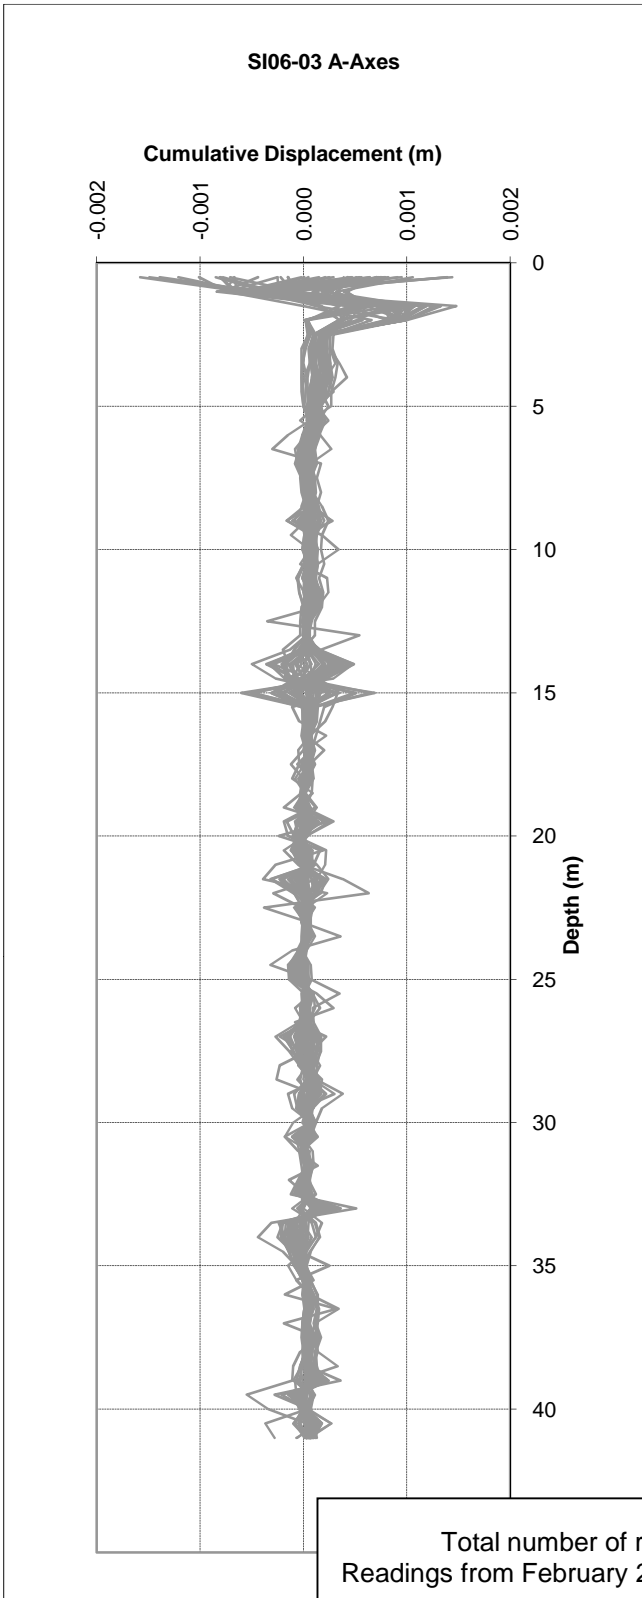
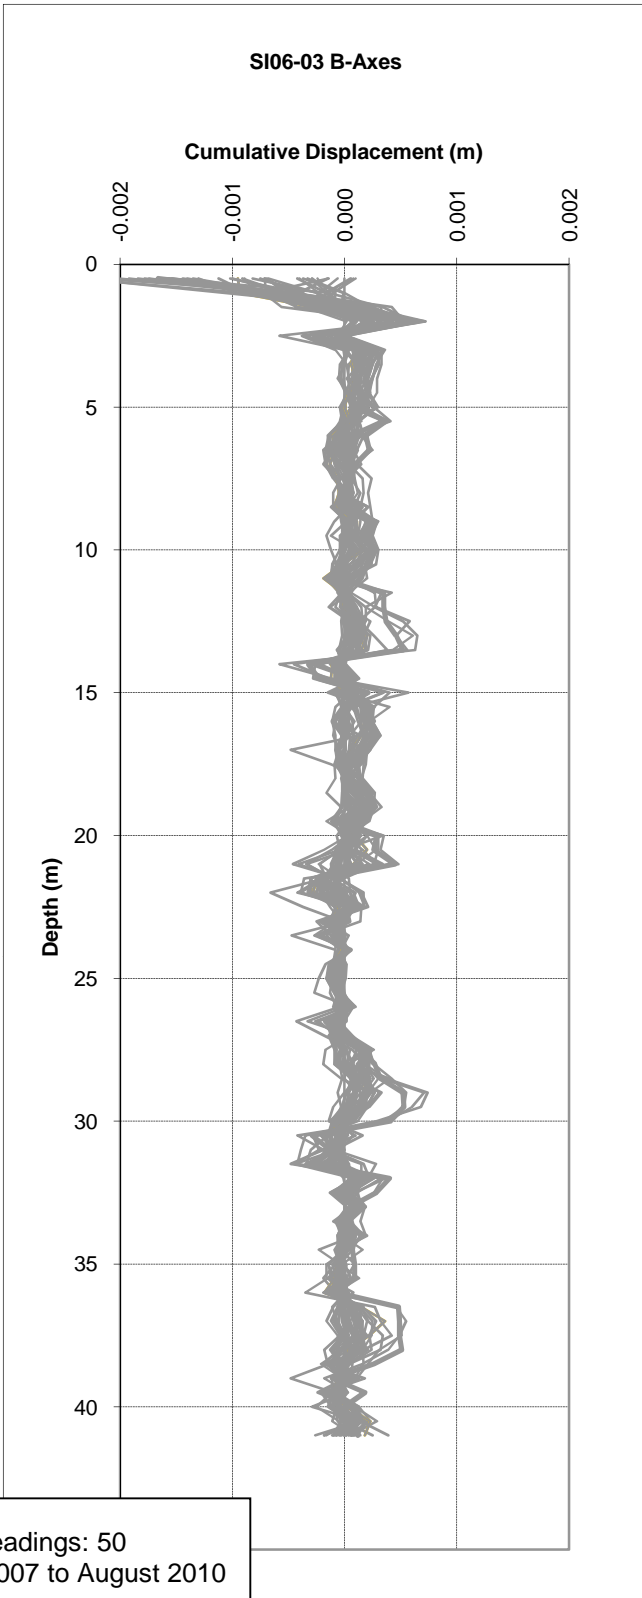
Total number of readings: 50
Readings from February 2007 to August 2010

MOUNT POLLEY MINING CORPORATION					
MOUNT POLLEY MINE					
TAILINGS STORAGE FACILITY STAGE 6B					
DOWN HOLE INCLINOMETER					
CUMULATIVE DISPLACEMENT SI06-03					
			P/A NO. VA101-1/29		REF NO. 2
			FIGURE B3

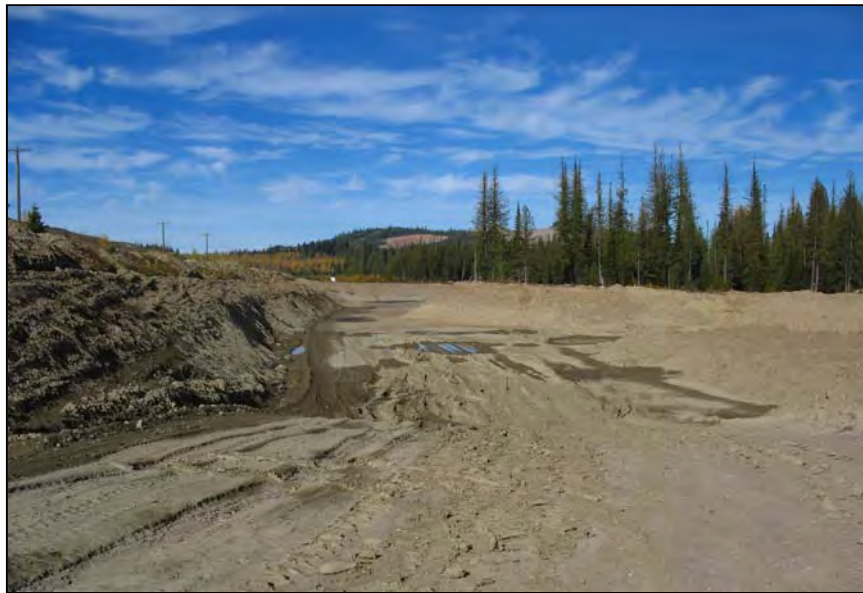
PHOTO 4 – Glacial Till borrow Downstream of Perimeter Embankment.

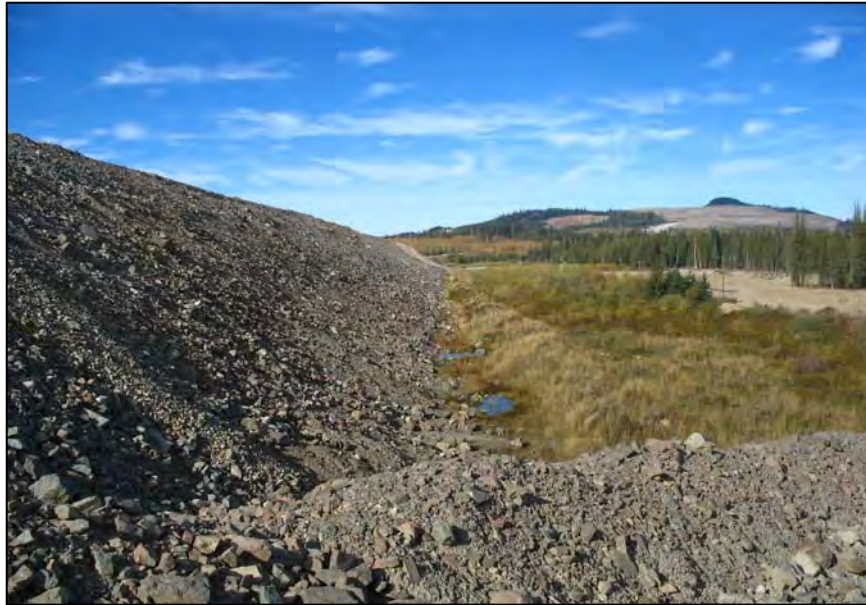
PHOTO 7 – Downstream Slope of Perimeter Embankment.

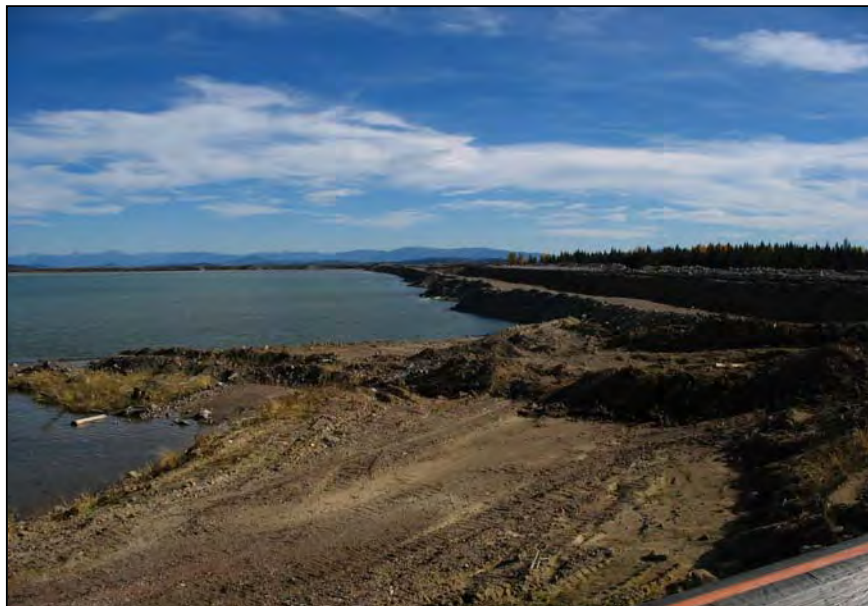
PHOTO 13 – South Embankment – Supernatant Pond adjacent to the dam
