Tailings Impoundment and Water Management Structures 2014 Dam Safety Inspection

Equity Silver Mine Houston, British Columbia

FINAL REPORT

October 14, 2014

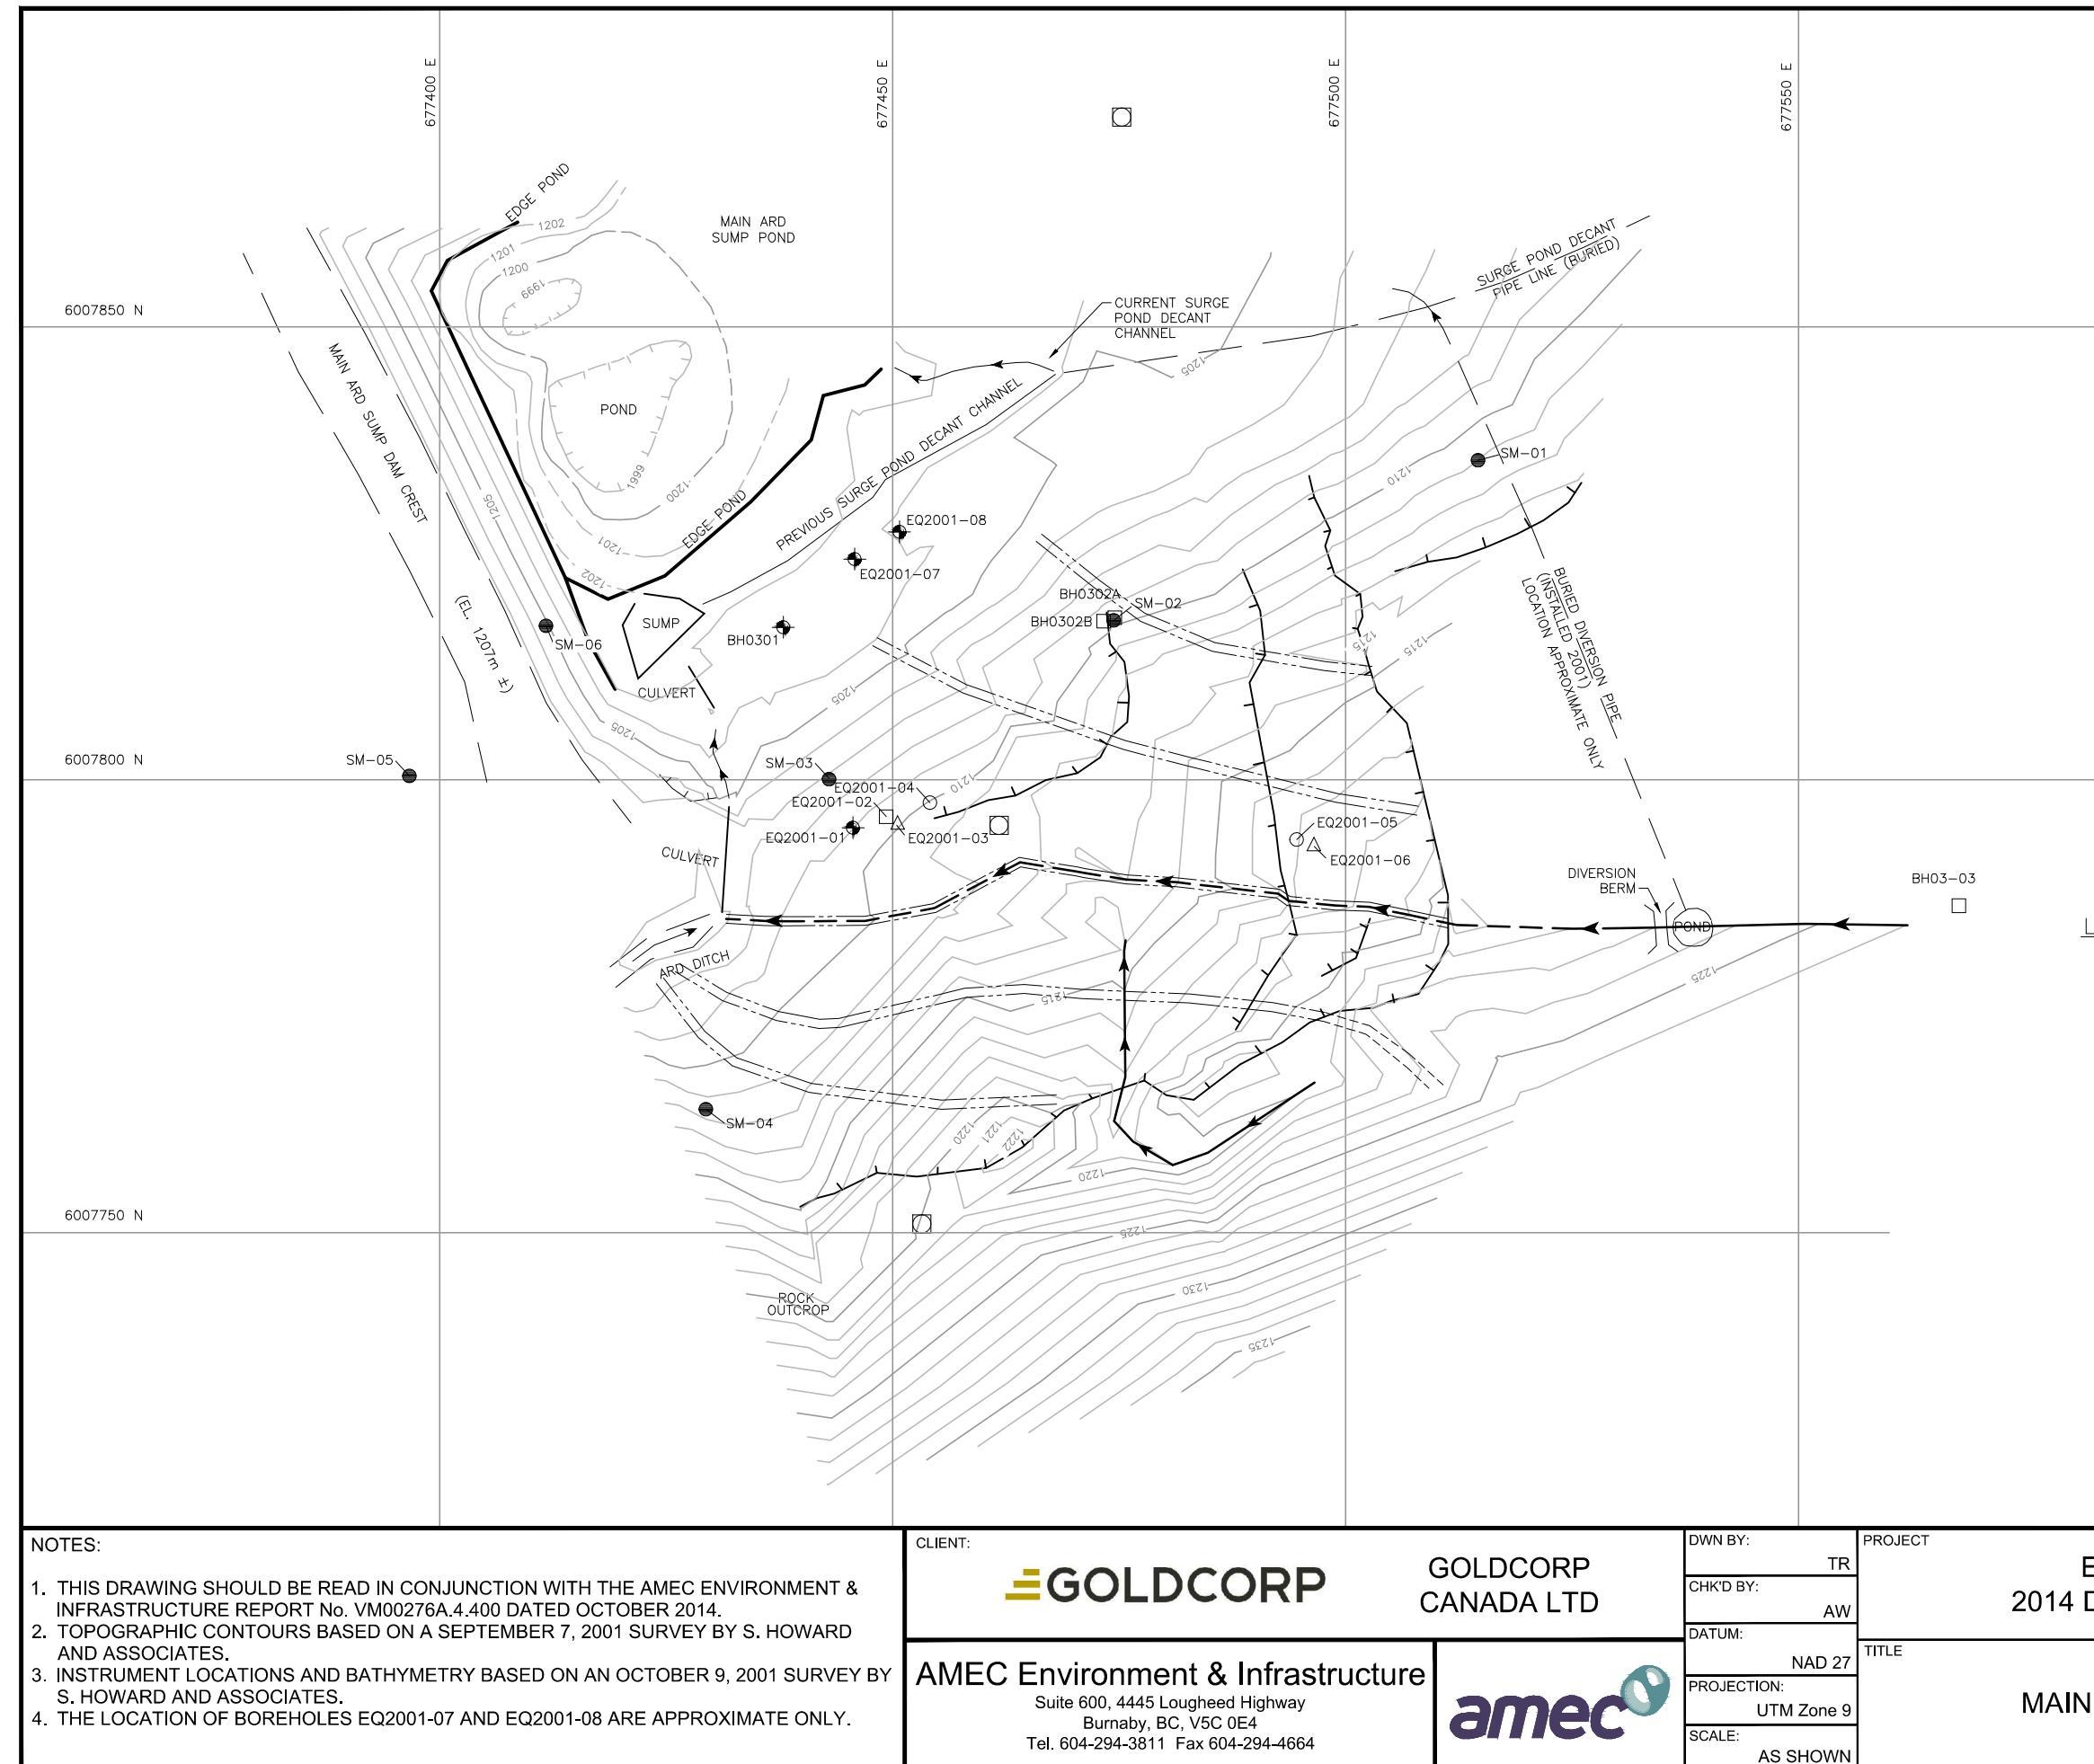
There are currently four survey monuments located near the Main ARD Pond: two on the slope and two on the south abutment of the Main ARD Pond Dam as shown on Figure 4. The monuments were installed before construction of the stabilizing berm in 2001. The survey data is given in Appendix E.

Two inclinometers were installed in the Main ARD Slope; the locations are shown on Figure 4. Summary plots of total displacement versus depth and total displacement versus time for the A-axis and B-axis for each inclinometer are given in Appendix E. The A-axis is oriented with the expected direction of slope movement and the B-axis orthogonal to that.

Three vibrating wire piezometers and one standpipe piezometer were installed in the ARD slope in 2001. Four additional standpipe piezometers were installed on and above the slope in October 2003. The locations of all the instrumentation installed in the ARD slope are shown on Figure 4. Plots for the piezometer data are given in Appendix E. The following tables give a summary of the piezometer information including completion stratum, tip elevation and ground/collar elevations.

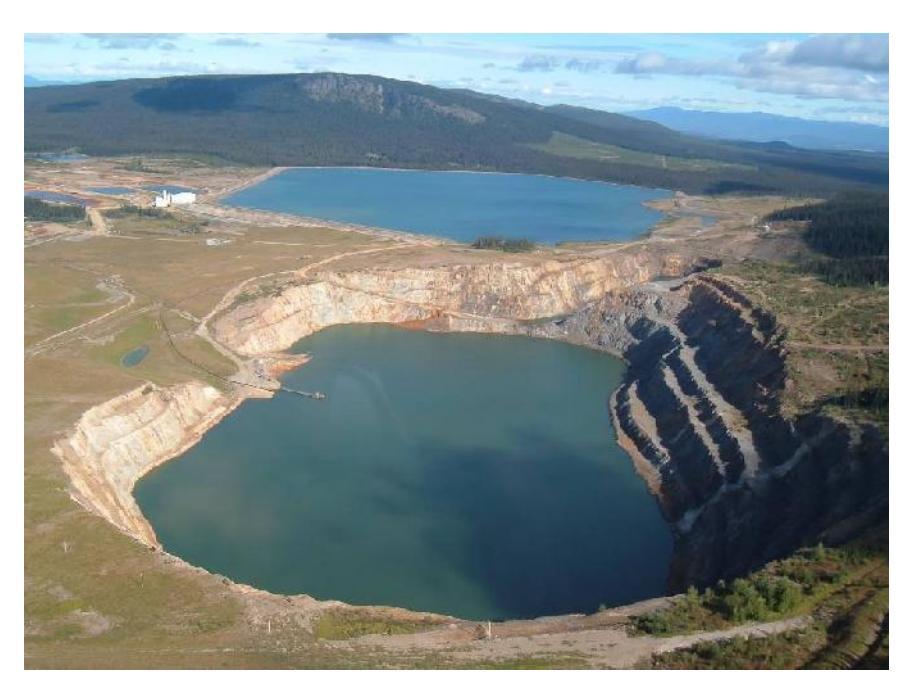
Photo 1: Overview of Equity Mine site (Main Zone Pit in foreground and Tailings Pond in background). Taken August 29, 2006.

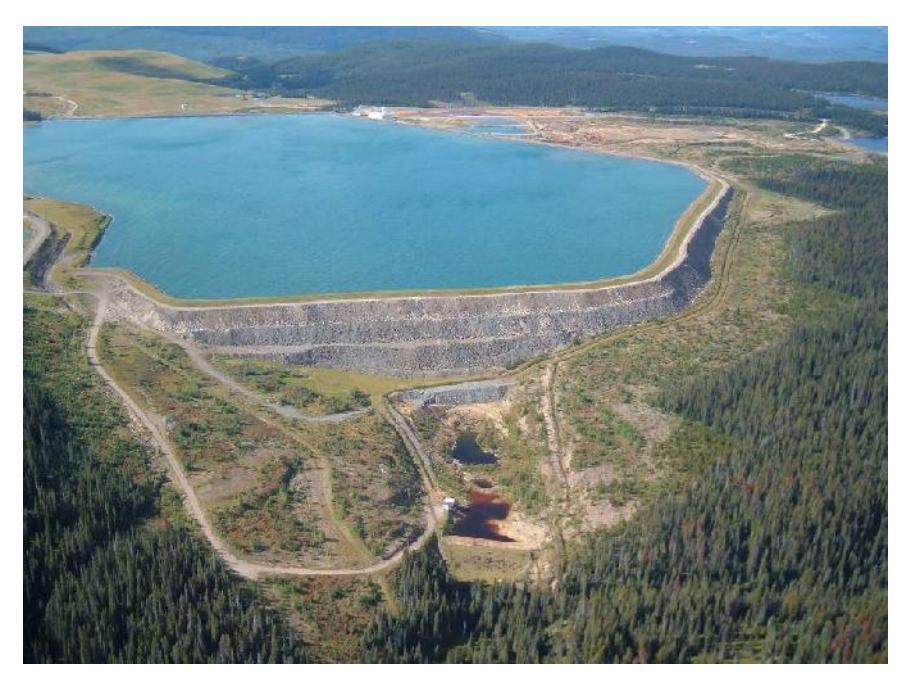
Photo 2: Aerial photograph of the Tailings Pond with Dam #1 Seepage Pond in foreground and treatment facilities in the background. Taken August 29, 2006.

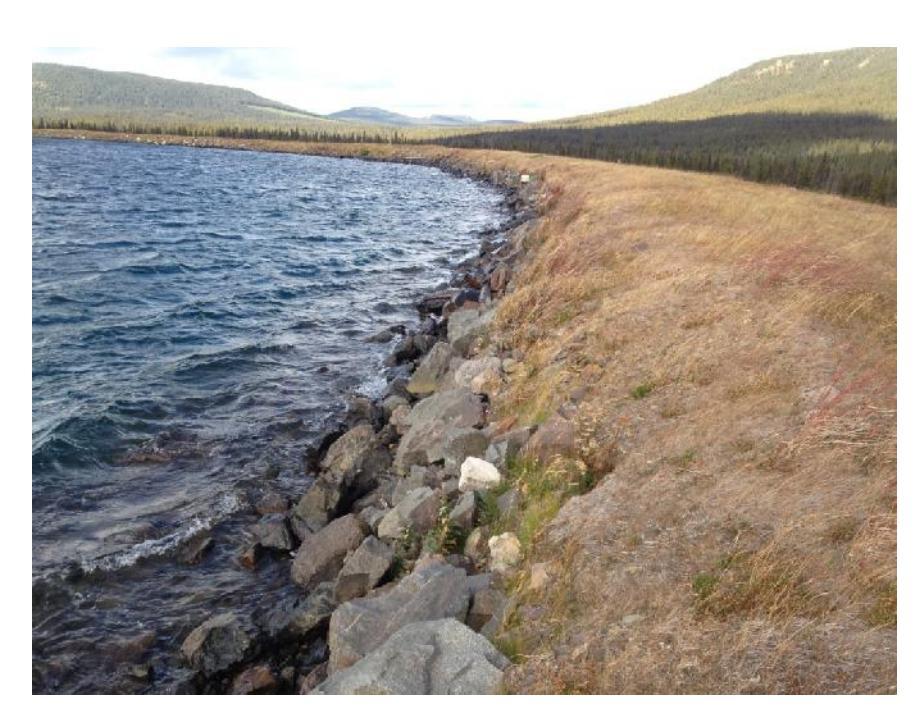
Photo 5: Dam No. 1, view of the upstream slope and riprap protection looking west.

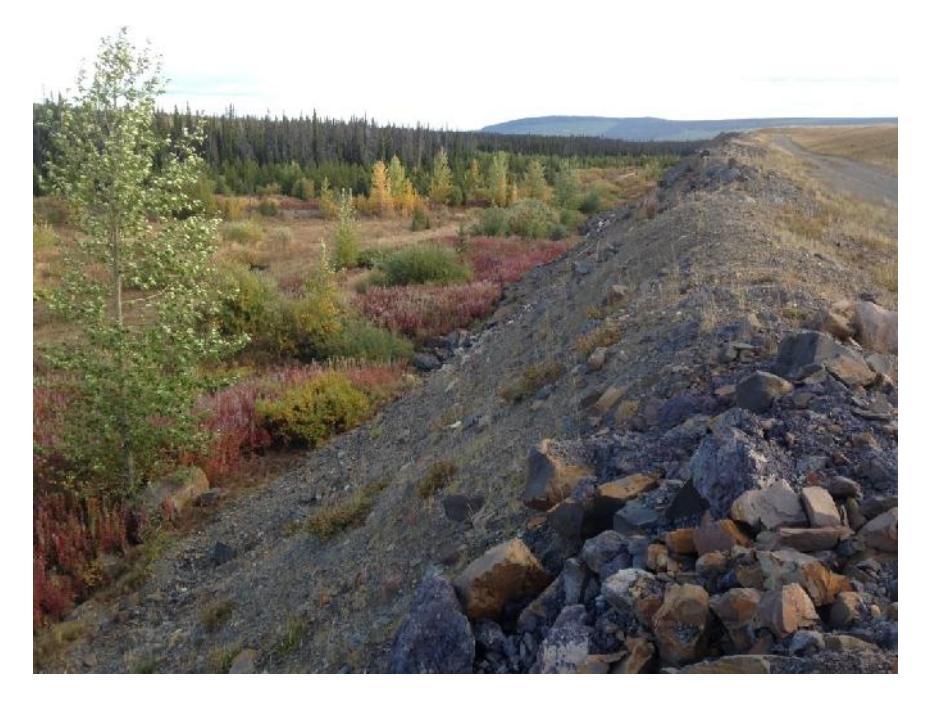
Photo 8: Dam No. 1, view of downstream face on west side with clean water diversion and seepage collection ditches.

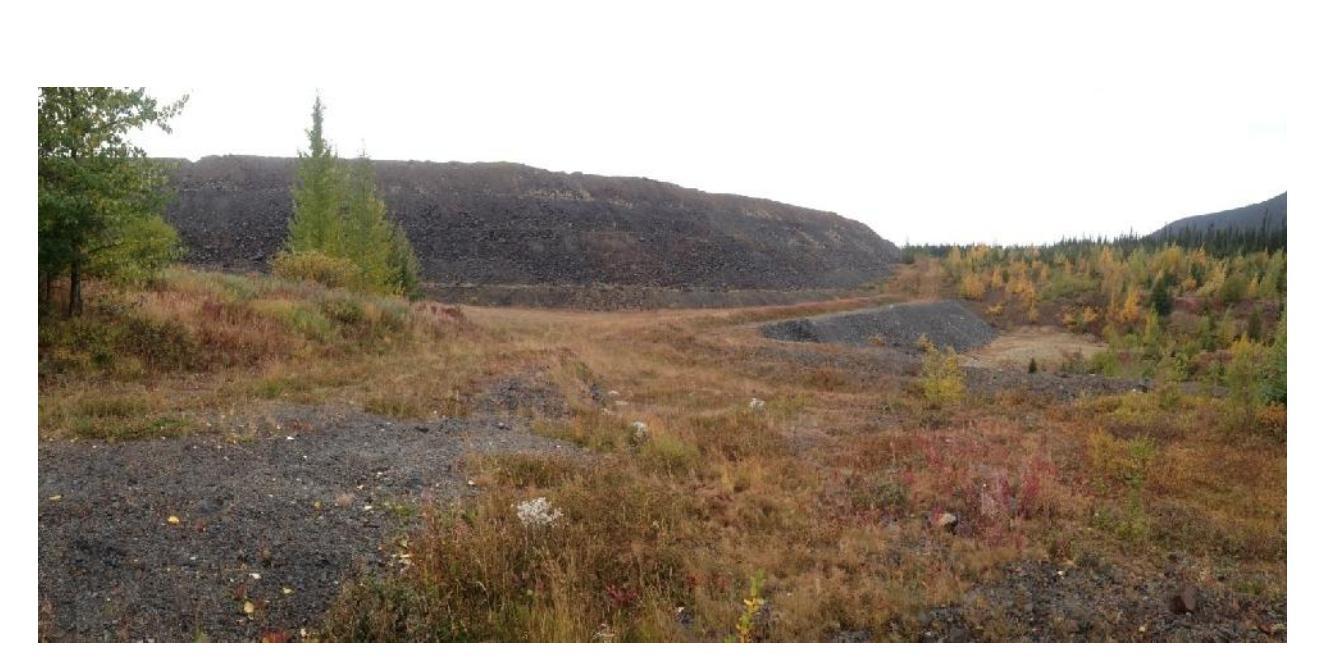
Photo 9: Dam No. 1, view of downstream shell

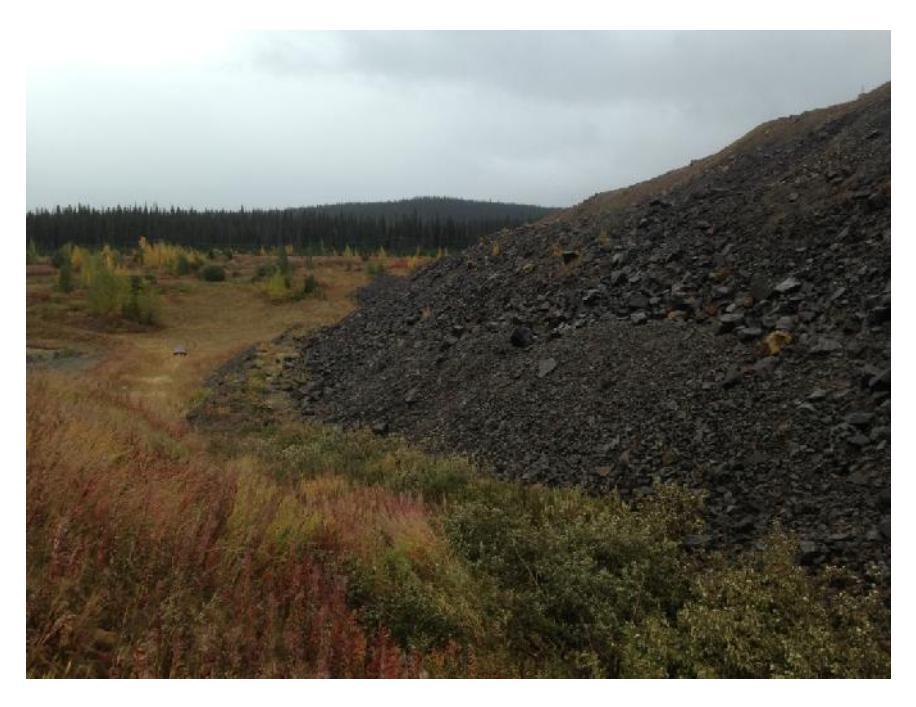
Photo 10: Dam No. 1, view of dam toe from left abutment.

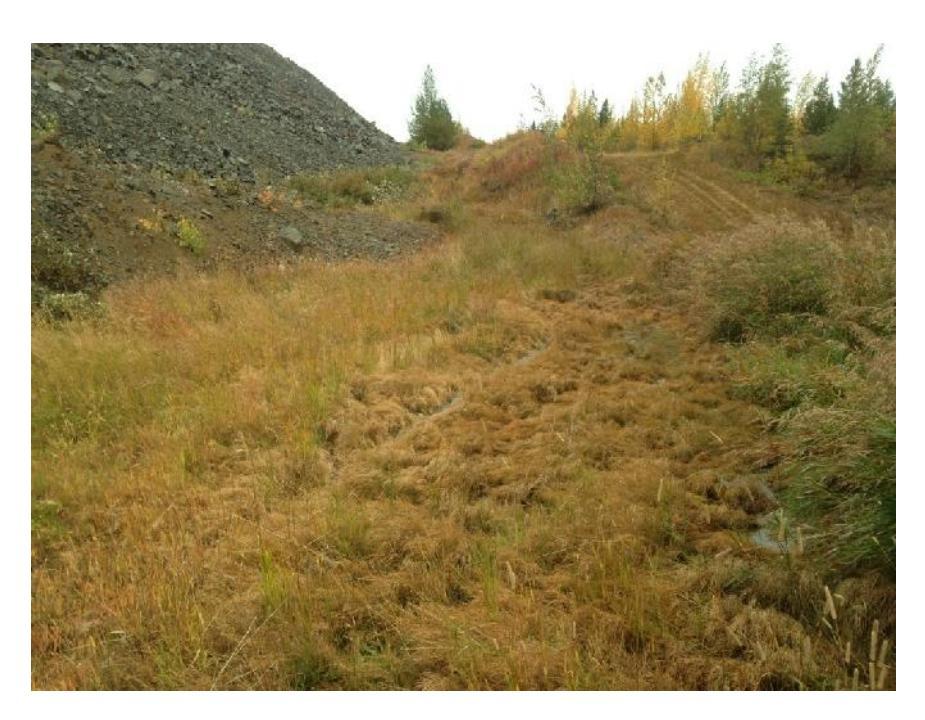
Photo 11: Dam No. 1, view of dam of pooling water on toe bench.

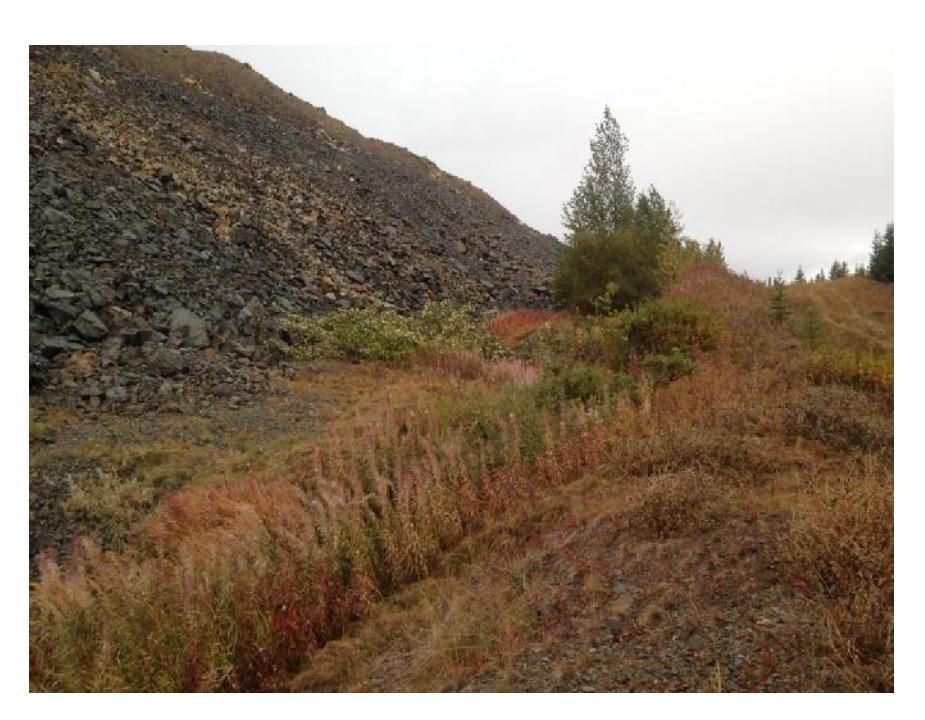
Photo 12: Dam No. 1, view of the seepage collection ditch at the toe of the downstream face. Note vegetation cut down but not removed.

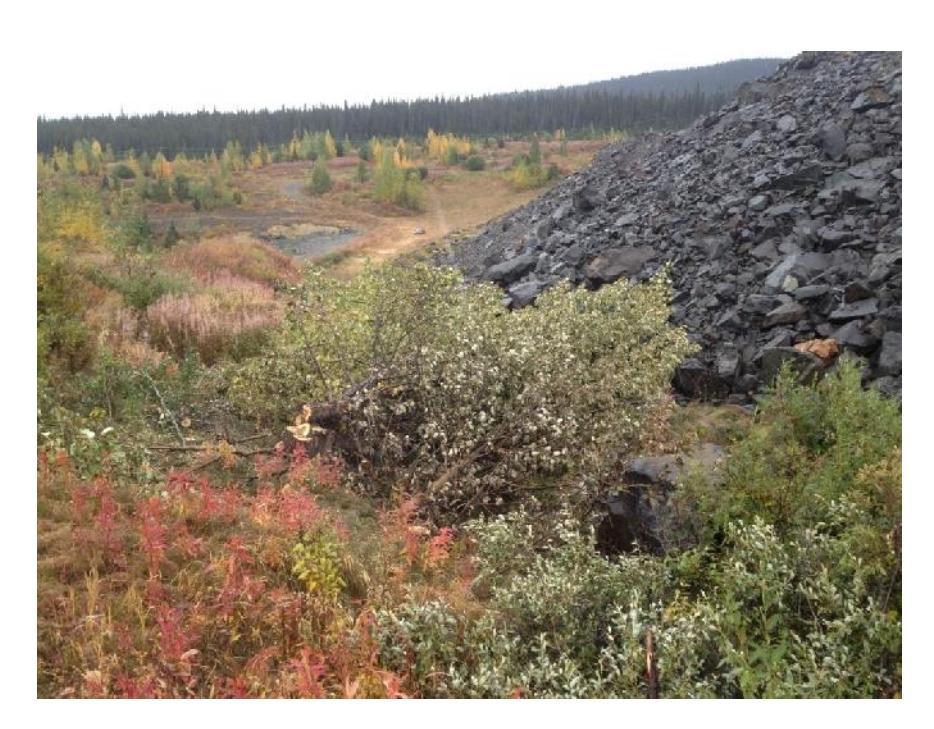
Photo 13: Dam No. 1, view of the seepage collection ditch at the toe of the downstream face. Note vegetation cut down but not removed.

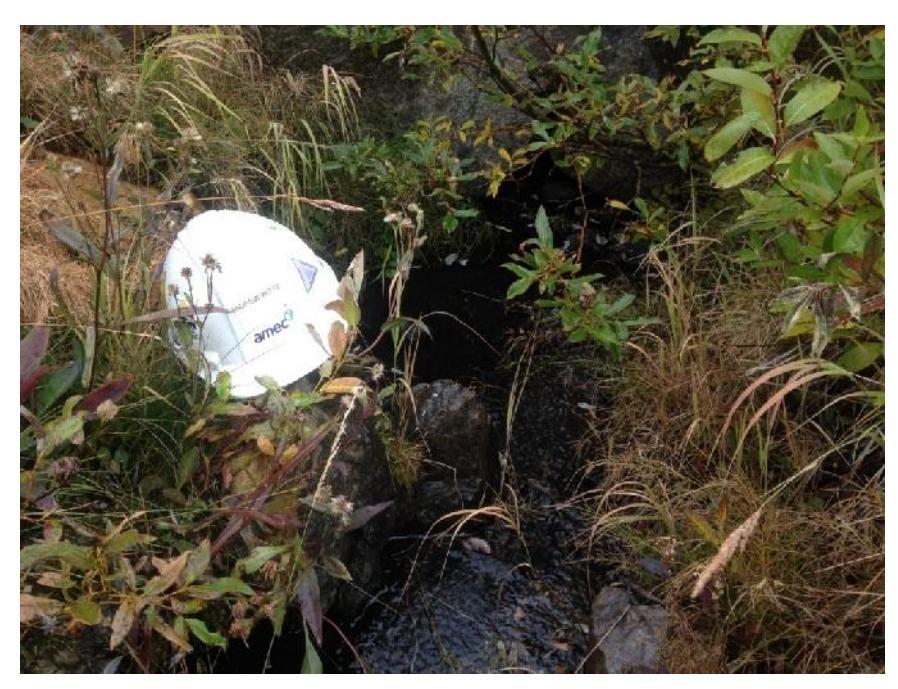
Photo 14: Dam No. 1, close-up view of the seepage collection ditch at the toe of the downstream face. Note seepage water is clear.

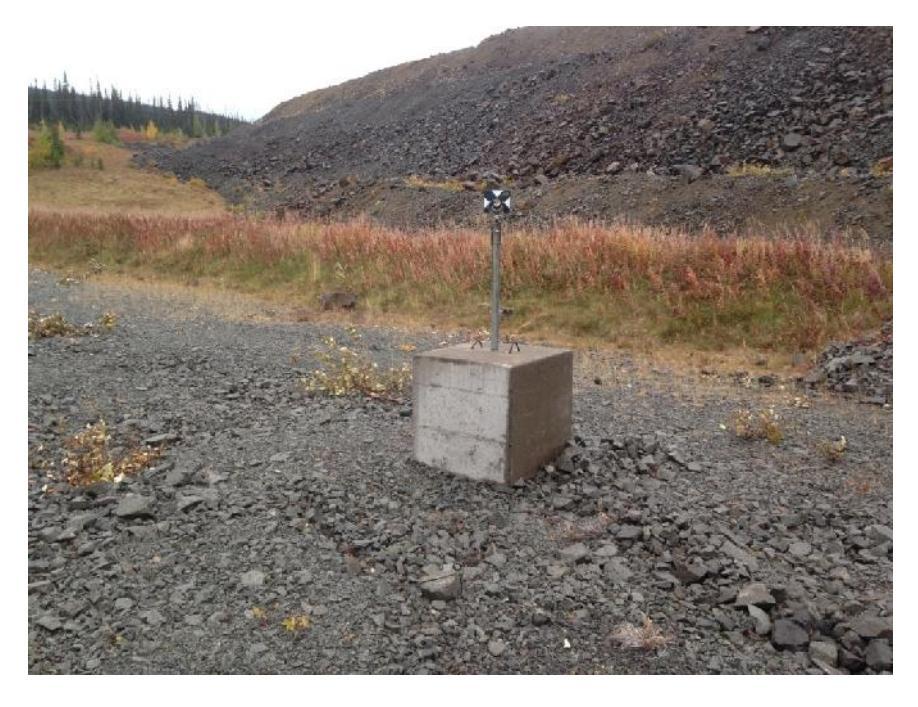
Photo 16: Dam No. 1, view of monitoring prism at dam toe.

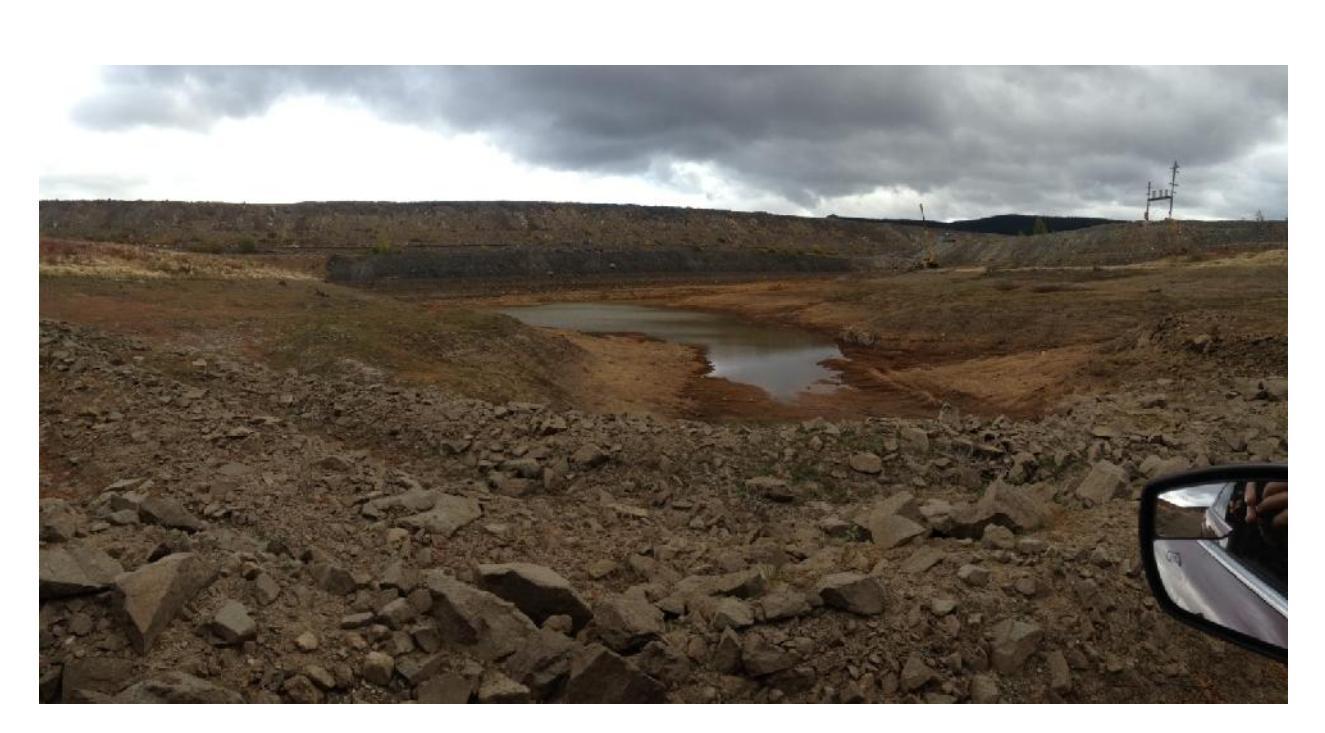
Photo 17: Diversion Dam, panoramic view from Diversion Pond.

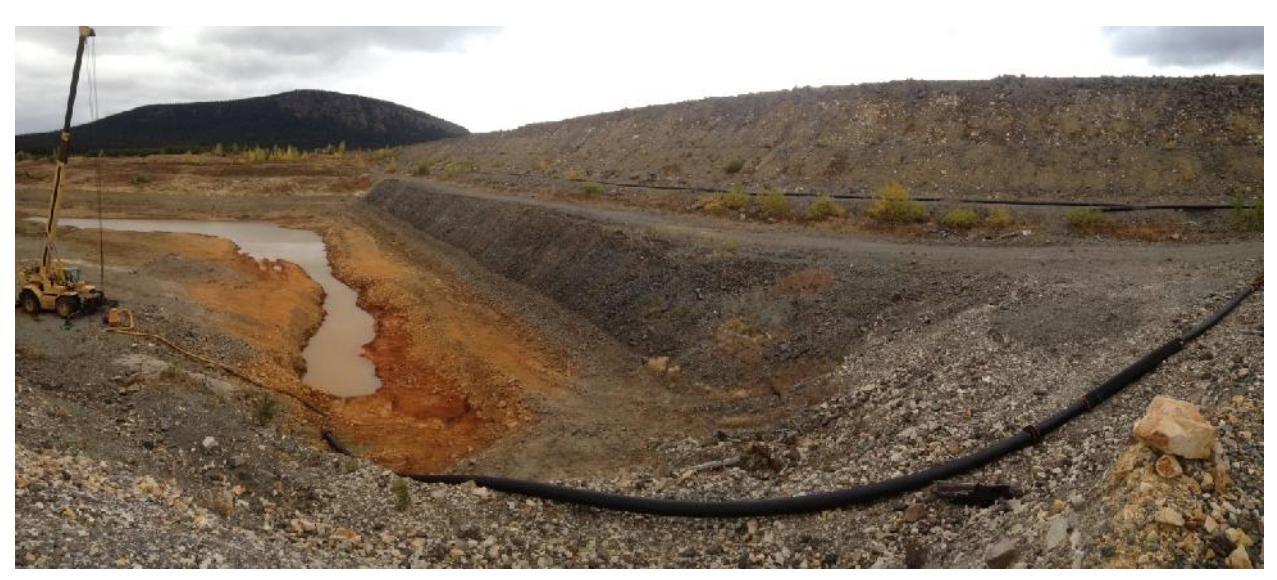
Photo 18: Diversion Dam, view of the downstream slope and pond at toe.

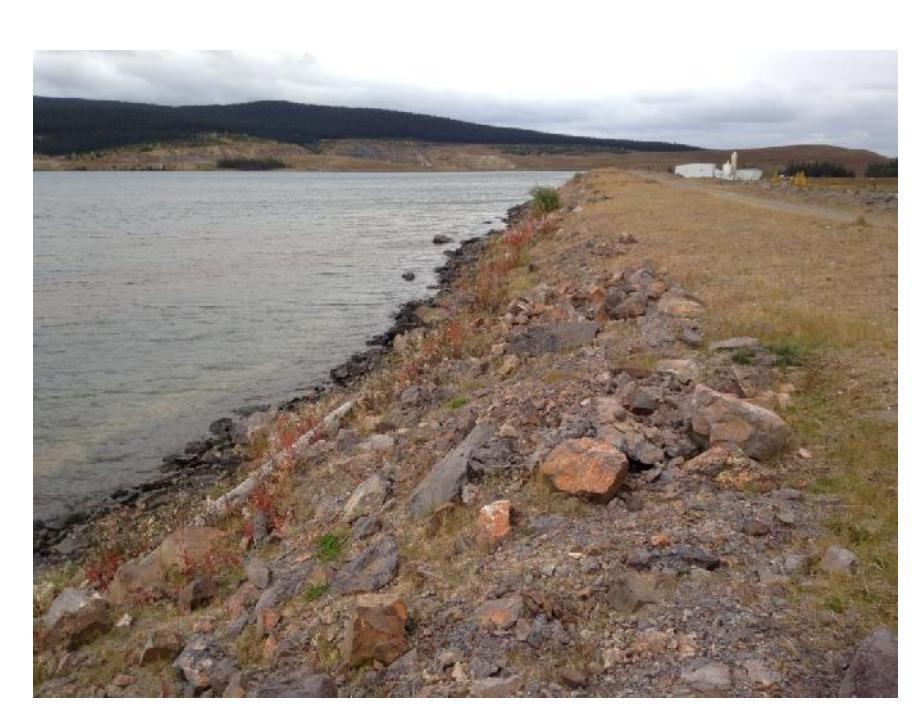
Photo 19: Diversion Dam, view of the upstream face and riprap protection.

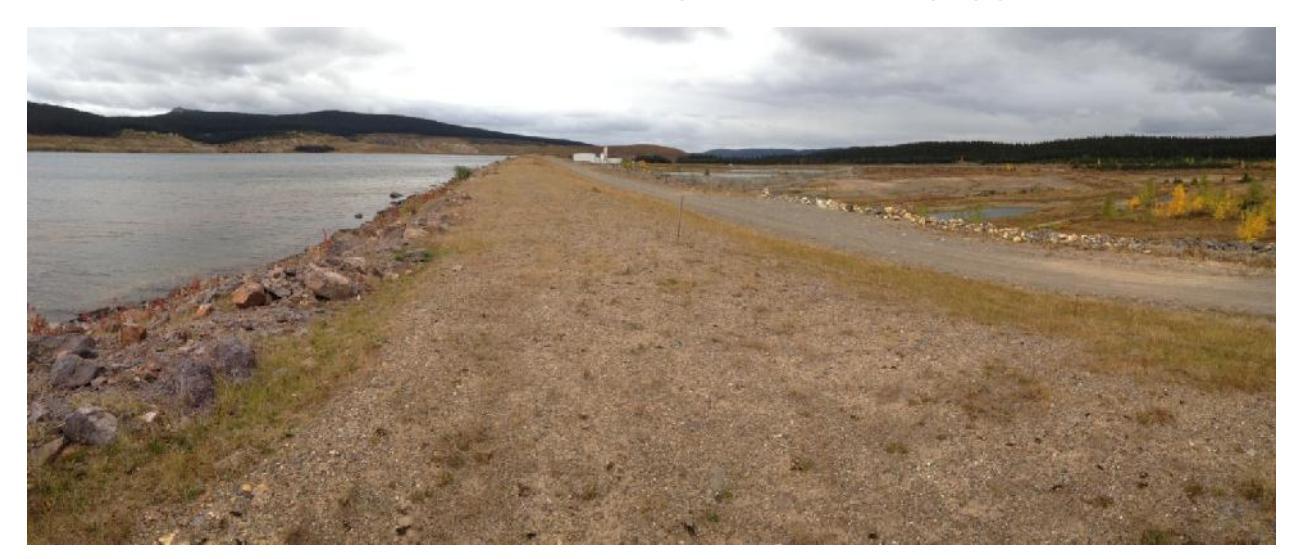
Photo 20: Diversion Dam, view of the dam crest.

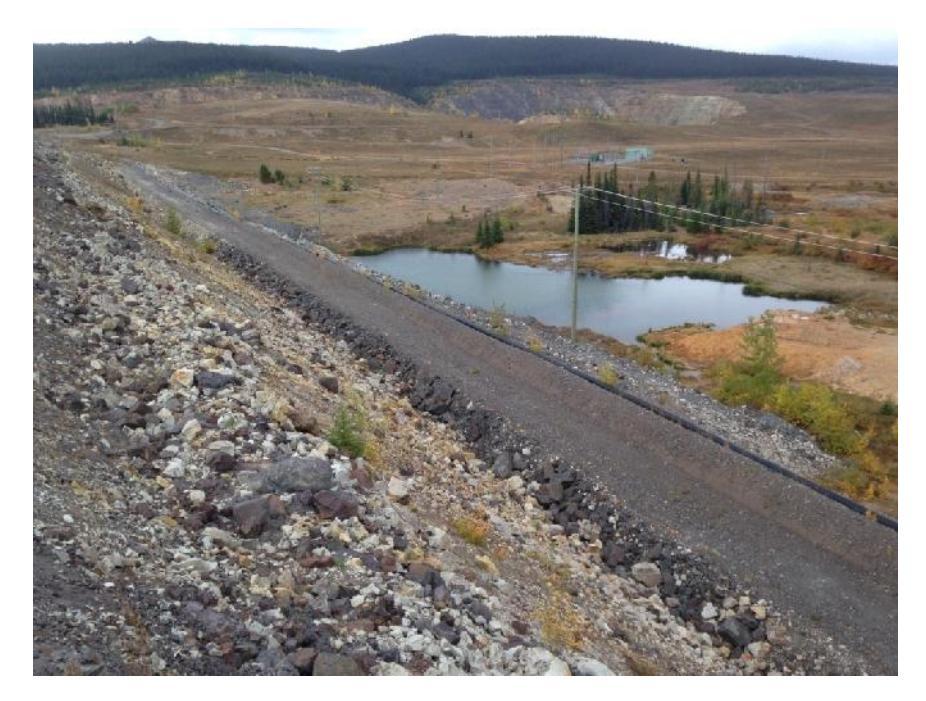
Photo 22: Dam No. 2, view of downstream face from crest. Note ponded water at toe.

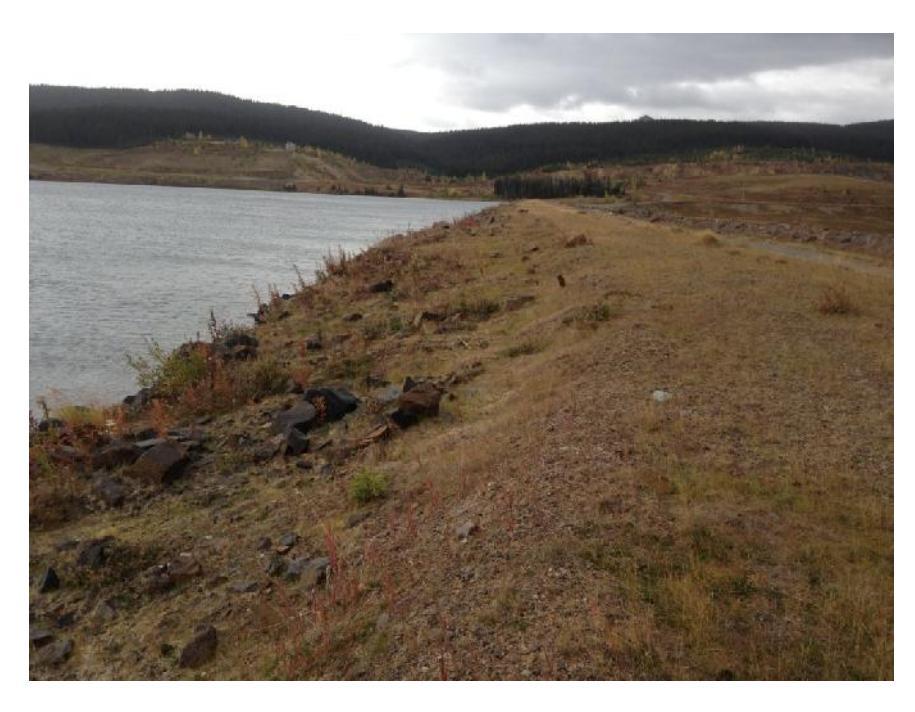
Photo 23: Dam No. 2, view of the upstream erosion protection.

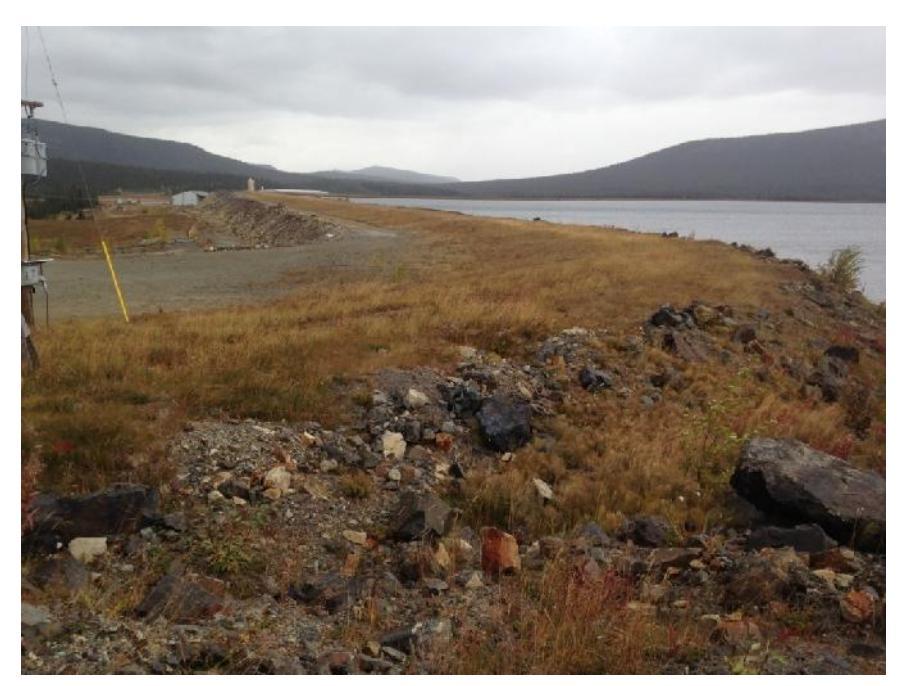
Photo 24: Dam No. 2, view of dam crest.

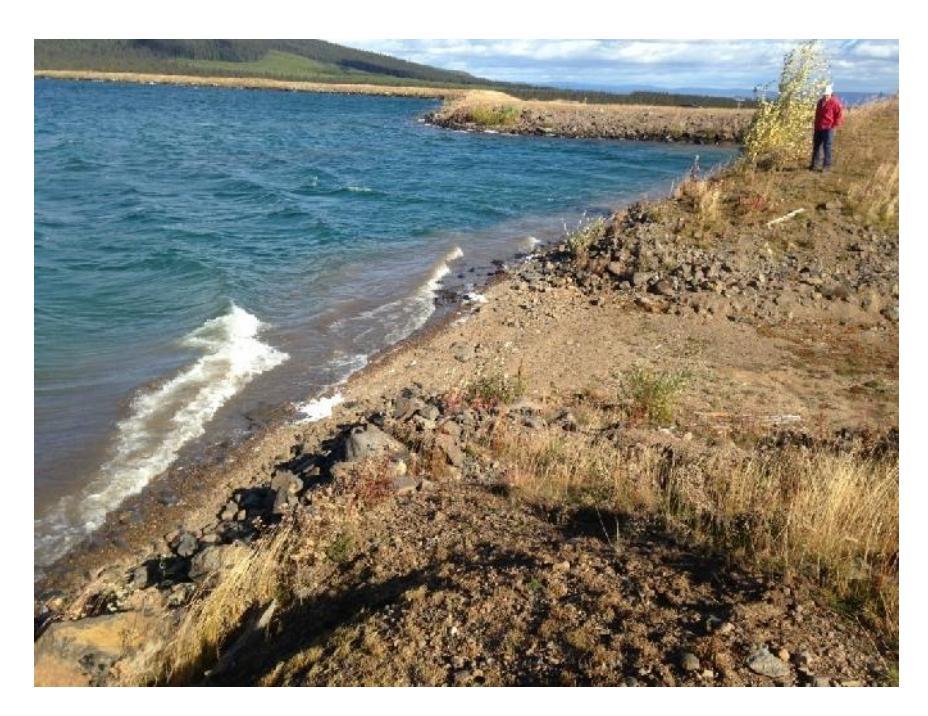
The spillway for the tailings impoundment was constructed in 1994. It is a permanent open channel structure with invert elevation of 1292.5 m (Photos 25 and 26). A visual inspection of the spillway showed that the structure appears to be in good physical condition with no visible signs of erosion, however there is limited to no erosion protection in the spillway channel (Photo 29). Some erosion protection was installed on the banks of the spillway inlet at the water line in

Photo 25: Spillway Inlet, view from above right hand side. Note the erosion protection in the foreground and wave action in the pond.

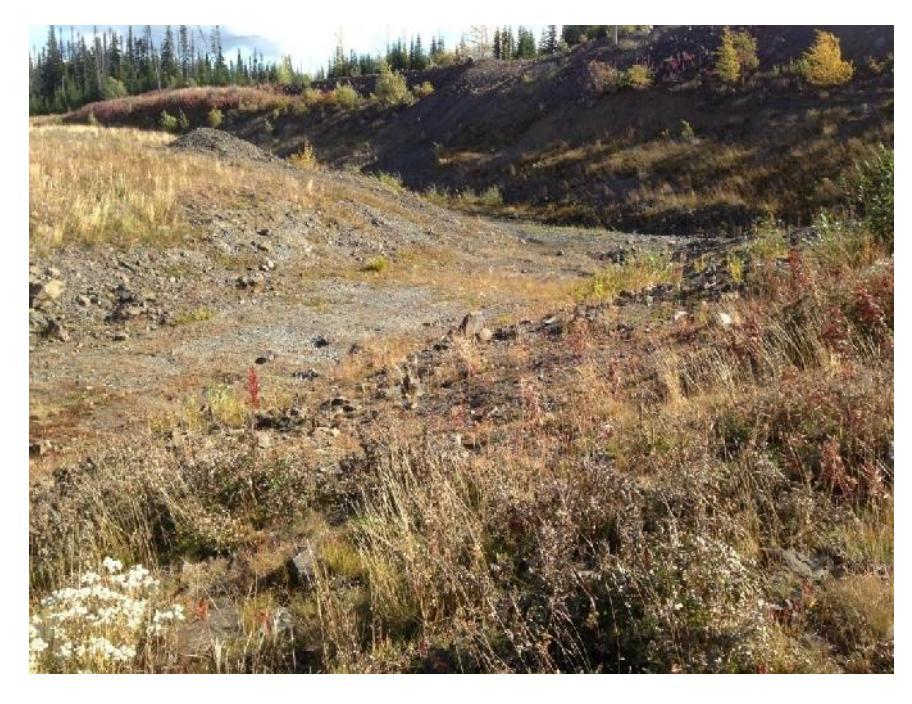
Photo 26: Spillway channel, looking downstream.

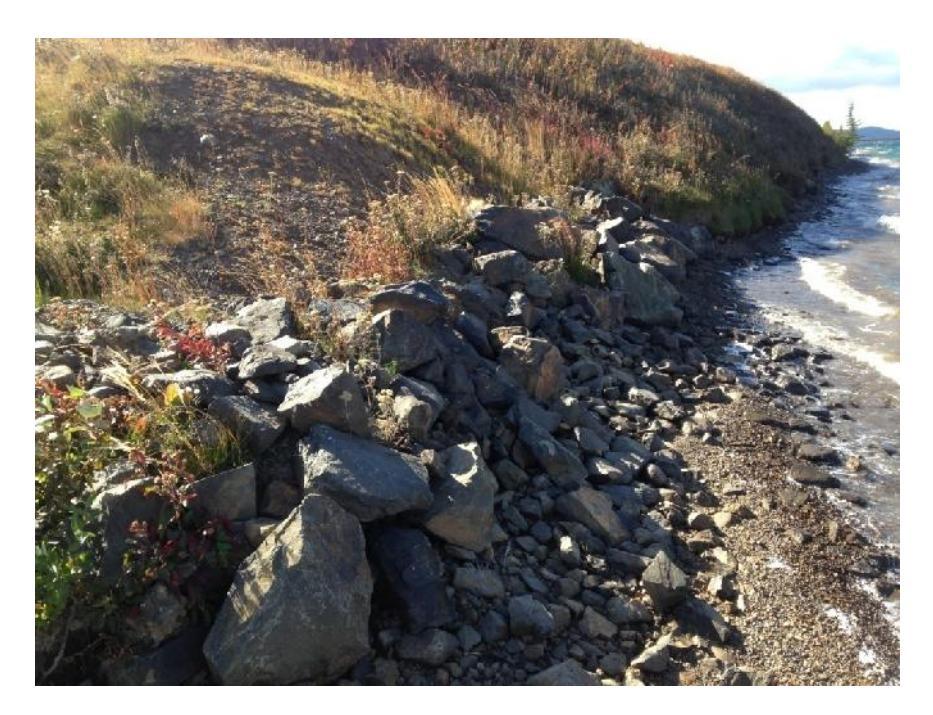
2012 and 2013 (Photos 27 and 28) to protect against wave induced erosion. The erosion protection appeared to be performing well.

Photo 27: Spillway inlet, right hand side erosion protection. Note wave action on shoreline.

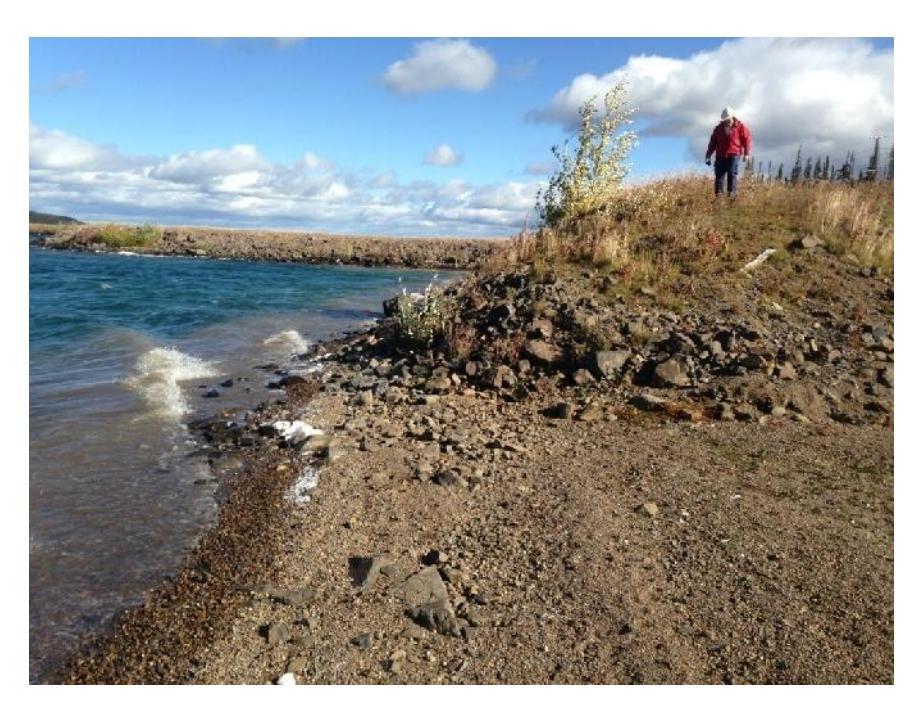
Photo 28: Spillway inlet, left hand side erosion protection. Note wave action on shoreline.

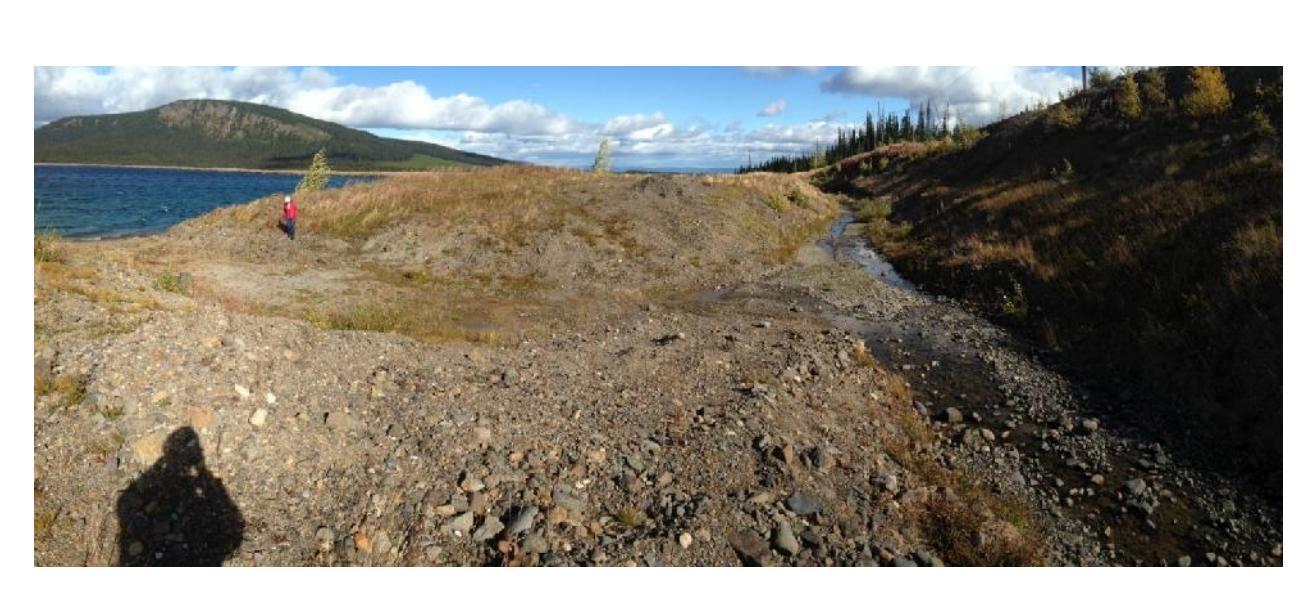
Photo 29: Spillway channel and outlet into Berzelius Diversion Channel.

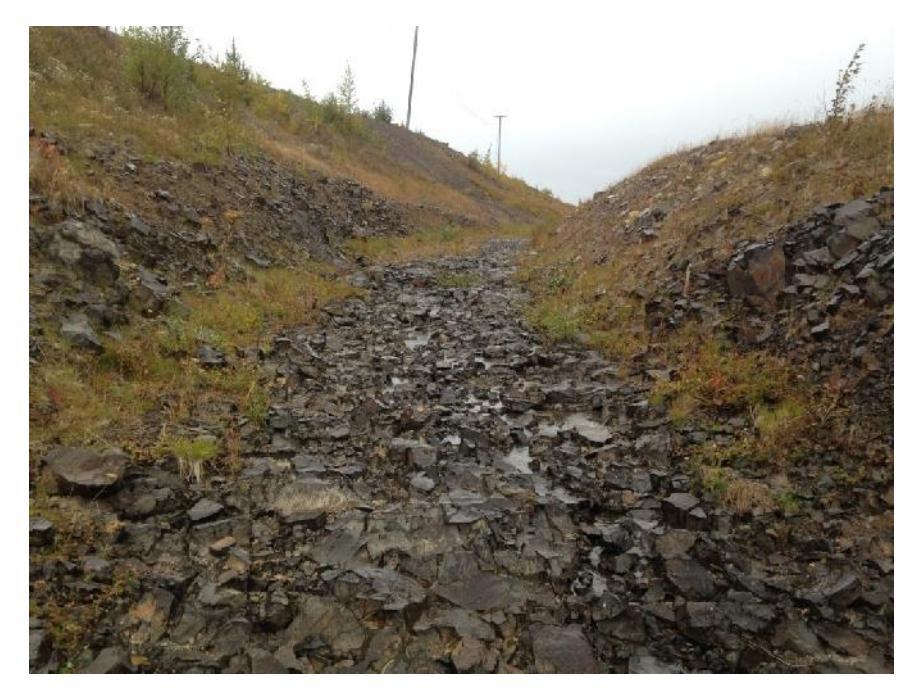
The Berzelius Creek Diversion collects water from Berzelius Creek above the Waterline Pit and diverts it north around the tailings impoundment to be discharged into Foxy Creek (Photos 30 through 38). Visual inspection of the ditch showed it to be in good general condition. Typical views of the ditch adjacent to the tailings pond are shown in Photos 33 and 34.

Photo 30: Berzelius Diversion, looking upstream from culvert crossing of spillway inlet.

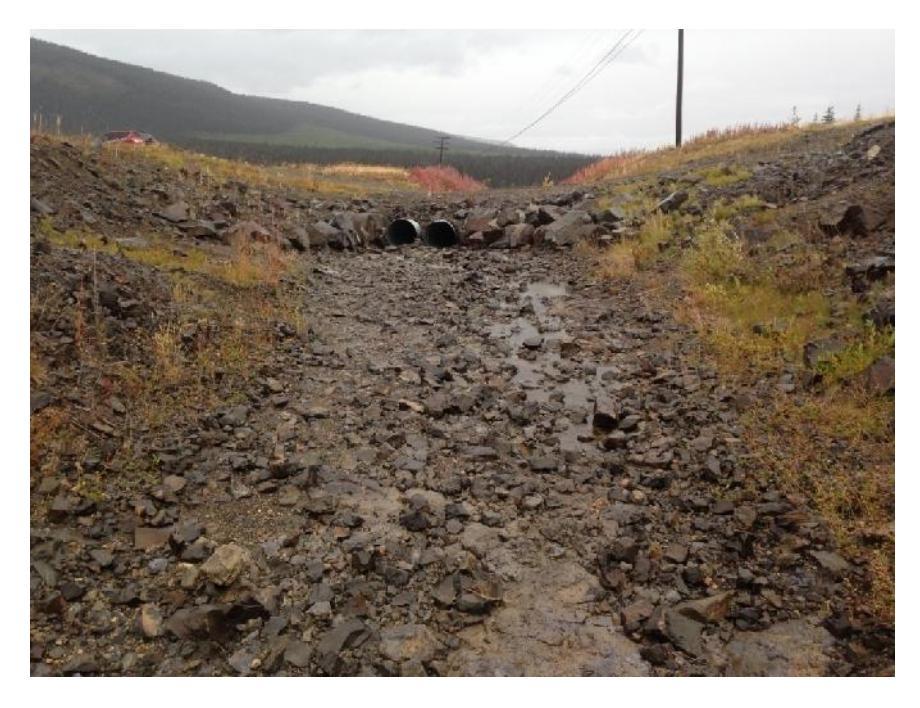
Photo 31: Culvert crossing in Berzelius Diversion looking downstream.

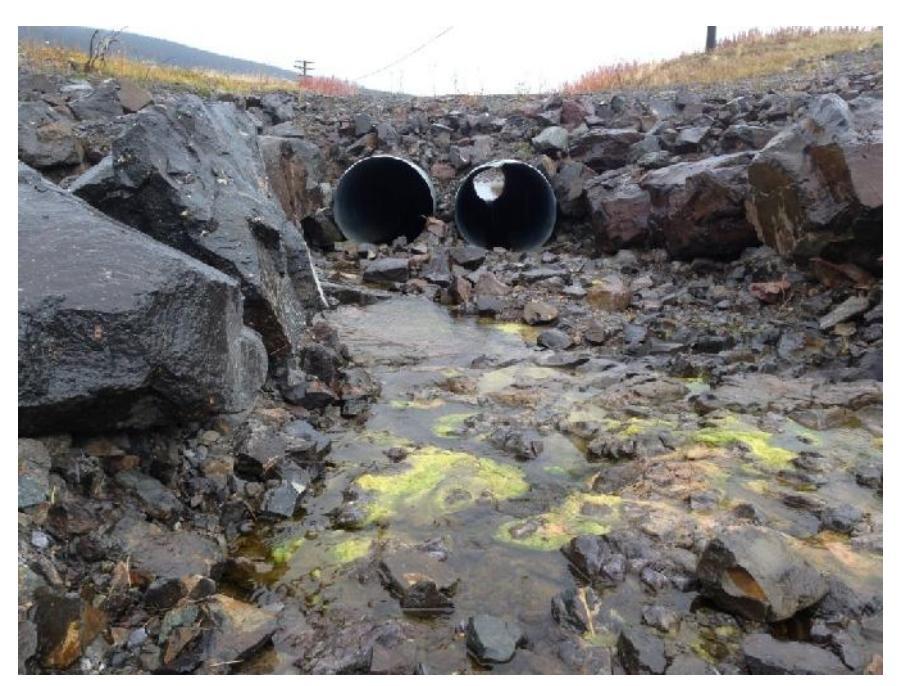
Photo 32: Culvert crossing in Berzelius Diversion looking downstream.
