Tailings Impoundment and Water Management Structures 2014 Dam Safety Inspection

Equity Silver Mine Houston, British Columbia

FINAL REPORT

October 14, 2014

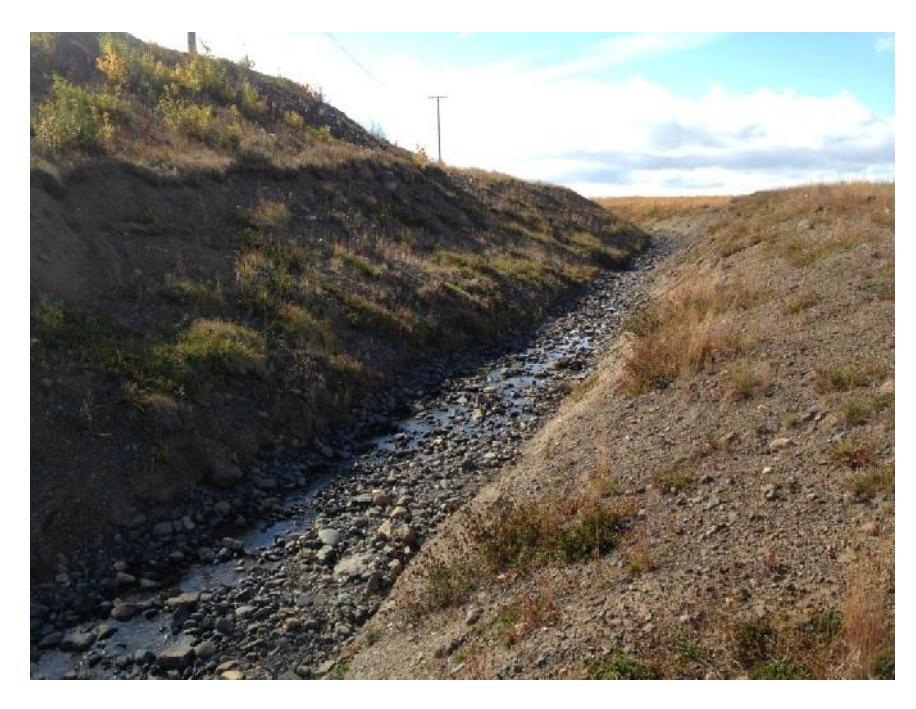
The Berzelius Creek Diversion collects water from Berzelius Creek above the Waterline Pit and diverts it north around the tailings impoundment to be discharged into Foxy Creek (Photos 30 through 38). Visual inspection of the ditch showed it to be in good general condition. Typical views of the ditch adjacent to the tailings pond are shown in Photos 33 and 34.

The area of noticeable slope movement and erosion about 50 m upstream of the junction with the spillway inlet noted in 2011 was repaired in 2012 and vegetation is beginning to establish itself on the banks of the channel (Photo 33).

Photo 33: Typical view of Berzelius channel adjacent tailings pond.

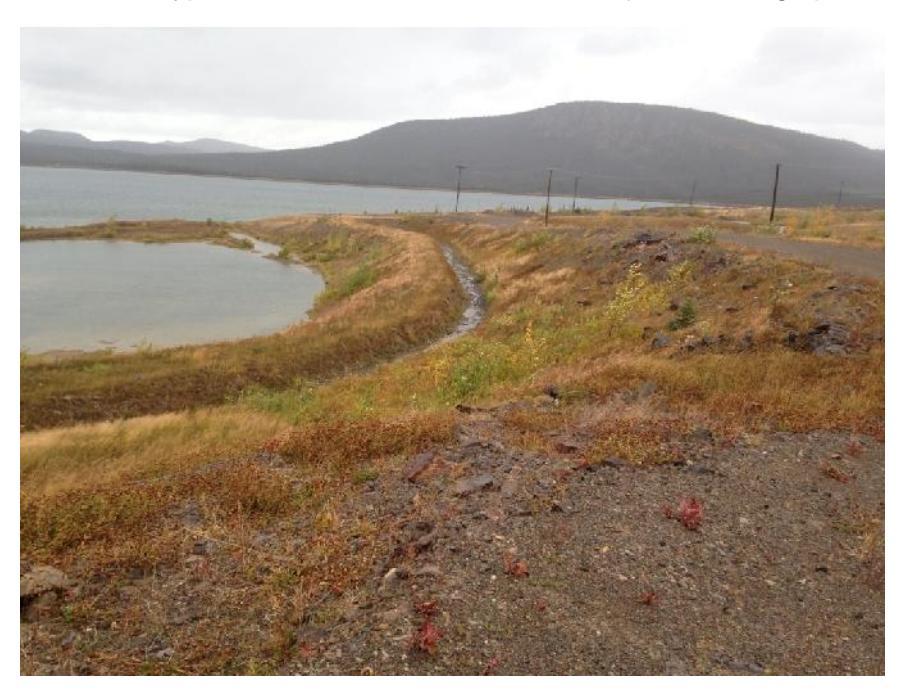
Photo 34: Typical view of Berzelius channel adjacent tailings pond.

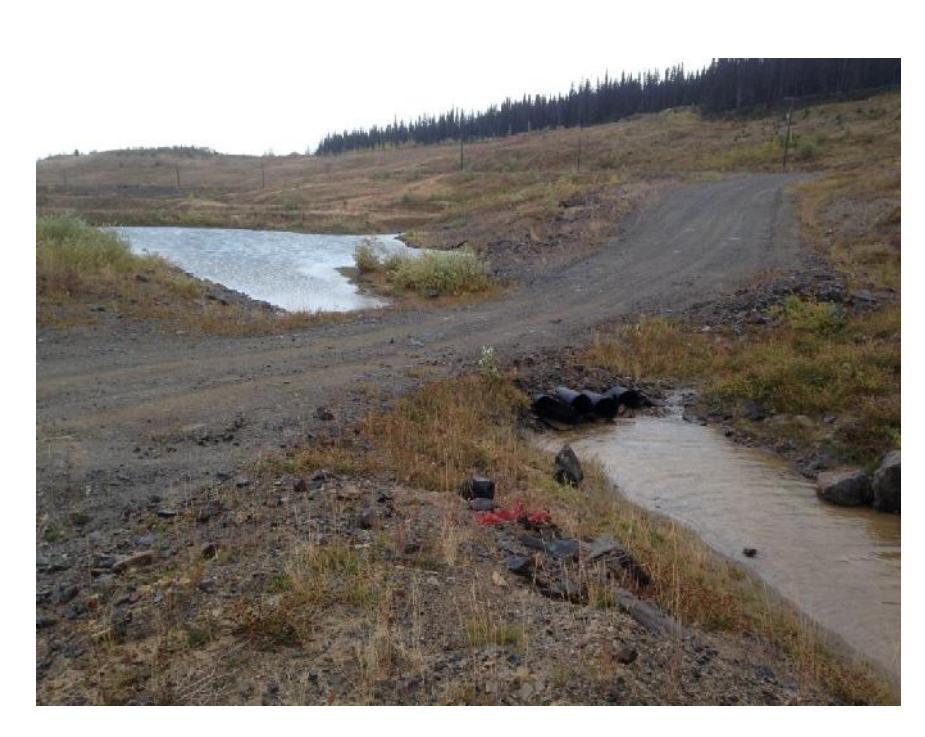
Photo 35: Berzelius Diversion Channel at road crossing near water tower.

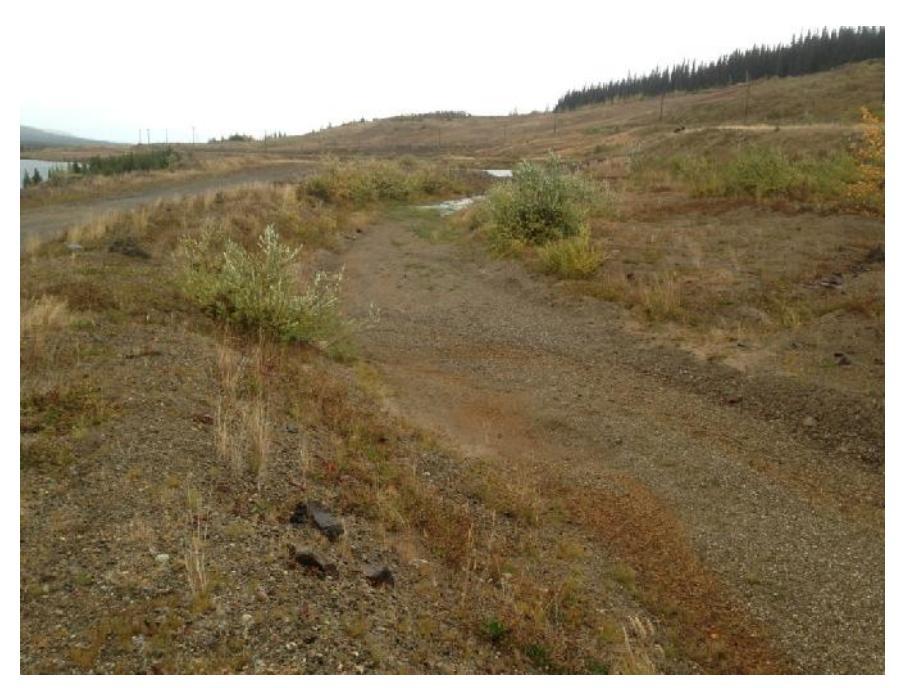
Photo 36: Berzelius Diversion Channel upstream of road crossing near water tower.

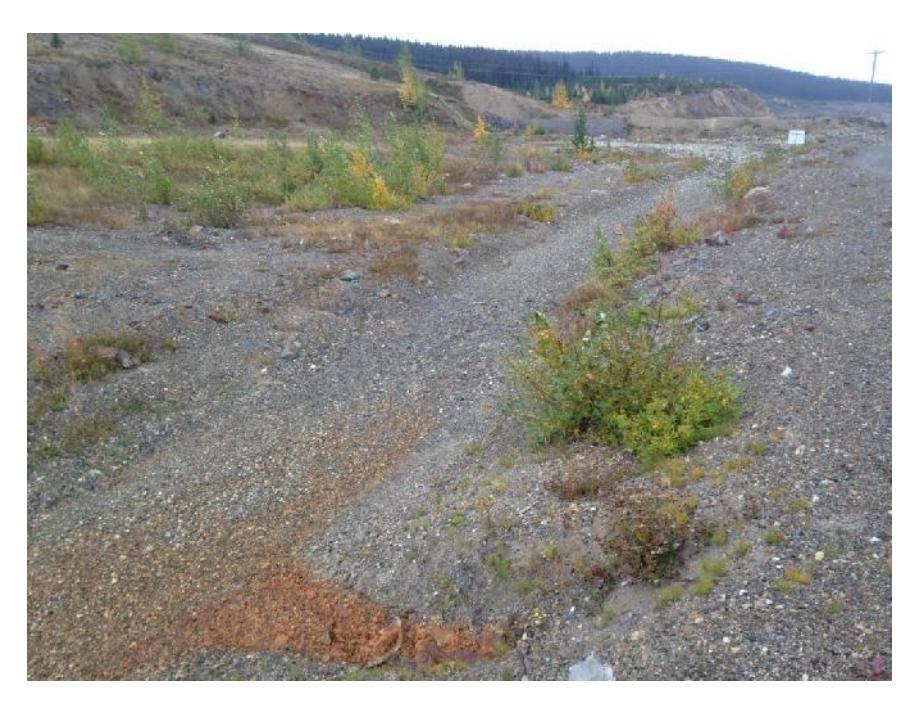
It was noted in the 2008 and 2009 reviews that cobbles and boulders had begun to obstruct the ditch approximately 150 m from the diversion start point (below the water tower). There was also a significant amount of sediment (gravel, cobbles and sand) deposited in the ditch upstream of the two access road crossings at that time. The ditch is cleaned out annually as required at these two areas as shown in Photos 37 and 38; this is expected to be an on-going maintenance requirement.

Photo 37: Berzelius Diversion Channel upstream of road crossing near water tower.

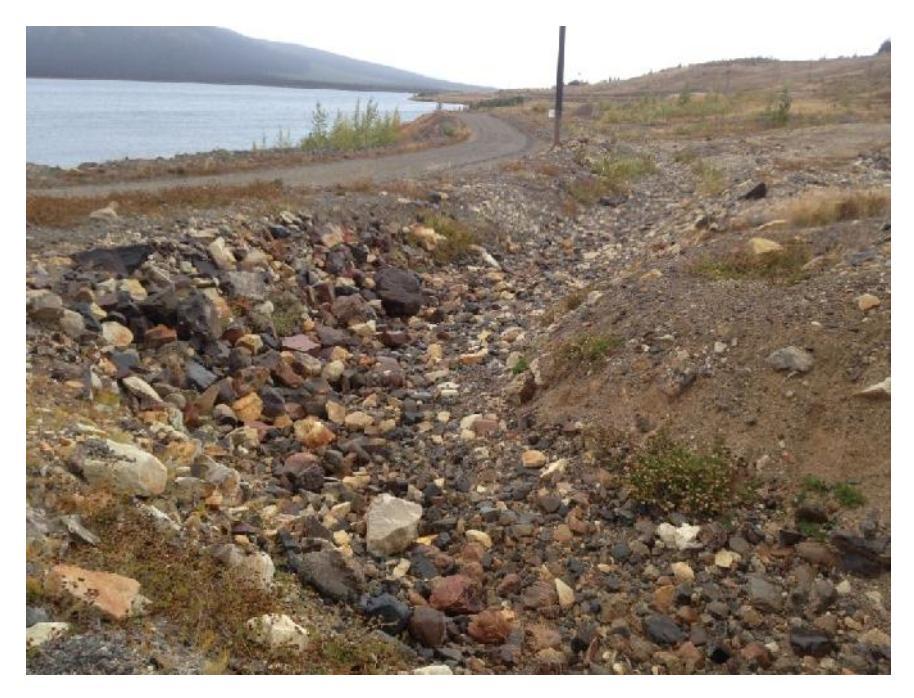
Photo 38: Berzelius Channel at the corner below the water tower.

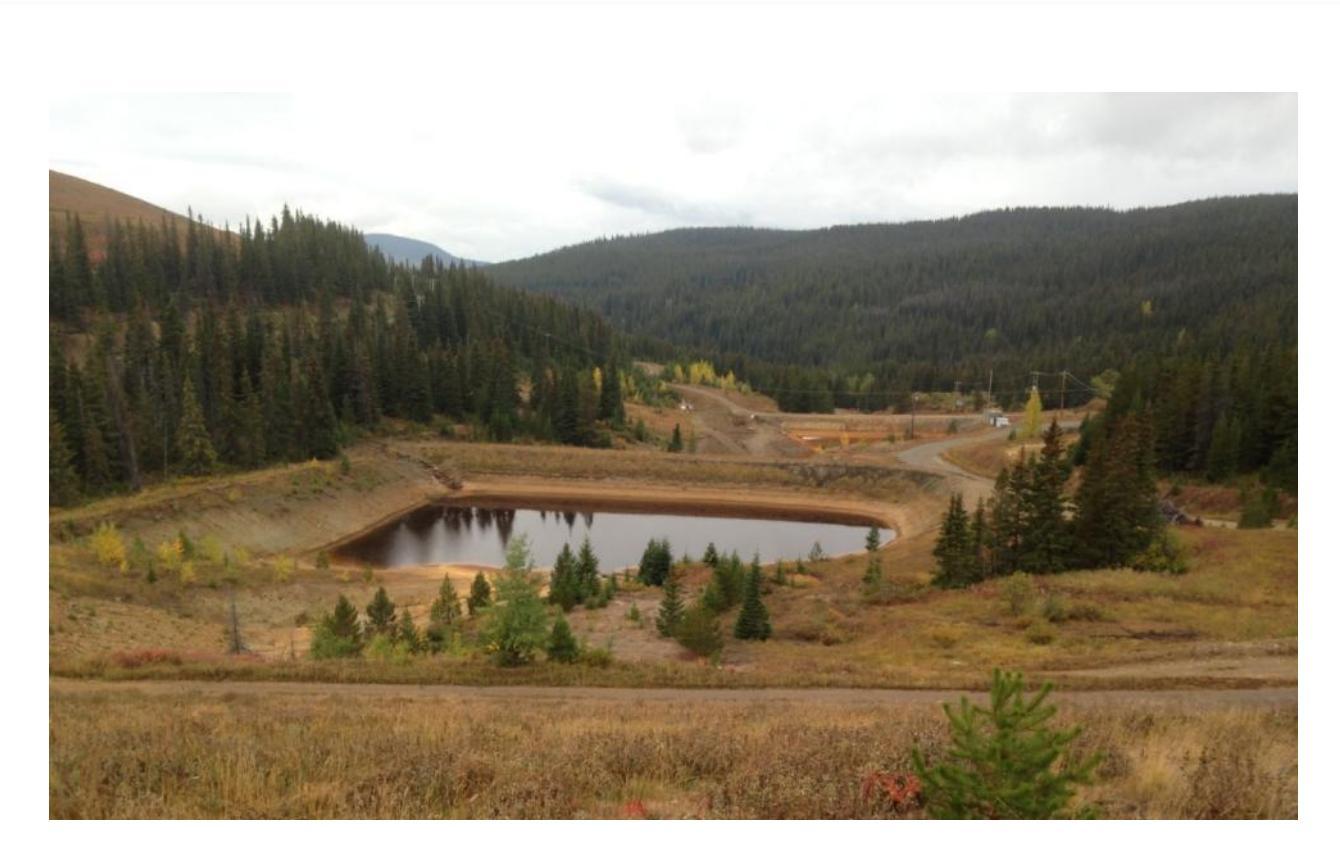
The ARD Surge Pond consists of a small dam and pipeline spillway, as shown in Photos 39, 40 and 41. ARD that originates at the waste dumps and the area between the old plant site and road reports to the Surge Pond. Discharge from the pond to the Main ARD Pond is controlled through a valved low level outlet. Two 400 mm (inside diameter) HDPE pipelines were installed in 2002 as emergency decants (Photo 46). They discharge into a ditch that includes a culvert, routed back to the Main ARD pond (Photos 47, 48 and 49). The Surge Pond Dam is approximately 5 m high and constructed of compacted glacial till.

Photo 39: ARD Surge Pond and Main ARD Pond, view from the waste dump above.

2014-05	Continue to Inspect the ARD Surge Pond dam regularly for evidence of instability, such as cracks or erosion and repair/upgrade the leaking ditch at the left abutment to convey runoff and seepage flows off the hillside and into the ponds in a more controlled manner.
2014-06	Remove accumulated sediment from Bessemer Creek Silt Check reservoir.
2014-07	The Berzelius Diversion should continue to be inspected and cleaned out on an annual basis to remove accumulated sediment with repairs made when required.
2014-08	The sediment accumulation at the outlet of the ARD collection ditch into the No.1 Sump Pond should be removed in order to maintain sufficient live storage within the pond.
2014-09	The OMS Manual and associated EPP should be updated based on the results of the dam breach and inundation studies currently underway.

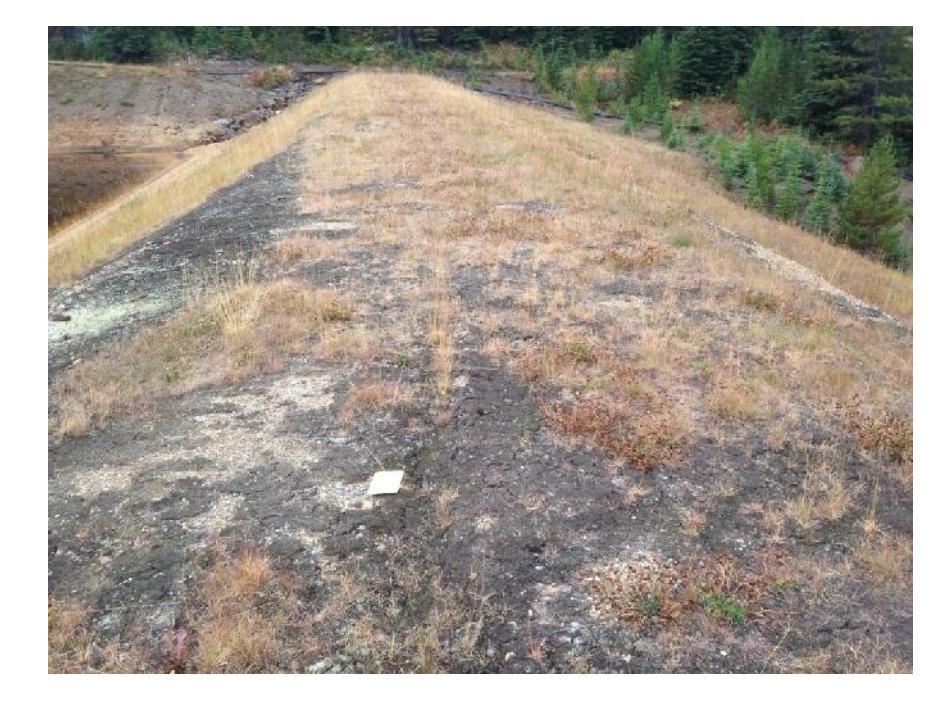
Photo 42: ARD Surge Pond Dam crest. Note rut in foreground from tire track.

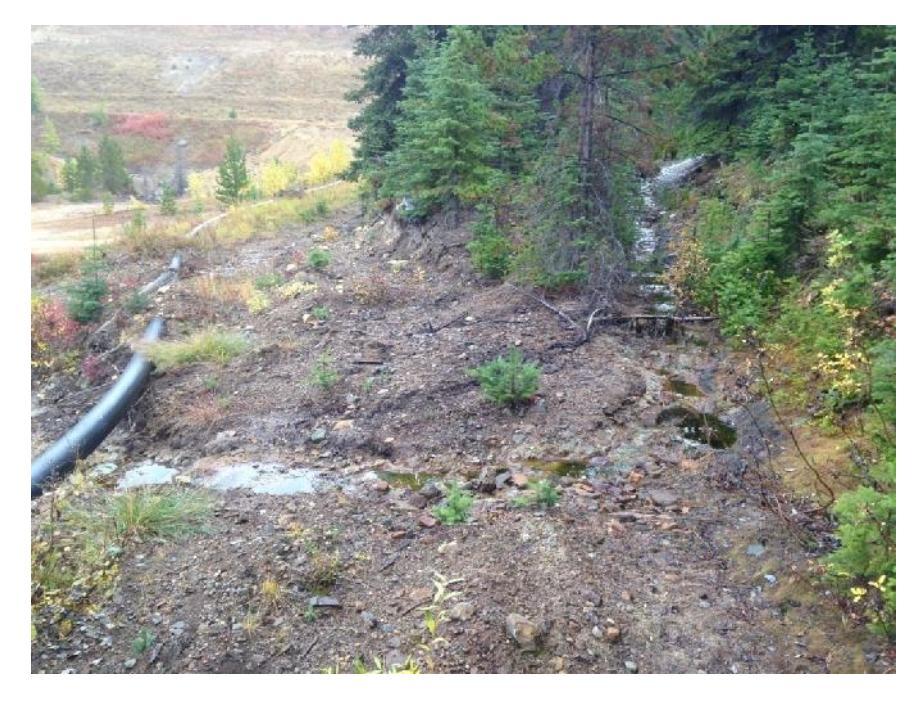
Photo 44: Water flowing into ARD Surge Pond at left abutment.

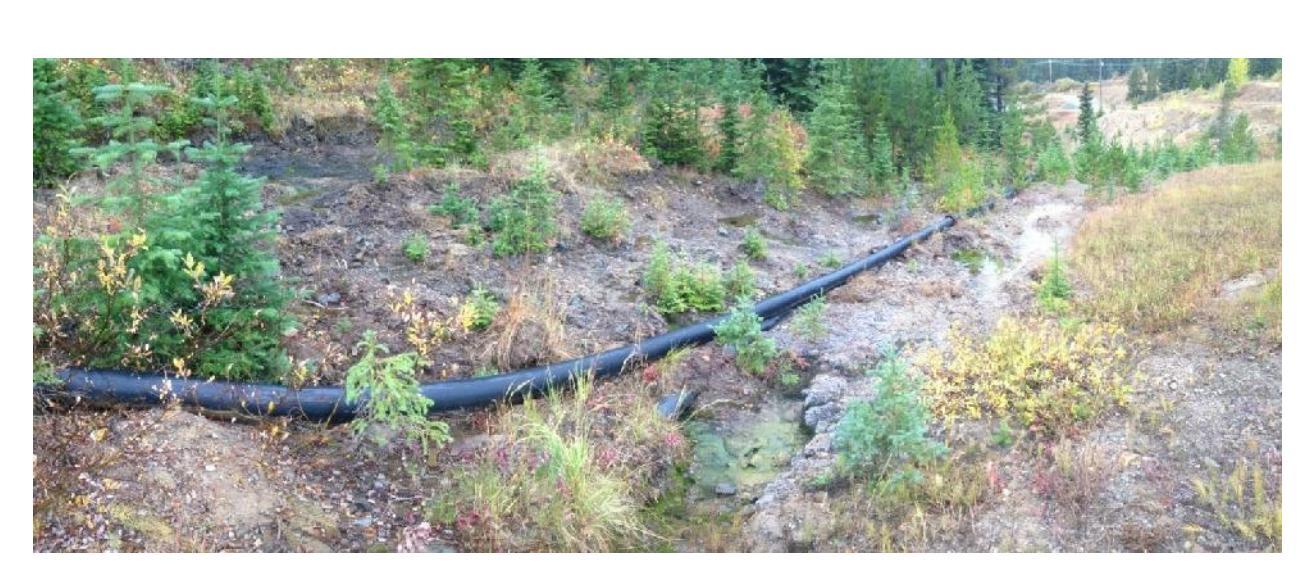
Photo 45: ARD Surge Pond Dam, view down left abutment on downstream slope. Note surface water and saturated ground along pipe alignment.

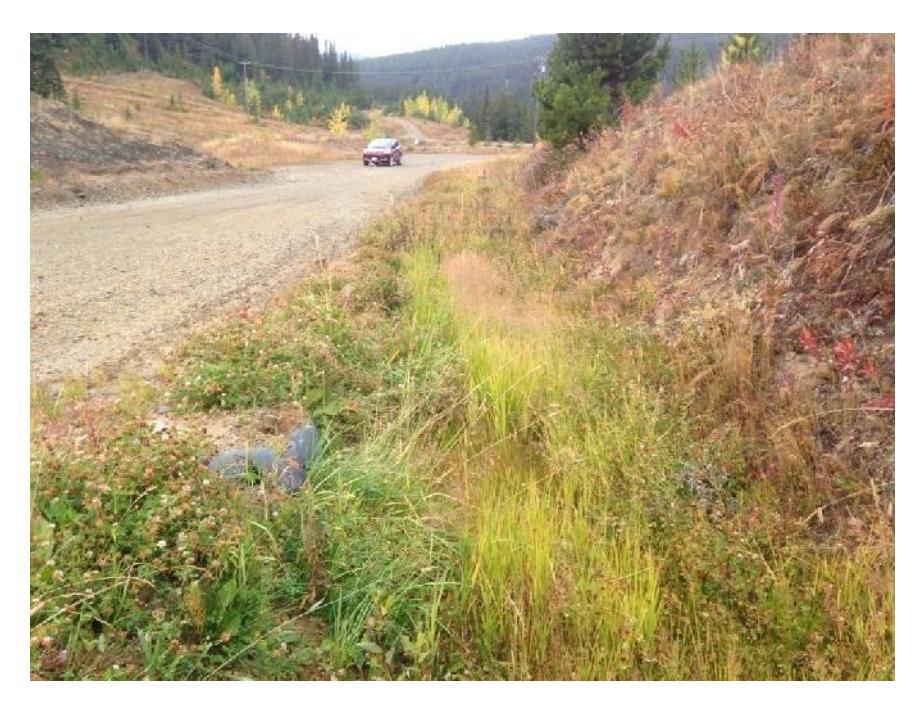
Photo 47: ARD Surge Pond Spillway outlet pipes. Note vegetation overgrowth.

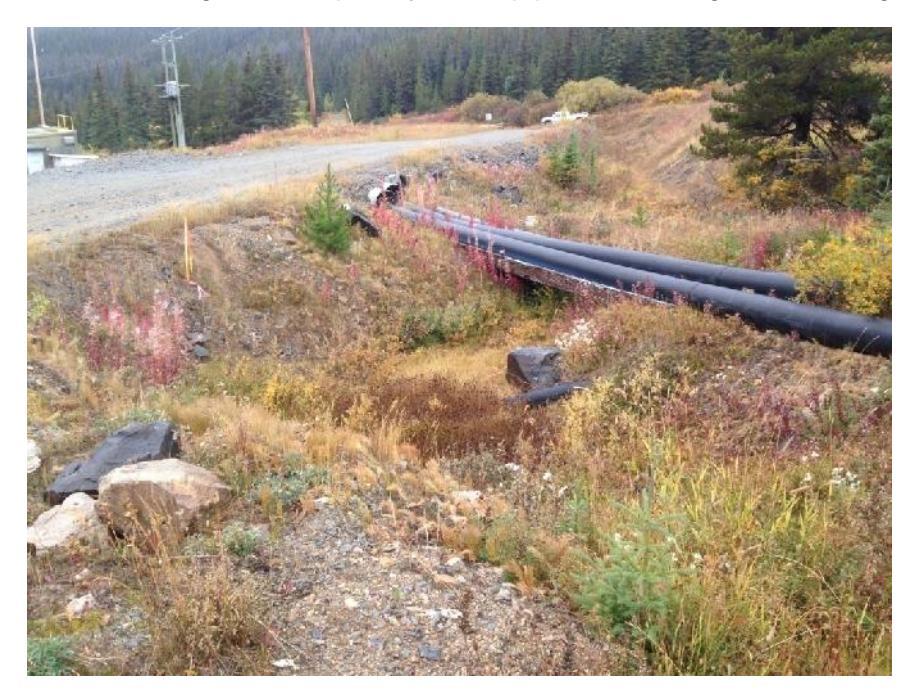
Photo 48: ARD Surge Pond Spillway downstream of outlet pipes. Note vegetation overgrowth and obstructed culvert inlet that discharges into the main ARD pond.

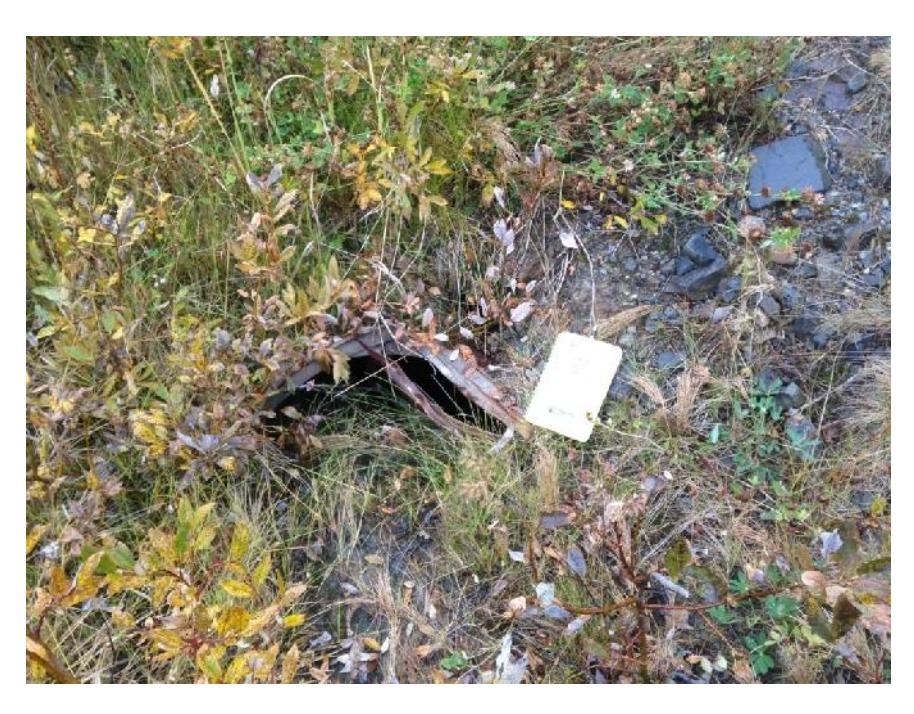
Photo 49: Inlet of culvert from ARD Surge Pond spillway to Main ARD pond. Note vegetation overgrowth obstructing inlet.

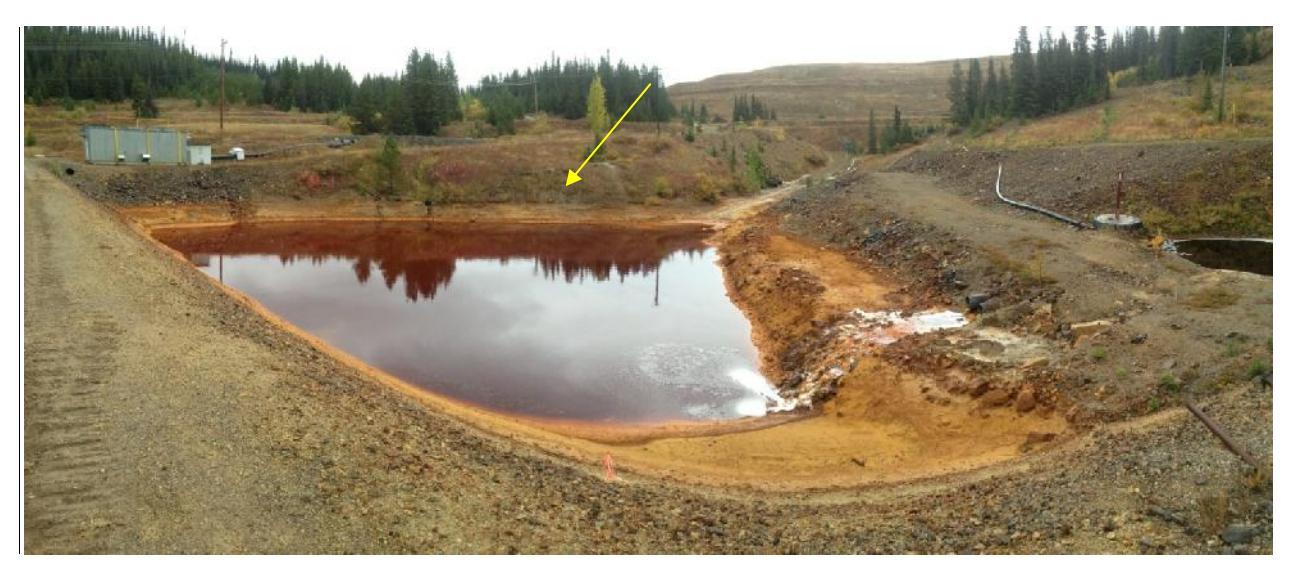
Photo 52: Main ARD Pond, view from left abutment. Note old instability on far shore.

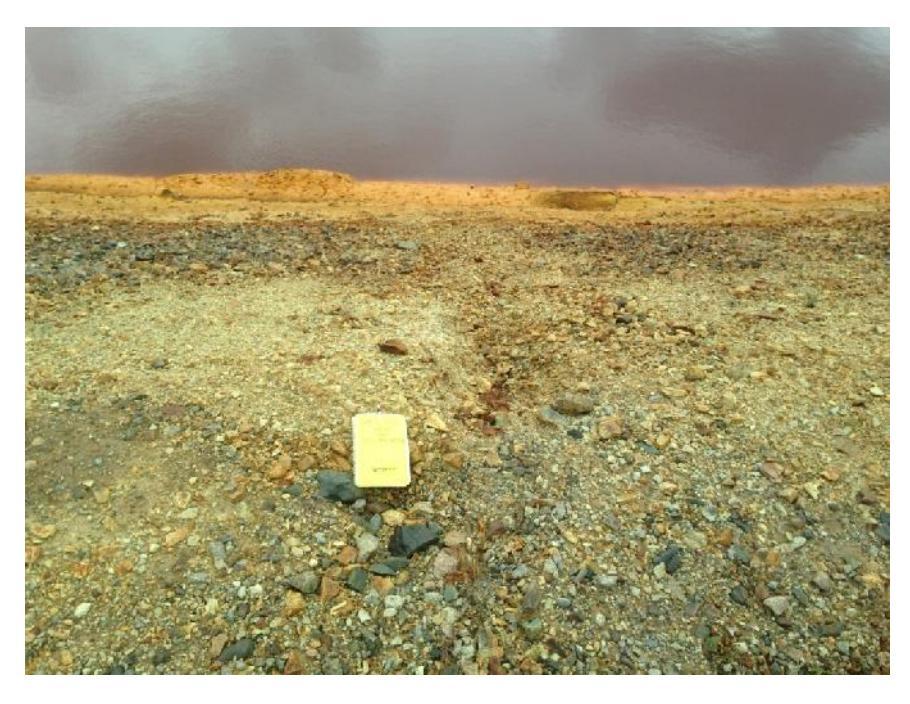
Photo 53: Rilling on upstream face of Main ARD Pond Dam face.

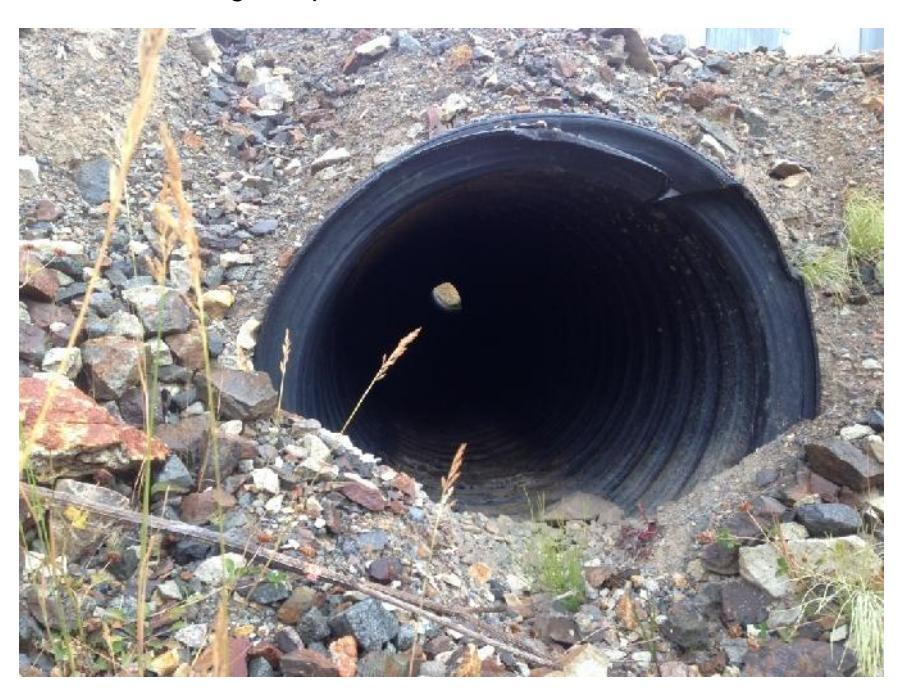
- The first pipe spillway culvert was free of obstructions (Photos 54 and 55) however the inlet to the second culvert crossing is still partially obstructed (Photo 57). The outlet channel was noted to be relatively free of vegetation however some re-growth is occurring (Photo 56).

Photo 54: Main ARD Pond spillway culvert inlet.

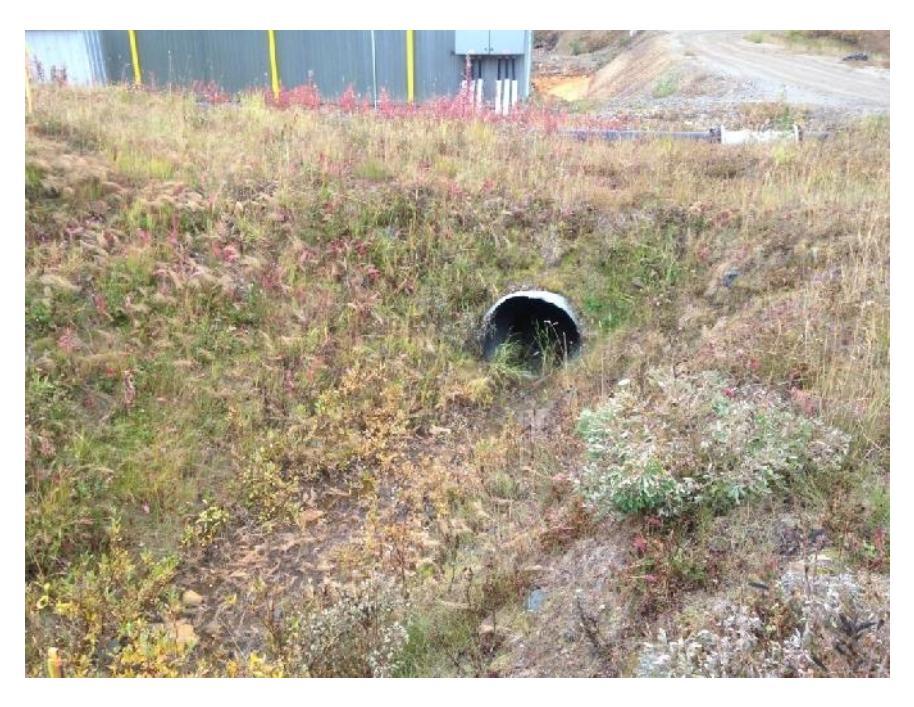
Photo 55: Main ARD Pond Spillway, view of culvert outlet

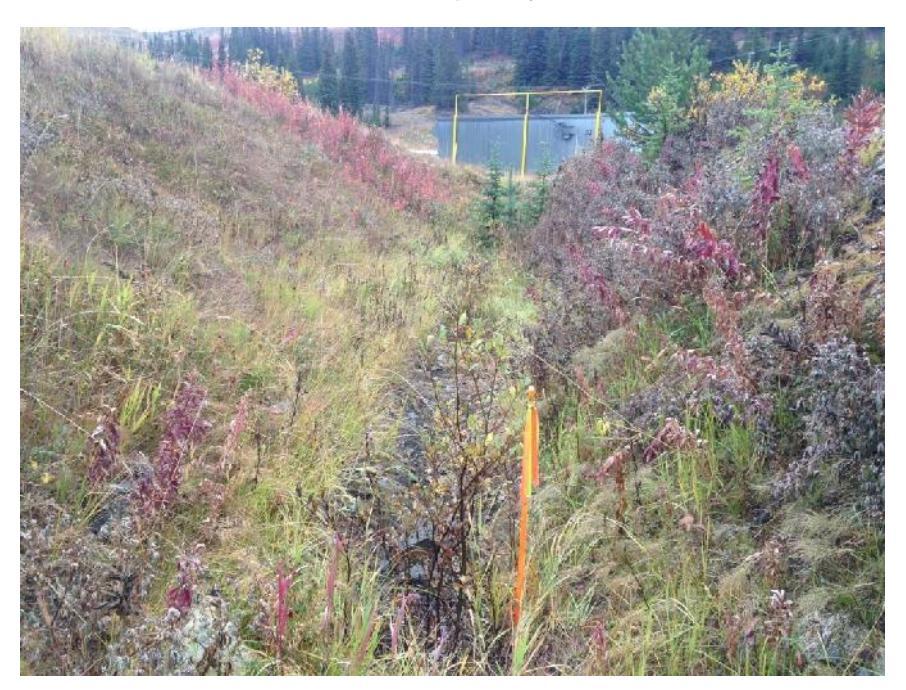
Photo 56: Main ARD Pond spillway. Note excessive vegetation.

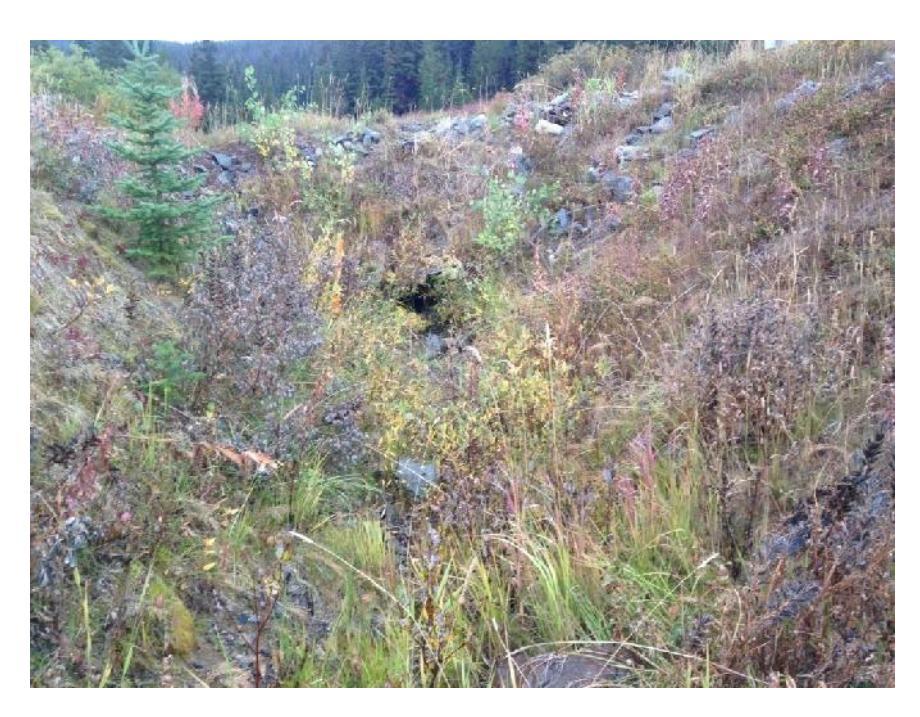
Photo 57: Main ARD Pond Spillway, view of second culvert crossing. Note culvert inlets are partially crushed and obstructed with vegetation.

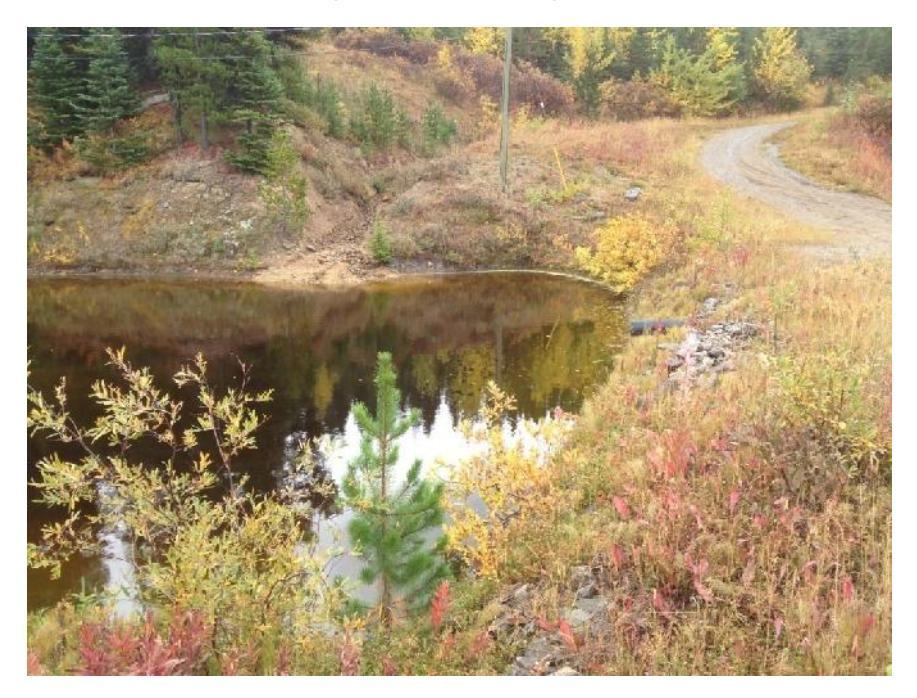
Photo 62: Upstream slope of No. 1 Sump Dam. Note sedimentation at ditch outlet.

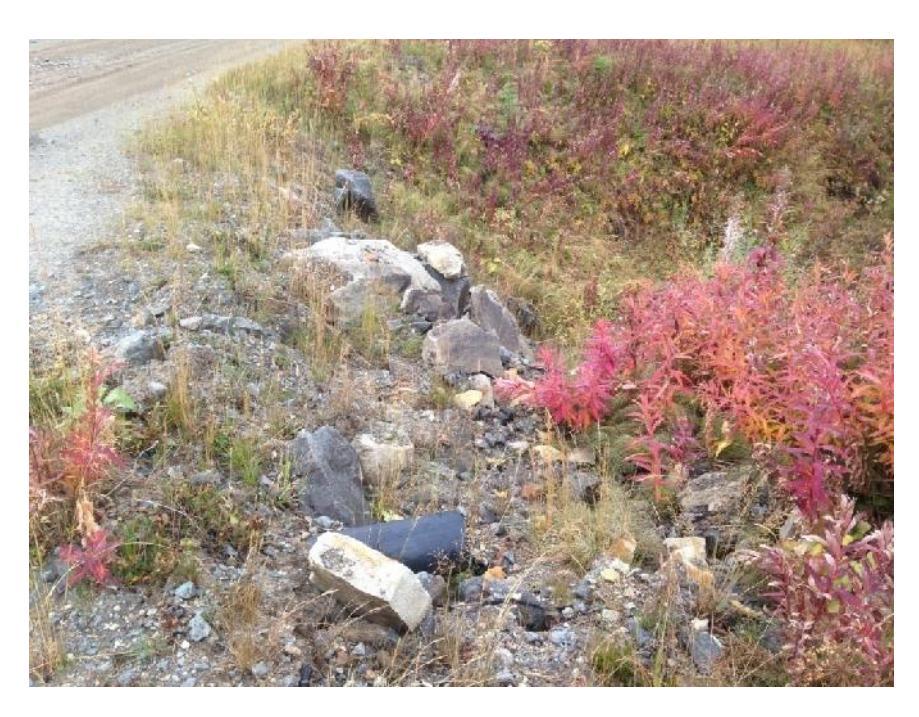
Photo 63: No. 1 Sump Dam, spillway culvert and downstream face. Note excessive vegetation.

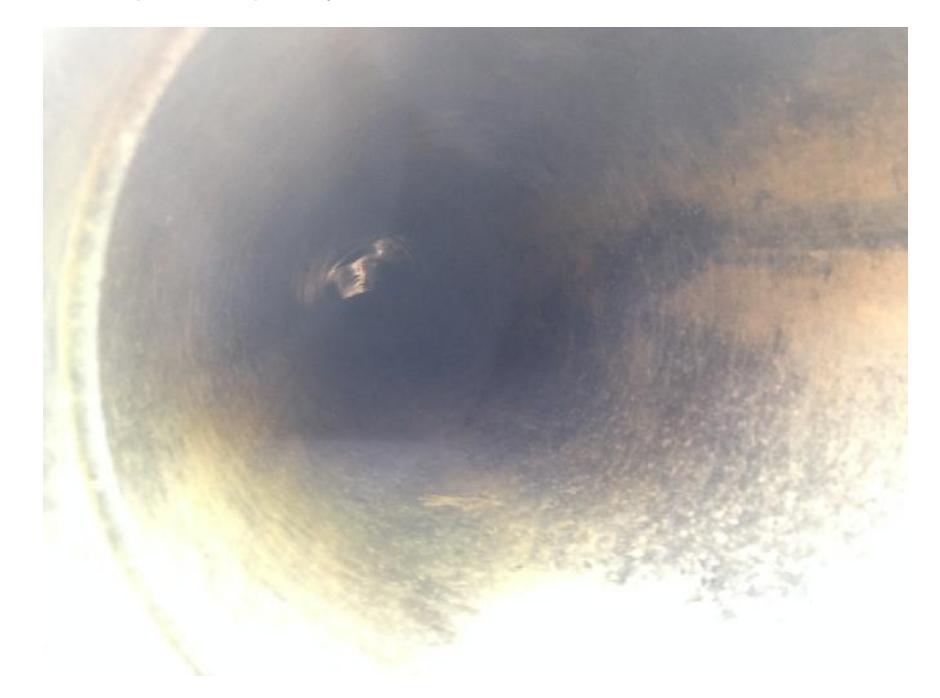
Photo 64: No. 1 Sump Dam spillway culvert, looking upstream. Note bend in pipe.

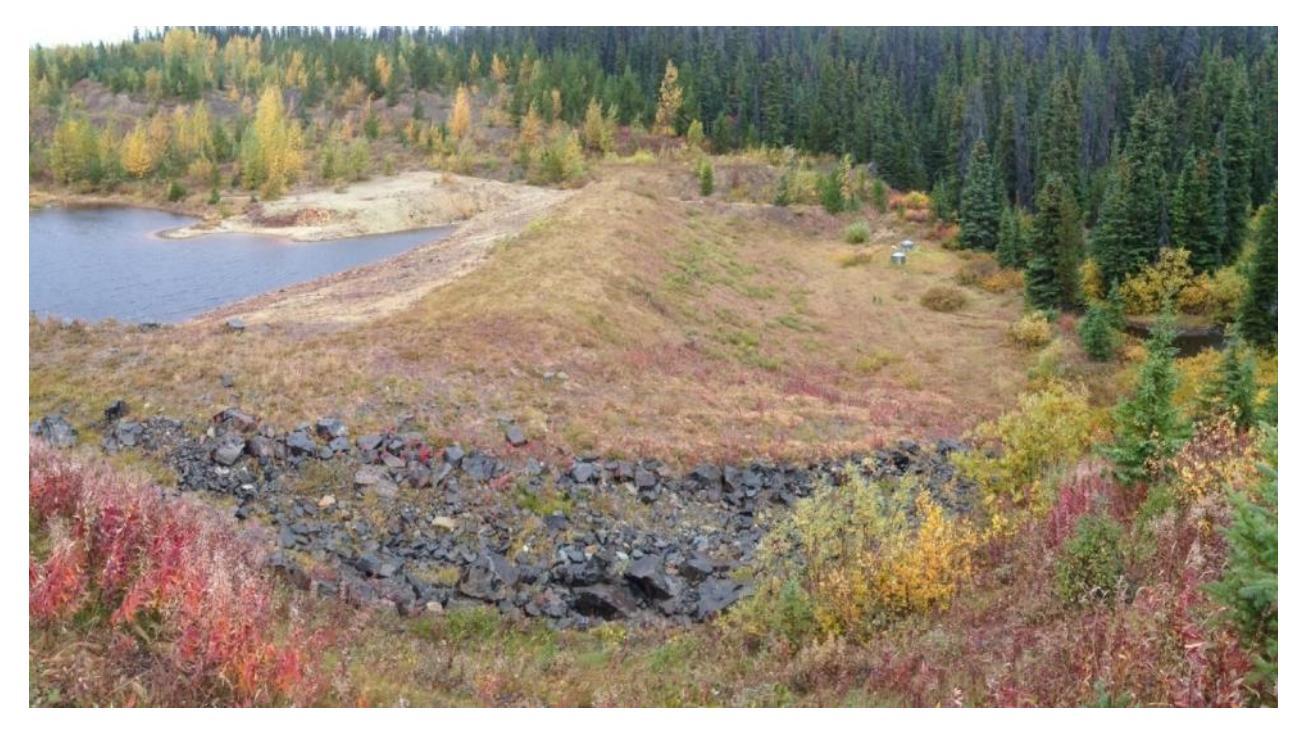
- The shrubs and small trees encroaching on the downstream face of the dam (Photo 66) as well as on the downstream of the fuse plug channel (Photo 70) as noted in previous inspections have been cut back and are well managed.

Photo 66: Dam No. 1 Seepage Collection Pond, view of downstream slope from right abutment.

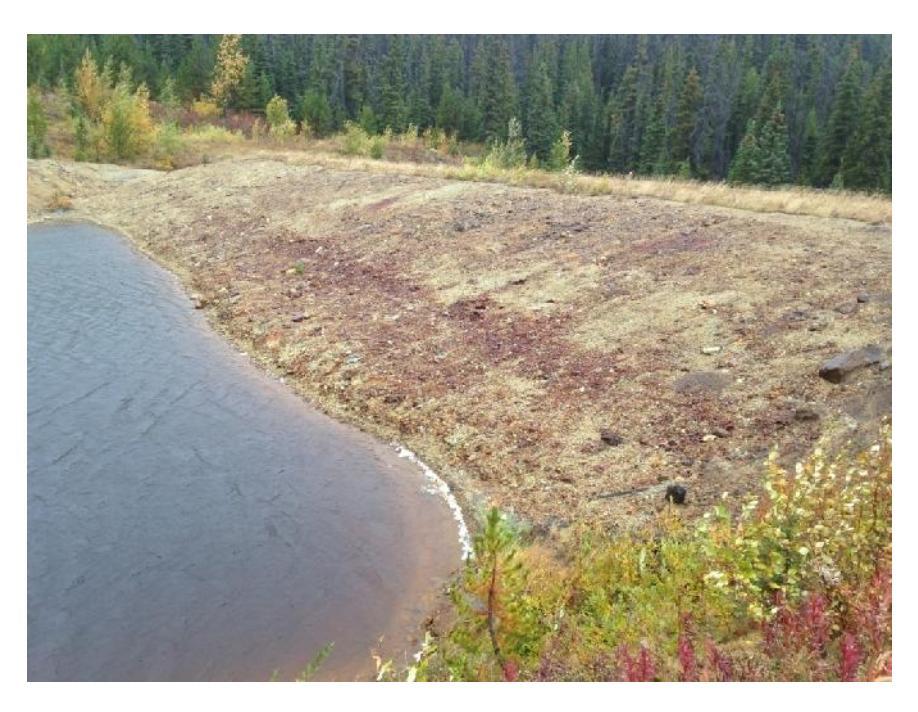
- There is no vegetation and limited erosion protection on the upstream face of the dam (Photo 67) which should be monitored in the future for potential erosion, formation of gullies, or slumping; mainly in the area closer to the water line.

Photo 67: Dam No. 1 Seepage Collection Pond, view of upstream slope from left abutment.

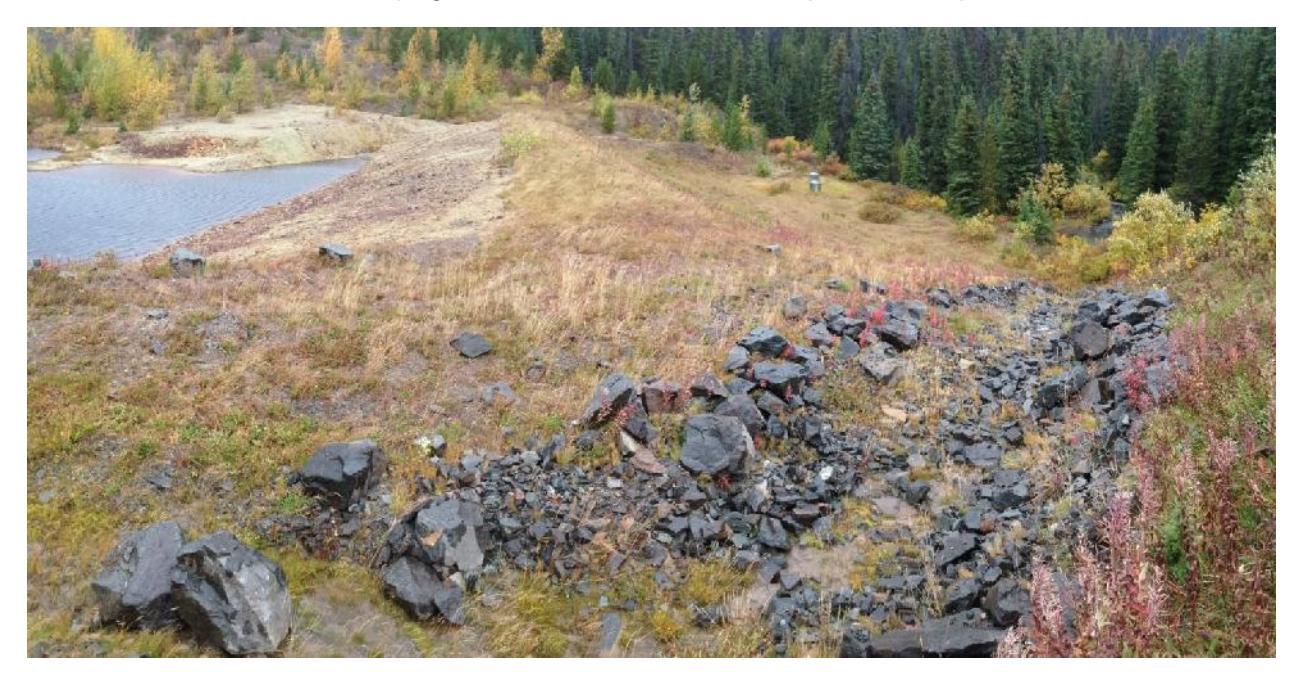
- The right abutment includes a small channel (Photo 68) that is lined with rockfill (for runoff from the eastern hillside). The 2005 inspection noted an erosion gully at the east (right) abutment of the dam caused by runoff from the eastern hillside. The mine repaired this gully by placing geotextile in it and filling it with rock to prevent further erosion in 2008. The area appeared to be in good physical condition at the time of the 2014 site inspection, with no further indication of erosion or damage to the slope or abutment. Continued monitoring of this area is recommended for future inspections.

Photo 68: Dam No. 1 Seepage Collection Pond dam crest.

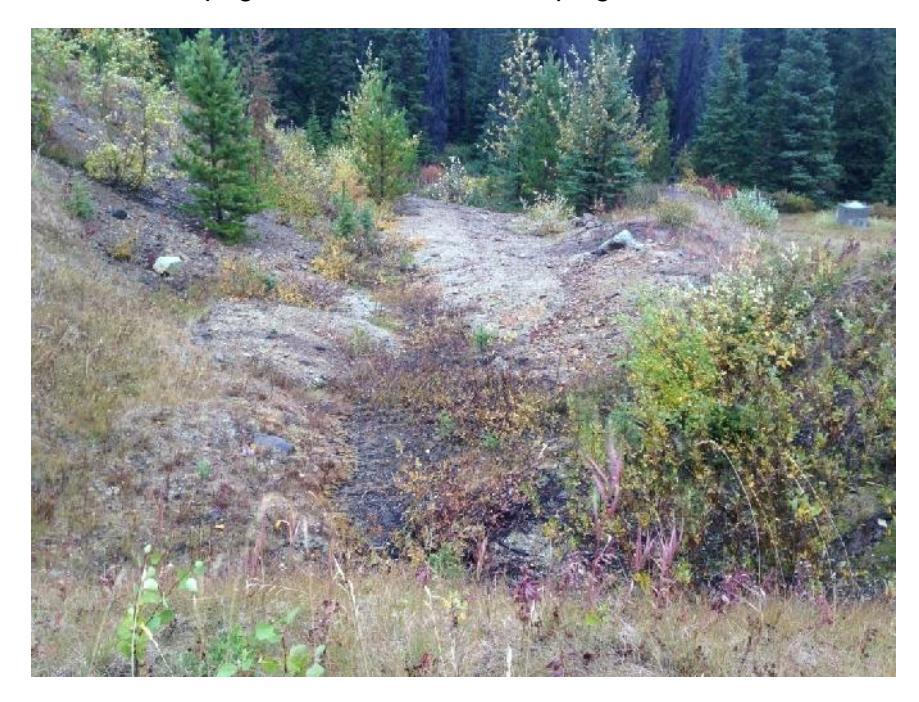
Photo 70: Dam No. 1 Seepage Collection Pond, spillway channel looking downstream.

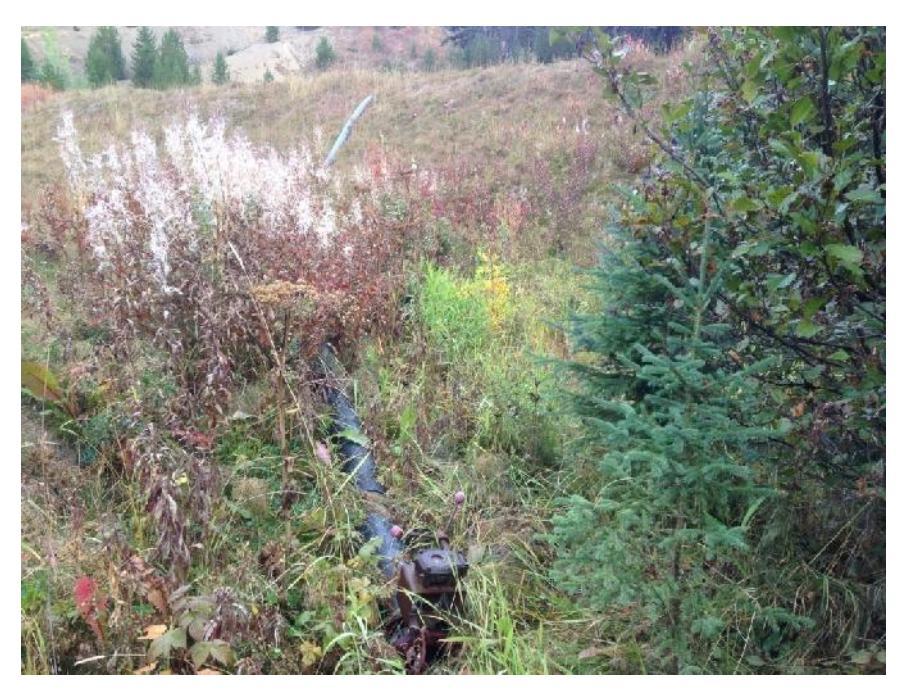
- Vegetation overgrowth noted in previous inspections (2010 and 2011) has been cut back however continued maintenance is recommended to facilitate future visual inspections and prohibit root ingress into the dam structure.
- The siphon pipe (Photos 73 and 74) was slightly flattened where it crossed the dam crest and the outlet was over grown with vegetation.
- Some minor erosion was noted at the outlet of a buried 100 mm diameter HDPE pipeline (presumably from Sump No. 5) on the upstream right abutment of the dam (Photo 75) similar to previous inspections. This area should be monitored as part of routine inspections with erosion protection measures installed as required.

Photo 74: Getty Creek Pond Dam, view of siphon system outlet.

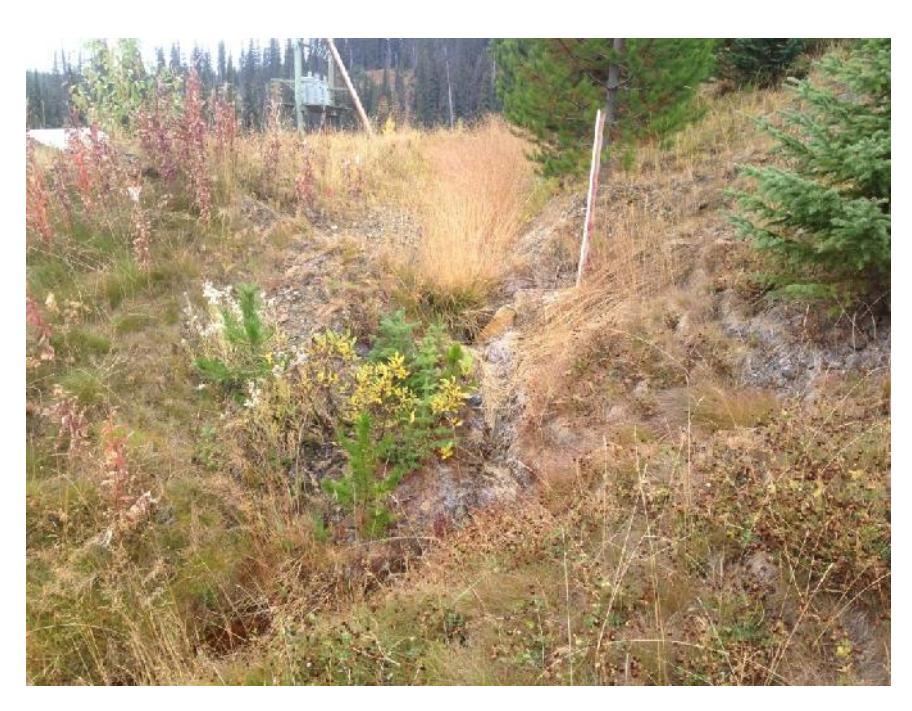
Photo 75: Getty Creek Pond Dam; view of the dam crest at right abutment. Note minor erosion at outlet of crest ditch.

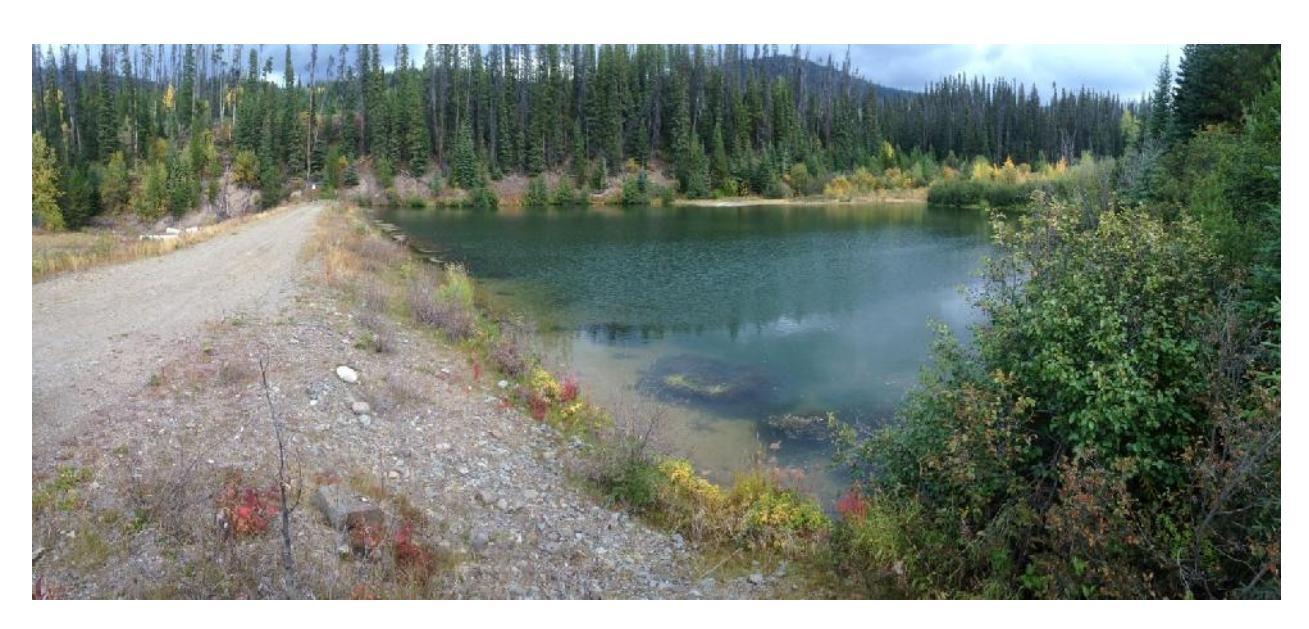
- The spillway inlet should be inspected regularly for potential obstructions with trees and deadfall / vegetation from the surrounding slopes, to avoid flow restrictions.
- Overgrown vegetation noted during previous inspections has been removed from the upstream and downstream slopes of the dam (Photos 81 and 82). However additional vegetation overgrowth was noted on the left and right abutments that should be removed.
- Significant silt accumulation was noted against the upstream face of the dam which should be monitored periodically regarding loss of pond capacity (i.e. sediment settling capacity) and removed as required. No sinkholes or signs of erosion were noted on the upstream face of the dam.

Photo 81: Bessemer Creek Silt Check Dam, view of upstream face and pond from left abutment.

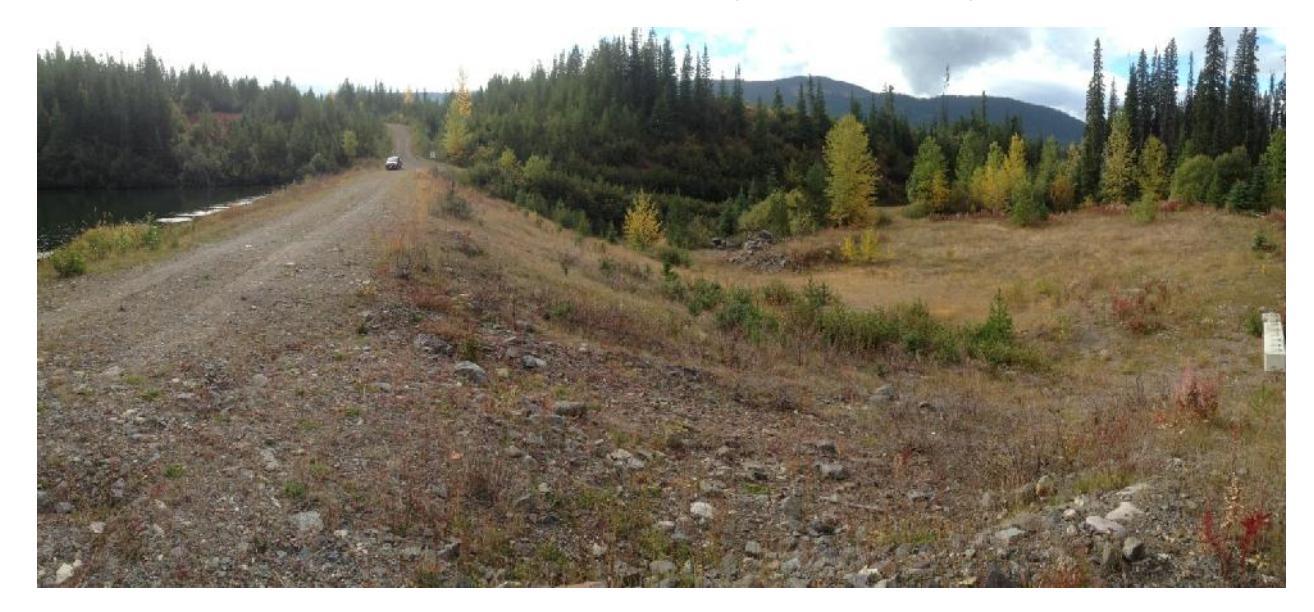
Photo 82: Bessemer Creek Silt Check Dam, view of dam crest and downstream face from right abutment.
