Tailings Impoundment and Water Management Structures 2014 Dam Safety Inspection

Equity Silver Mine Houston, British Columbia

FINAL REPORT

October 14, 2014

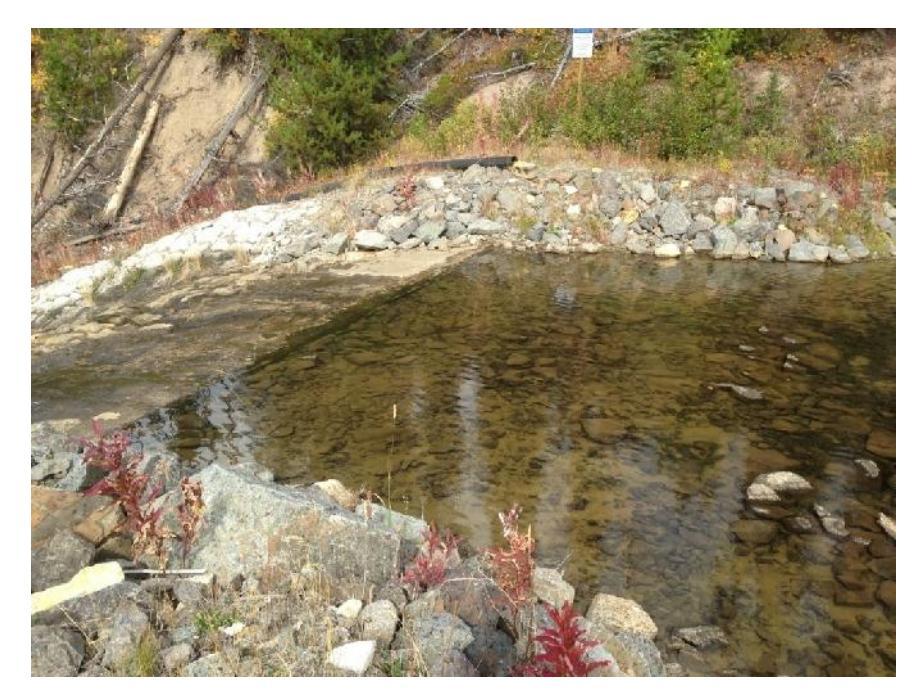
Photo 84: Bessemer Creek Silt Check Dam, view of spillway inlet sill. Note overgrown vegetation on dam crest opposite spillway inlet.

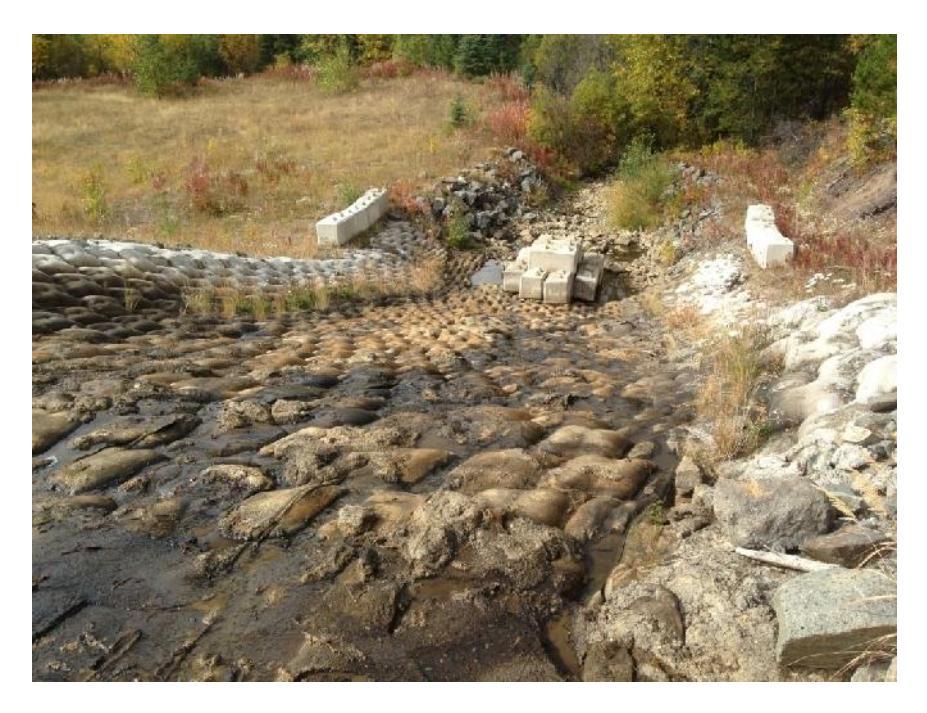
Photo 85: Bessemer Creek Silt Check Dam spillway.

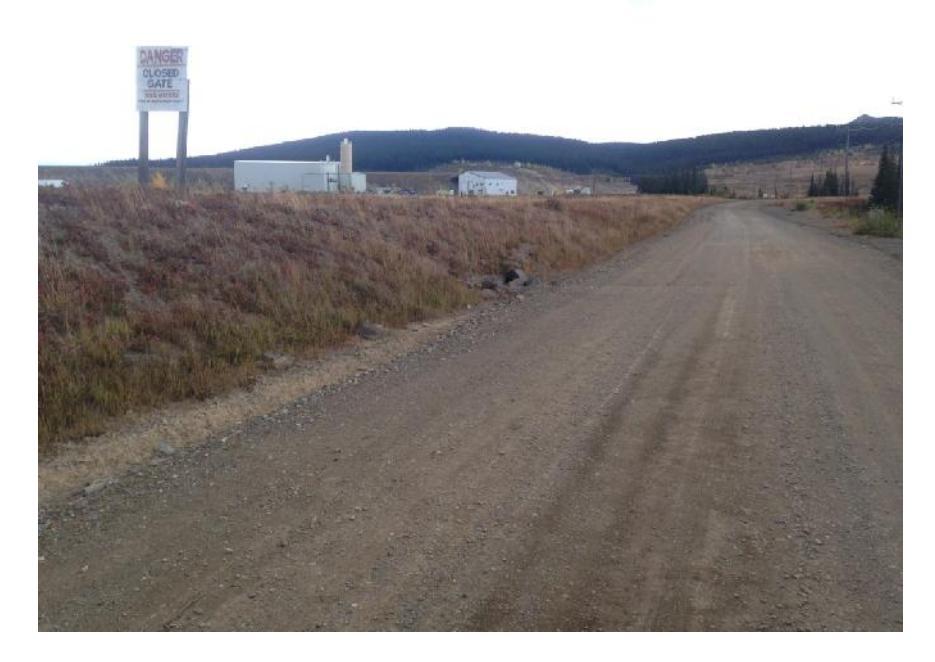
Photo 88: ARD Storage Pond, view of mine access road and downstream side of South dam.

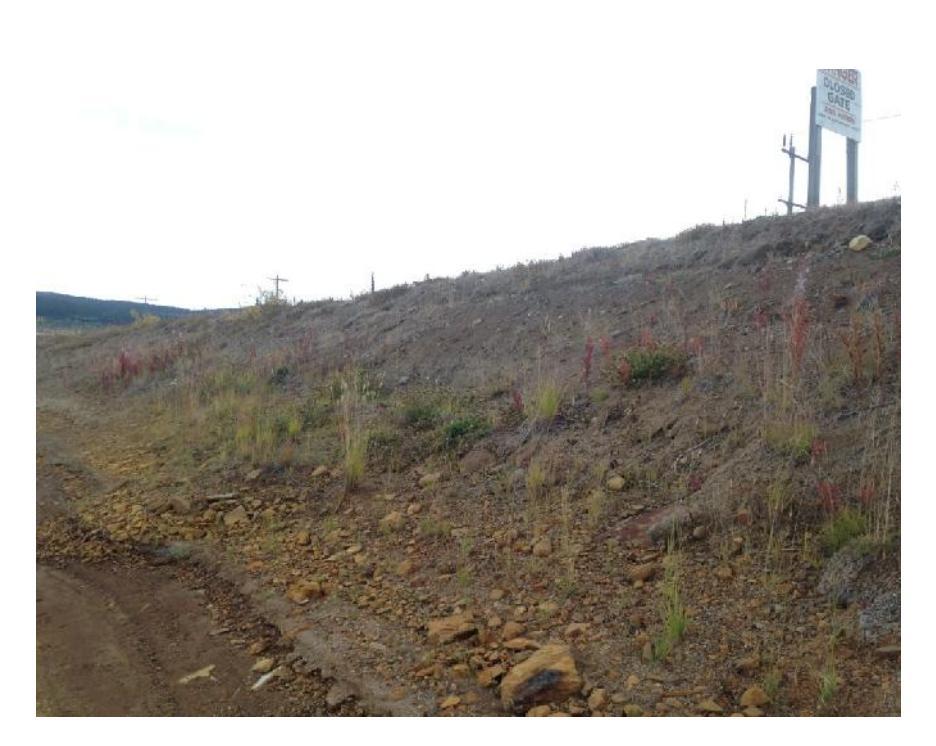
In 2013, a small slump was noted on the upstream face of the South Dike adjacent to the "Closed Gate" sign (Photo 89). An area of coarse rock was also noted at the pond side edge of the access road directly opposite the slumped area (Photo 90) which is connected to a buried road drainage culvert (Photo 91). As-built documents indicate that the culvert terminates at the edge of the road within the coarse rock and does not underlay the dike fill (AMEC 2003b) however the location of the slump directly opposite the active culvert is highly coincidental. It is recommended that the slumped area be

Photo 89: ARD Storage Pond south dam, view of upstream face opposite "Closed Gate" sign. Note slumping of upstream slope above water line.

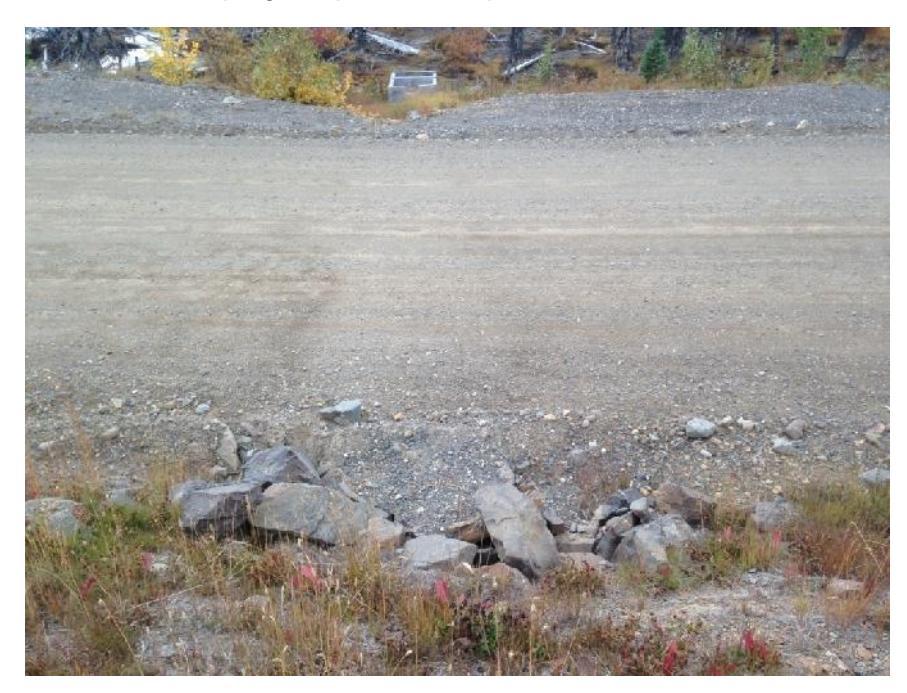
Photo 90: ARD Storage Pond south dam, view of inlet to road culvert (inlet covered with large rock) adjacent to "Closed Gate" sign.

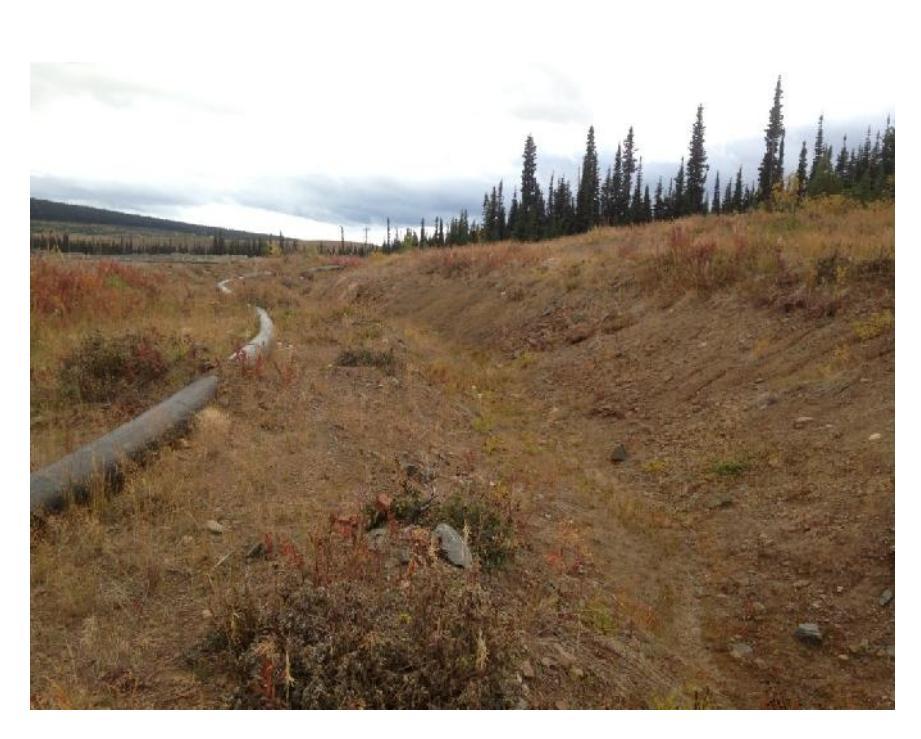
Photo 93: ARD Storage Pond, emergency overflow trench

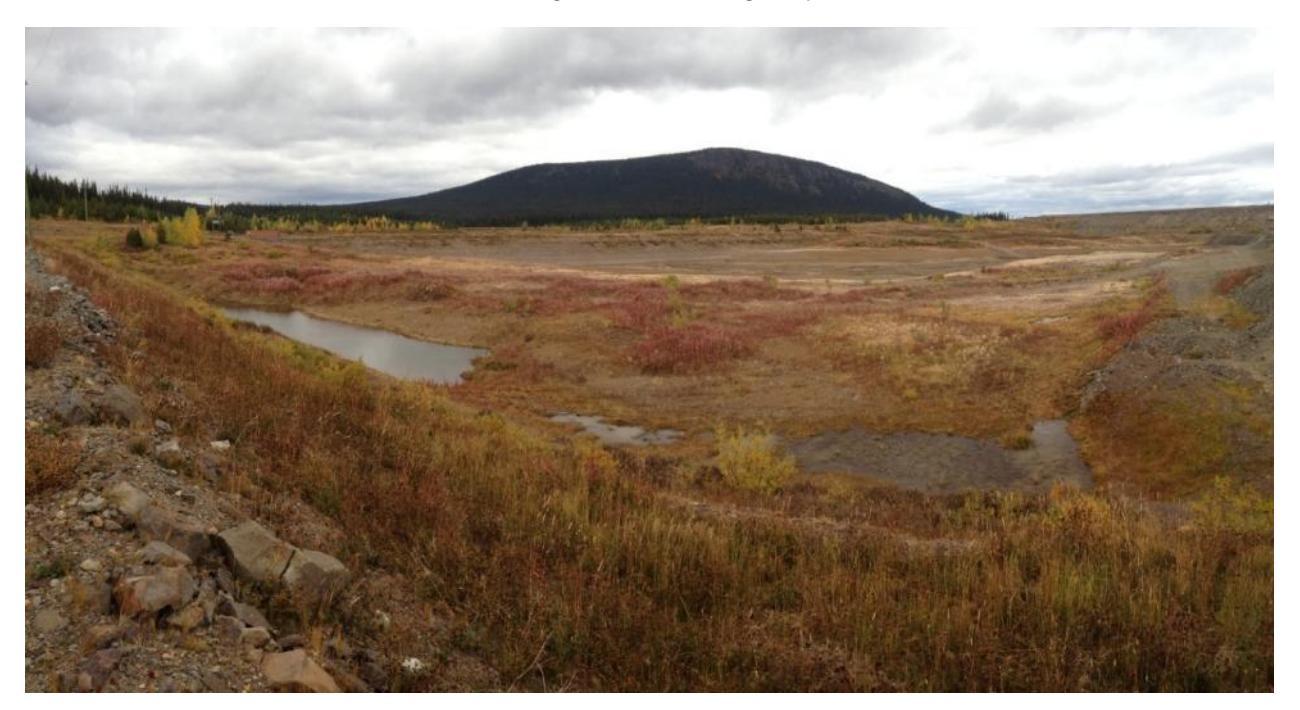
The water levels were fairly low during the DSI (Photos 94 and 95). The Splitter Dike is a relatively new structure and appeared to be in very good condition at the time of the inspection. The following observations were made during the field inspection:

Photo 94: Splitter Dike, view from Diversion Pond side.

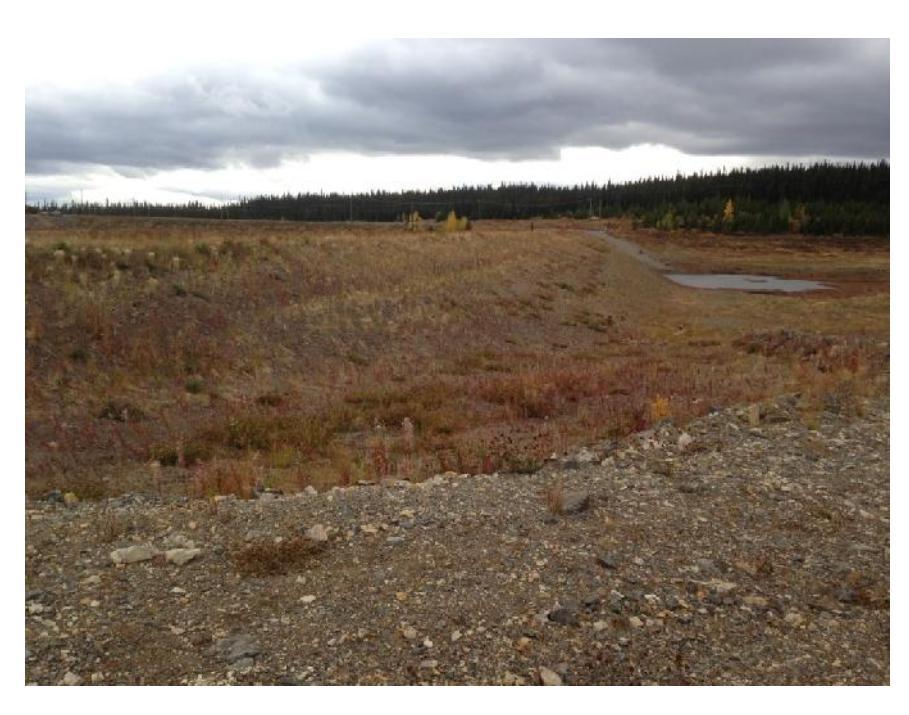
Photo 95: Splitter Dike, view from the north abutment at the Emergency Pond side.

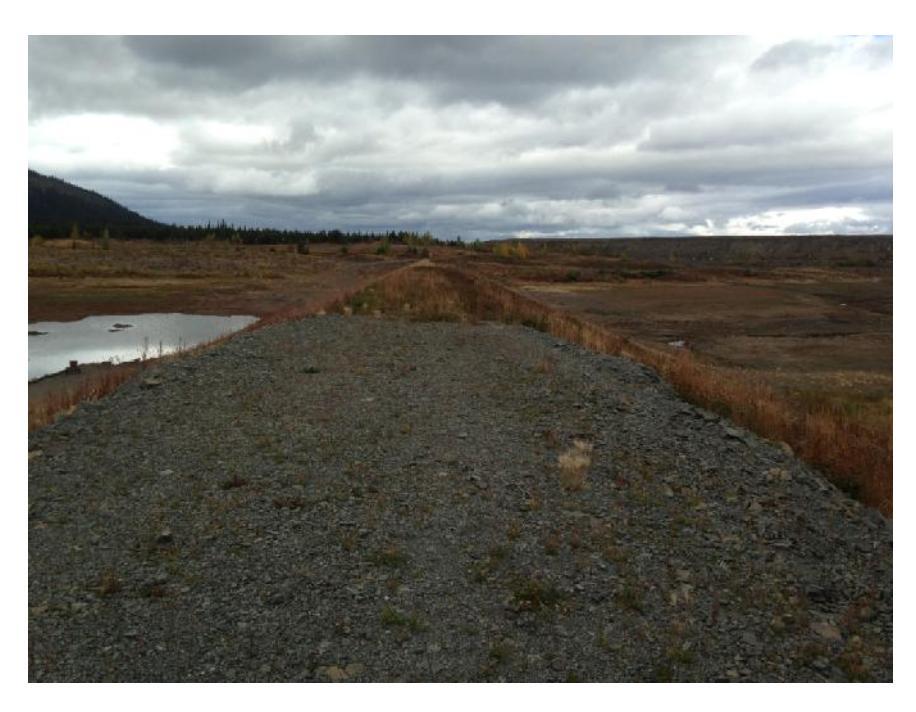
Photo 97: Splitter Dike, view from the south abutment crest. Note low water level on both sides.

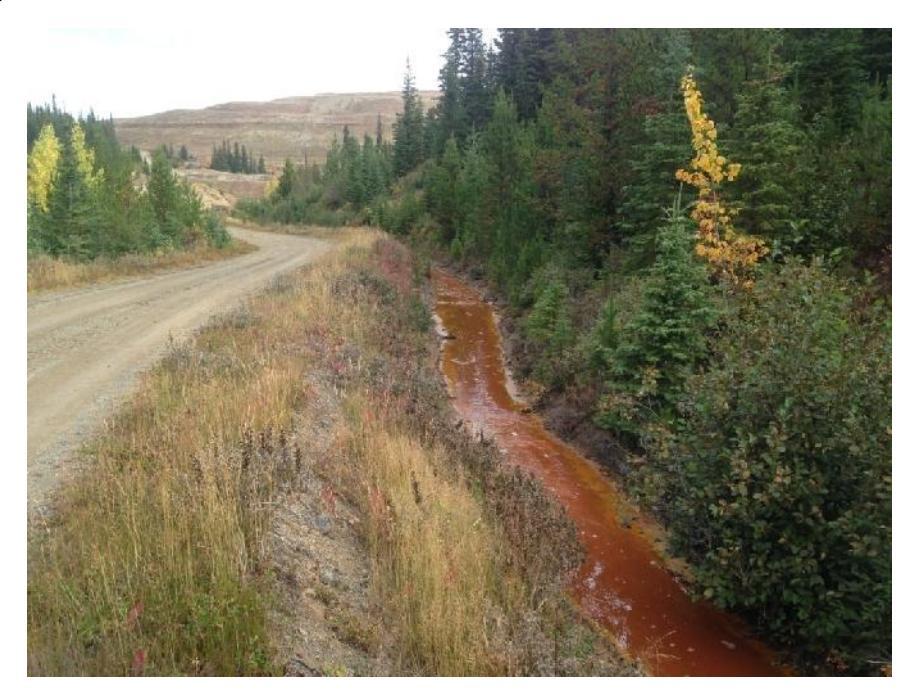
The collection ditches intercept ARD discharging from the waste rock dumps, the old plant site, and Getty hillside, and direct it to the ARD Collection Ponds (Photo 98).

Photo 98: Main ARD Collection Ditch typical view upstream of weir.

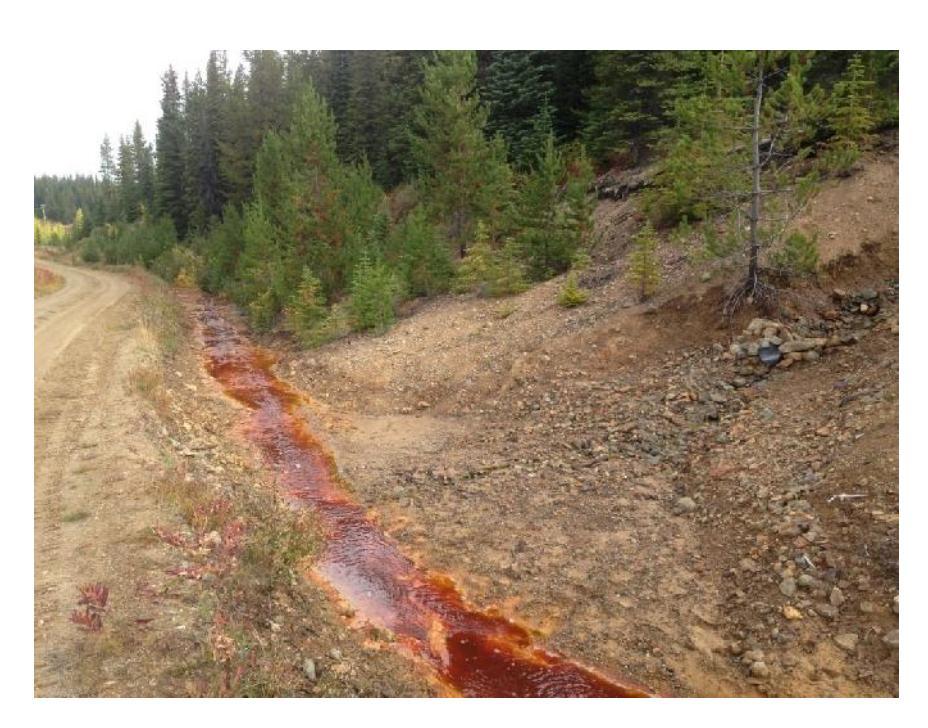
The ARD collection ditches appeared to be in good physical condition at the time of the inspection. In general, some slumping of surface cover material occurs every year along various sections of the ditches and this material is periodically cleaned out (Photo 99). To date, these surface slumps have not affected the performance of the ditches and are not considered to be significant. However, monitoring should continue as part of the annual review process. To maintain continued performance and sufficient capacity, periodic inspection should continue with repairs and clean-outs being made as required.

Photo 99: Main ARD Collection Ditch. Note sediment accumulation in the ditch from ARD side drainage.

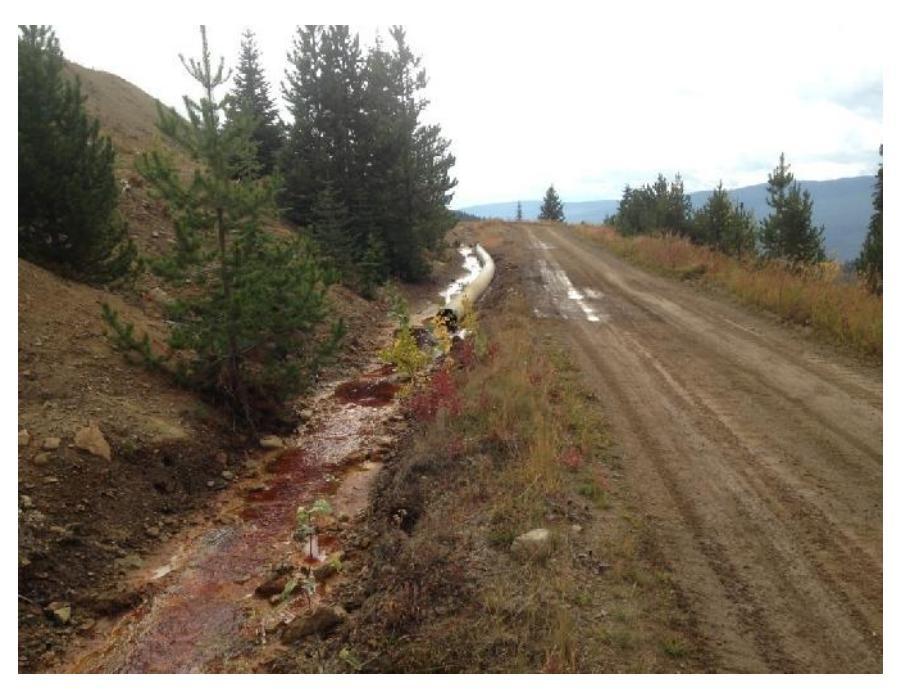
A bypass HDPE culvert is located approximately 500 m up the main ARD Collection Ditch from the Main ARD Pond. The pipe was installed to divert ARD flows around a segment of the ditch founded in more pervious sand and gravel material at the south-western corner of the waste dump. The pipe was replaced in 2012 with a new 450 mm diameter HDPE pipeline to enhance flow capacity and reduce sedimentation in the pipe (Photos 100 and 101).

Photo 100: Main ARD Collection Ditch Bypass Pipe outlet.

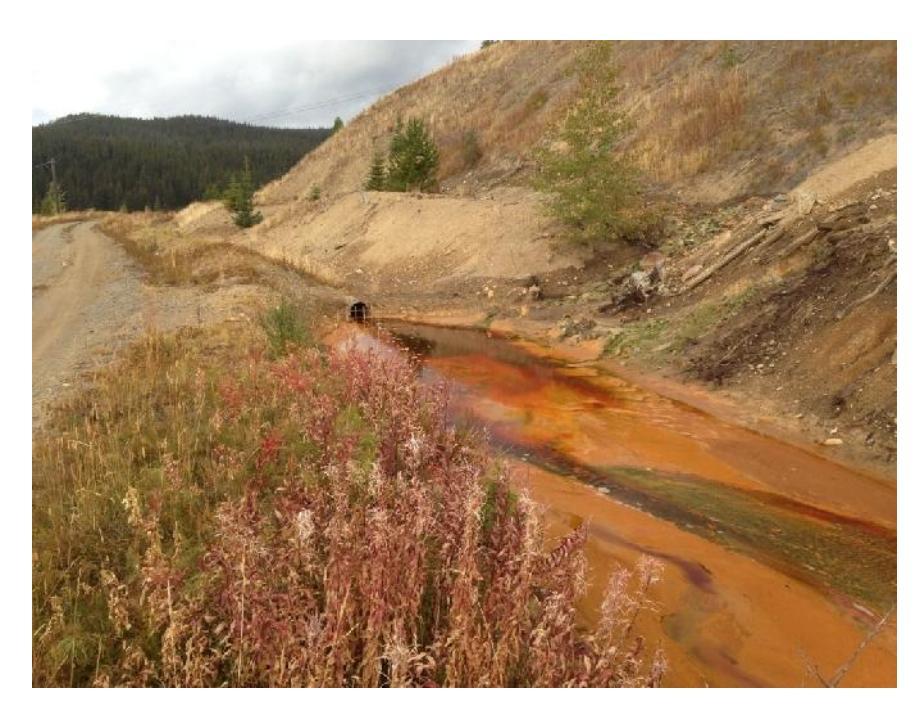
Photo 101: Main ARD Collection Ditch Bypass Pipe inlet.

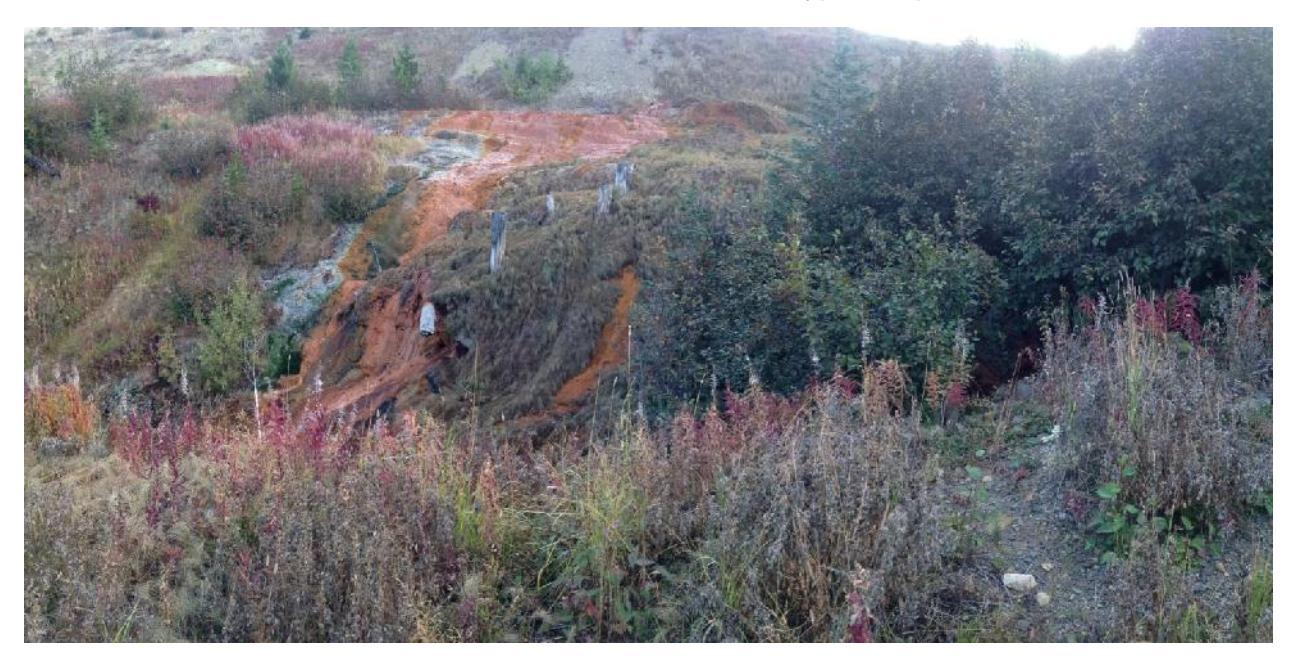
From the inspections in 2003 to 2014, the "bulge" area does not appear to have changed significantly, except for the growth of vegetation and formation of precipitate (Photo 102). However, Equity staff has noted that the location of primary seepage flow discharging to the Main ARD ditch has moved slightly to the Northeast. It is recommended that this area continue to be inspected as part of the annual review and after heavy rain events. If changes are noted on the slope, including movement, tension cracks, or increased seepage, the slope should be investigated further.

Photo 102: Southern Tail Pit Bulge, looking North from below.

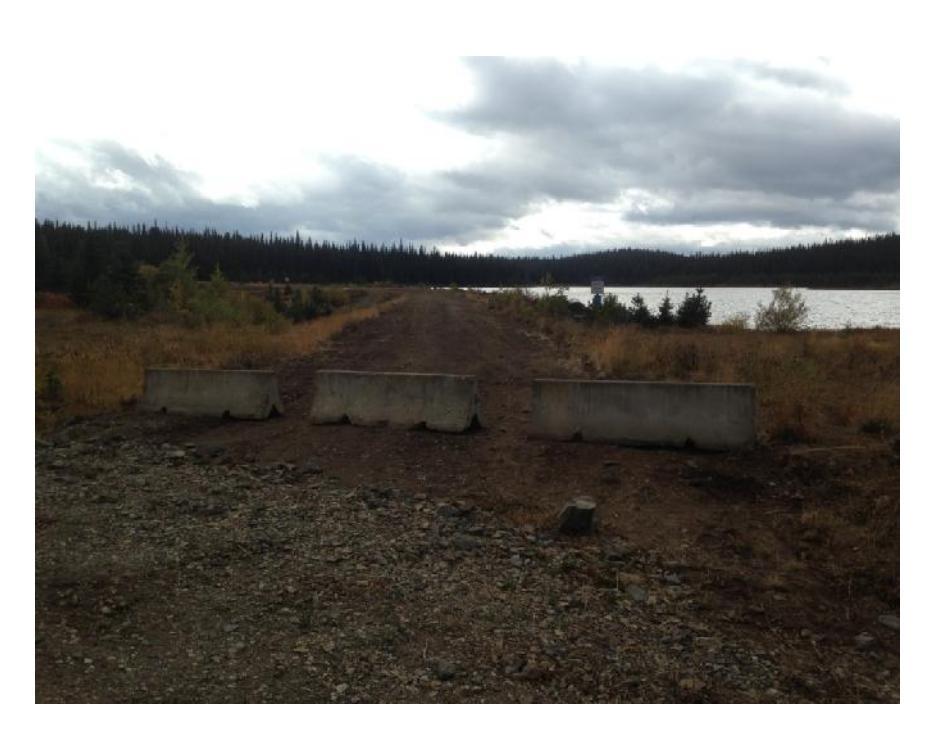
- The crest of the North Dam has been recently graded to repair rutting and ponded water as noted in previous inspections. Road barriers have been installed at the entrance to the north dam crest to inhibit public vehicle access and reduce future rutting (Photo 103).
- Vegetation overgrowth (i.e. large shrubs and trees) was noted along both dams (Photos 104 and 106); vegetation maintenance should be completed, both on the crest and along the slopes of the dams to facilitate future visual inspections.
- Standing water was noted at the downstream toe of the South Dam (Photo 107). Although it is not clear if this causes any problems in terms of stability of the dam, consideration should be given to the practicality of providing positive drainage in this area to direct water away from the dam toes.

Photo 103: Lu Lake North Dam, view of dam crest from left abutment. Note dam crest has been graded and access to dam crest restricted with barriers.

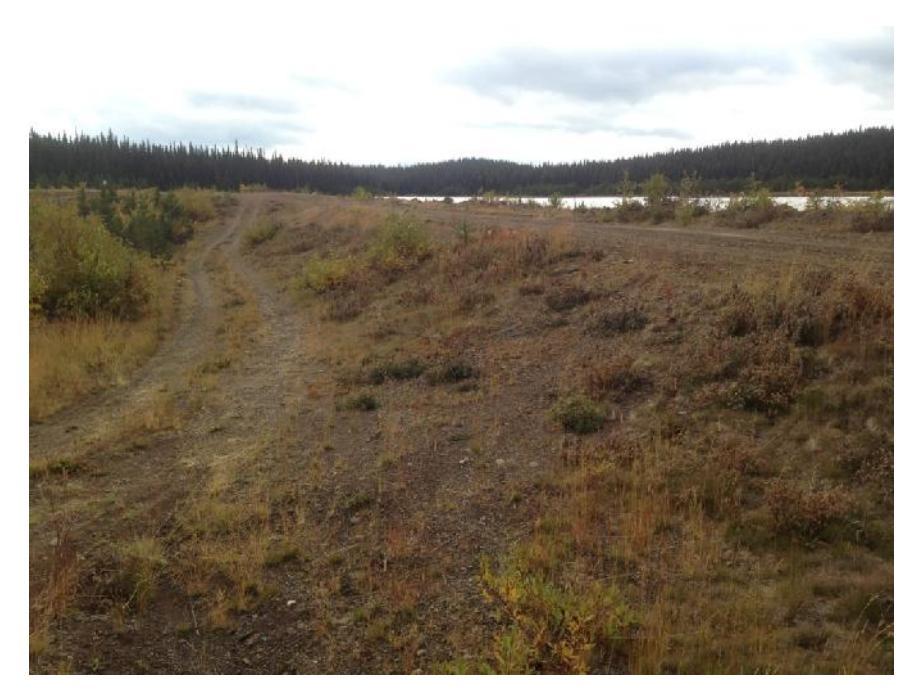
Photo 104: Lu Lake North Dam downstream slope, view from left abutment.

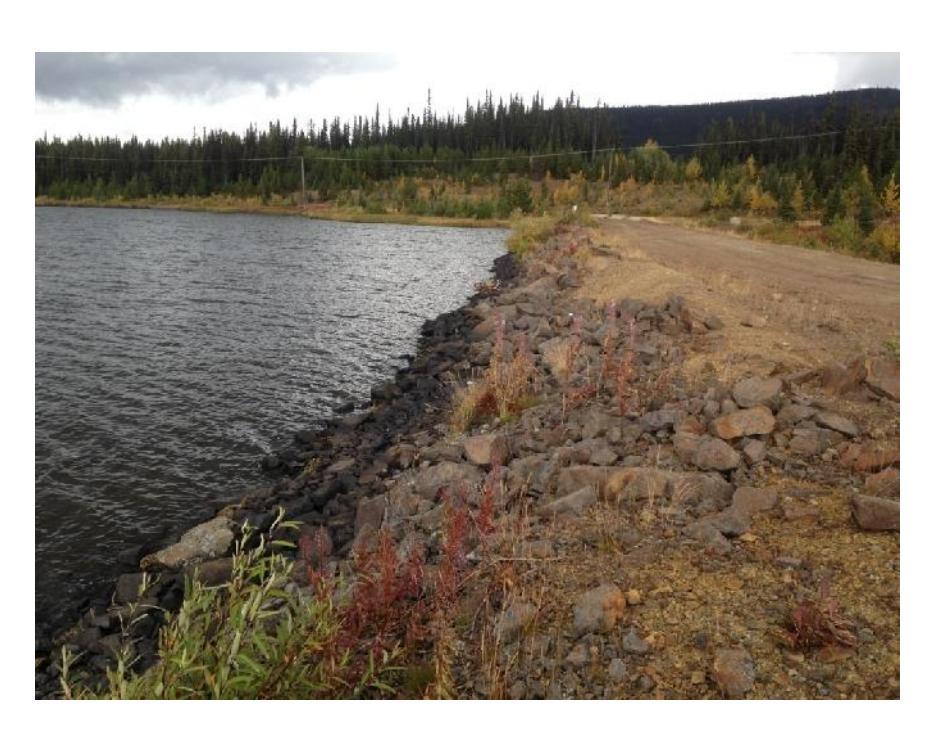
Photo 105: Lu Lake North Dam, view of upstream face and erosion protection looking towards the left abutment.

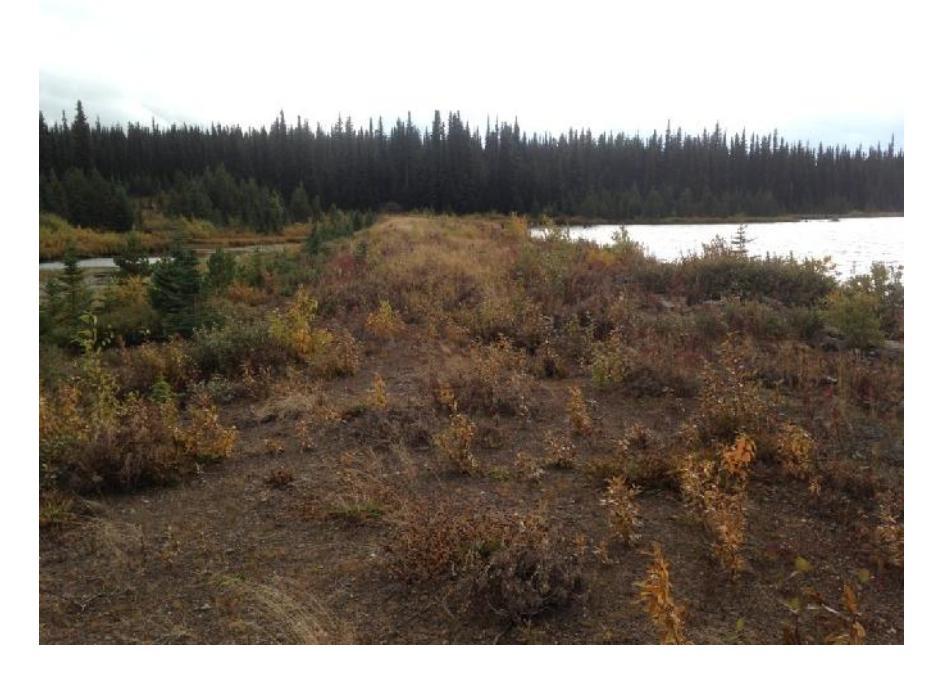
Photo 106: Lu Lake South Dam, view of dam crest from spillway inlet channel.

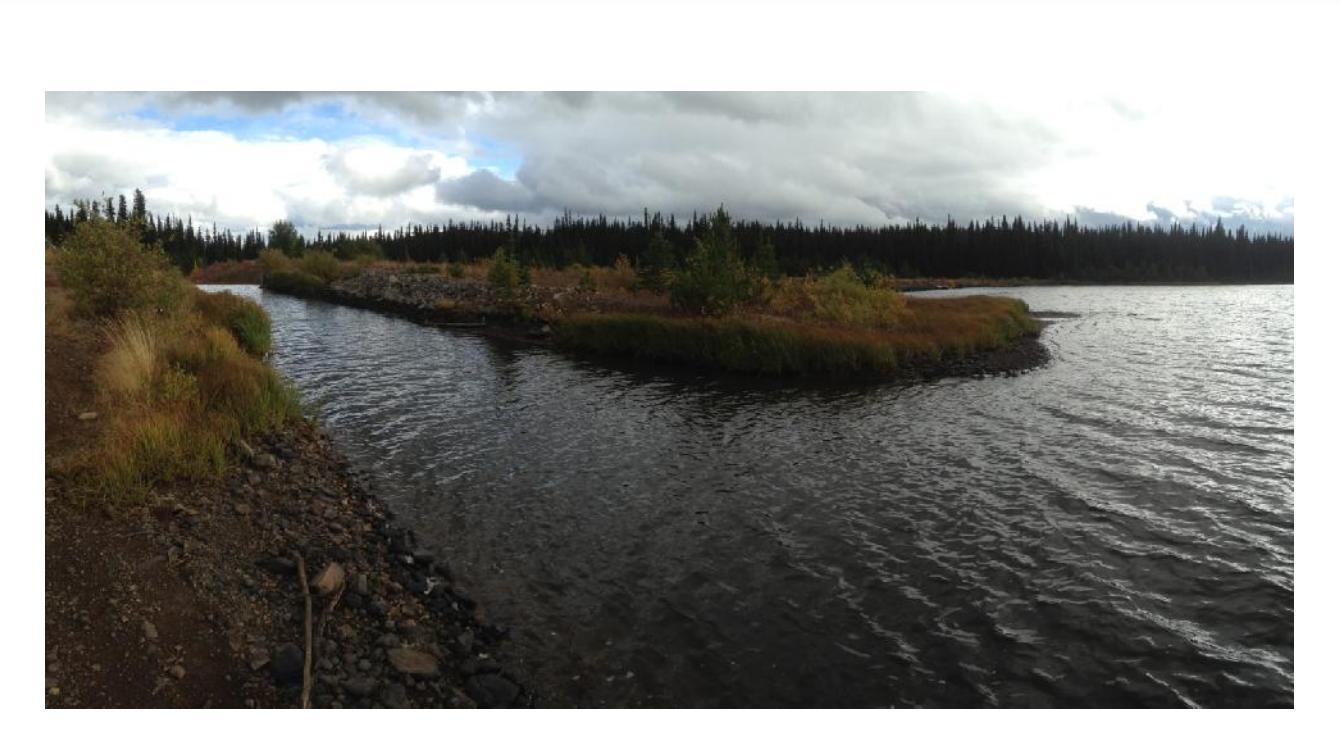
The lake water level is controlled by the elevation of the stop log weir structure (Photos 109 and 110). At the time of the site inspection Equity staff were in the process of removing the wooden weir boards for replacement. The water level was being drawn down at a rate of one board per day. New weir boards will be installed to a level sufficient to provide the requisite amount of freeboard during flood routing (weir level requirements are currently being assessed).

Photo 109: Lu Lake spillway inlet channel looking downstream.

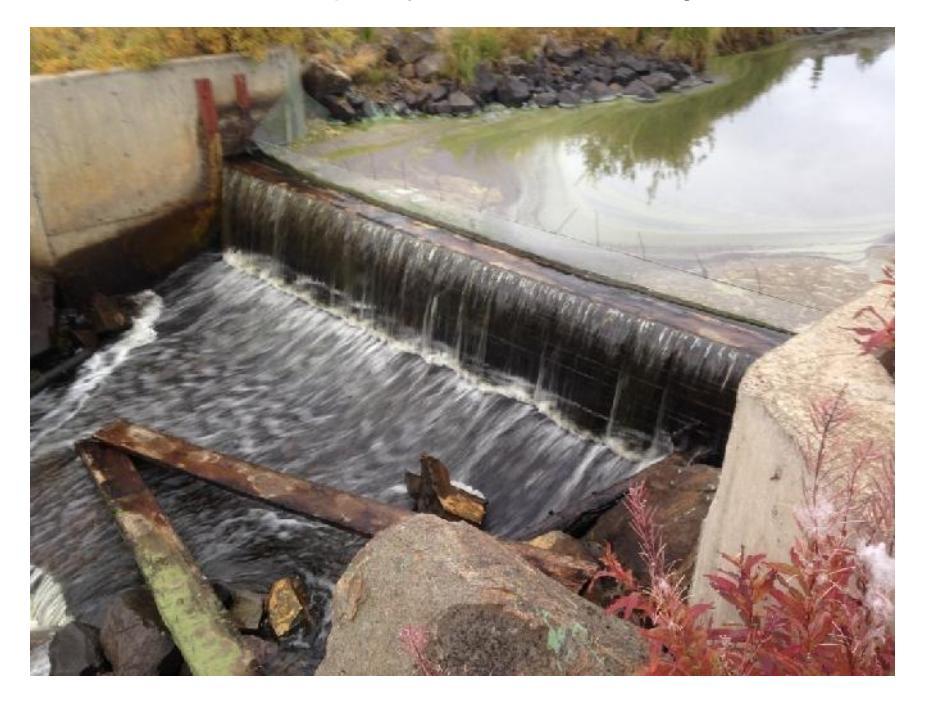
Photo 110: Lu Lake spillway weir. Note wood being removed to lower level, and waterline visible on sidewall.
